Race Street Quarterly Site Progress Report Third Quarter 2011

2000 Race Street Baltimore, MD

Appendix A Site Inspection Reports

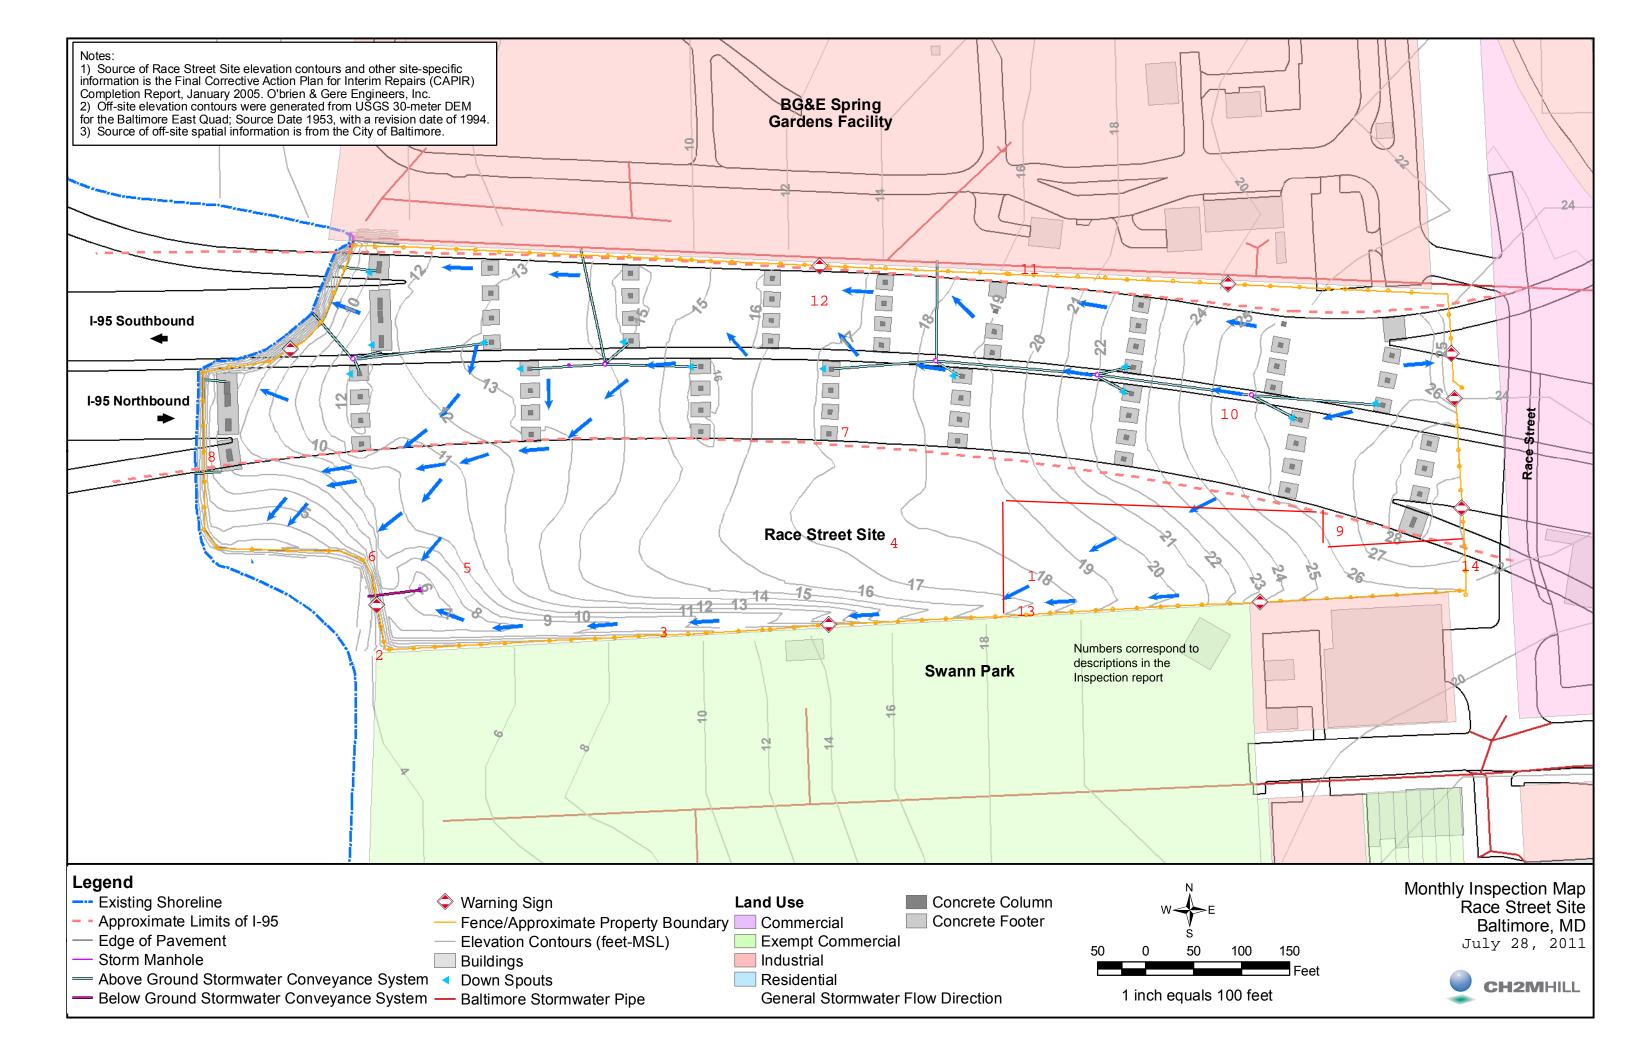
3. Engineered Cap				
Inspect cap for alligator cracking. Identify estimated	9) 20'X20' Area with asphalt cracking		TBD	Asphalt repairs to be performed as part of ongoing
area of cracking and location via description or on				2011 O&M activities.
Site Plan (attach to Monthly Site Inspection				
Checklist)				
Inspect cap for holes. Identify number of holes, width	5) Localized erosion at former boring location	None	TBD	Asphalt repair to be performed as part of scheduled
and depth, and location via description of on Site				2011 drilling activities.
Plan (attach to Monthly Site Inspection Checklist)				
Inspect cap for cracks less than 0.5 inches wide.	1) ~50' of cracks w/ vegetation	None	TBD	Asphalt repairs to be performed as part of ongoing
Note number of cracks. Identify location of cracks via	l '			2011 O&M activities.
description or on Site Plan (attach to Monthly Site	6) ~70' of cracks ~3/4" along slope ridge

Inspection Checklist).	11) 20' of cracking w/ vegetation			
Inspect cap for cracks greater than 0.5 inches wide.	None	None	NA	NA
Note number of cracks. Identify location of cracks via				
description or on Site Plan (attach to Monthly Site				
Inspection Checklist).				
Inspect cap for any signs of ponding of water	12) 15' X 10' - localized standing water	None	TBD	Asphalt repairs to be performed as part of ongoing
				2011 O&M activities
Inspect shorefront embankment for evidence of	None	None	NA	NA
erosion or releases

10) 100 100 100 100 100 100 100 100 100	.	TDD	
Identify any other observations related to the	10) MW-14 bollad damaged	None	TBD	Well to be repaired during scheduled 2011 drilling
condition of the cap and potential for cap damage				activities.

4. Fence				
Inspect fence for holes. Note number of holes.	2) Temporary repair remains intact	None	NA	Section of fence was noted to be damaged during
Identify location of holes via description or on Site	2) Tomporary repair formains intact	110.10	13/1	previous inspections and was repaired by the City.
Plan (attach to Monthly Site Inspection Checklist).				providuo inopediiono and was repaired by the Oity.
i ian (attaon to monthly ofte mapection offection).				
	<u> </u>	ļ	1	<u> </u>

Site Inspection	Results			
Task	Observations	Actions Taken	Date Completed	Comments/Additional Observations
Inspect fence to determine if there is any erosion	None	None		NA
compromising the integrity of the fence				
	None	None	NA	NA
condition		1.10.10		
Inspect gates, chains, and locks for damage	13) Gates between the parking area and the	City posted two signs at gates	TBD	Gate damaged by BGE vehicle; BGE to pay for
	park are open.	noting that the gates will be locked		gate repair

14) Gates between Race Street and the	after sporting events.		
	parking area are damaged and are open.			
Inspect fence to determine if any vegetation is	11) Vegetation in barbed wire	None	TBD	City performs vegetation control during ongoing
damaging or otherwise compromising fence				O&M activities.
Inspect fence to determine if there is any burrowing	None	None	NA	NA
beneath fence				
Identify any other observations related to the	None	None	NA	NA
condition of the fence and potential for fence				
damage (e.g., points of weakness, corrosion)				
J (3/1

5. Aboveground Stormwater Conveyance System			•	
Inspect aboveground stormwater conveyance	8) Down spout pipe leader disconnected	None	TBD	MDTA notified of need to reattach pipe leader.
system including piping, downspouts, and drain in	,			• •
southwest corner of site for proper operation

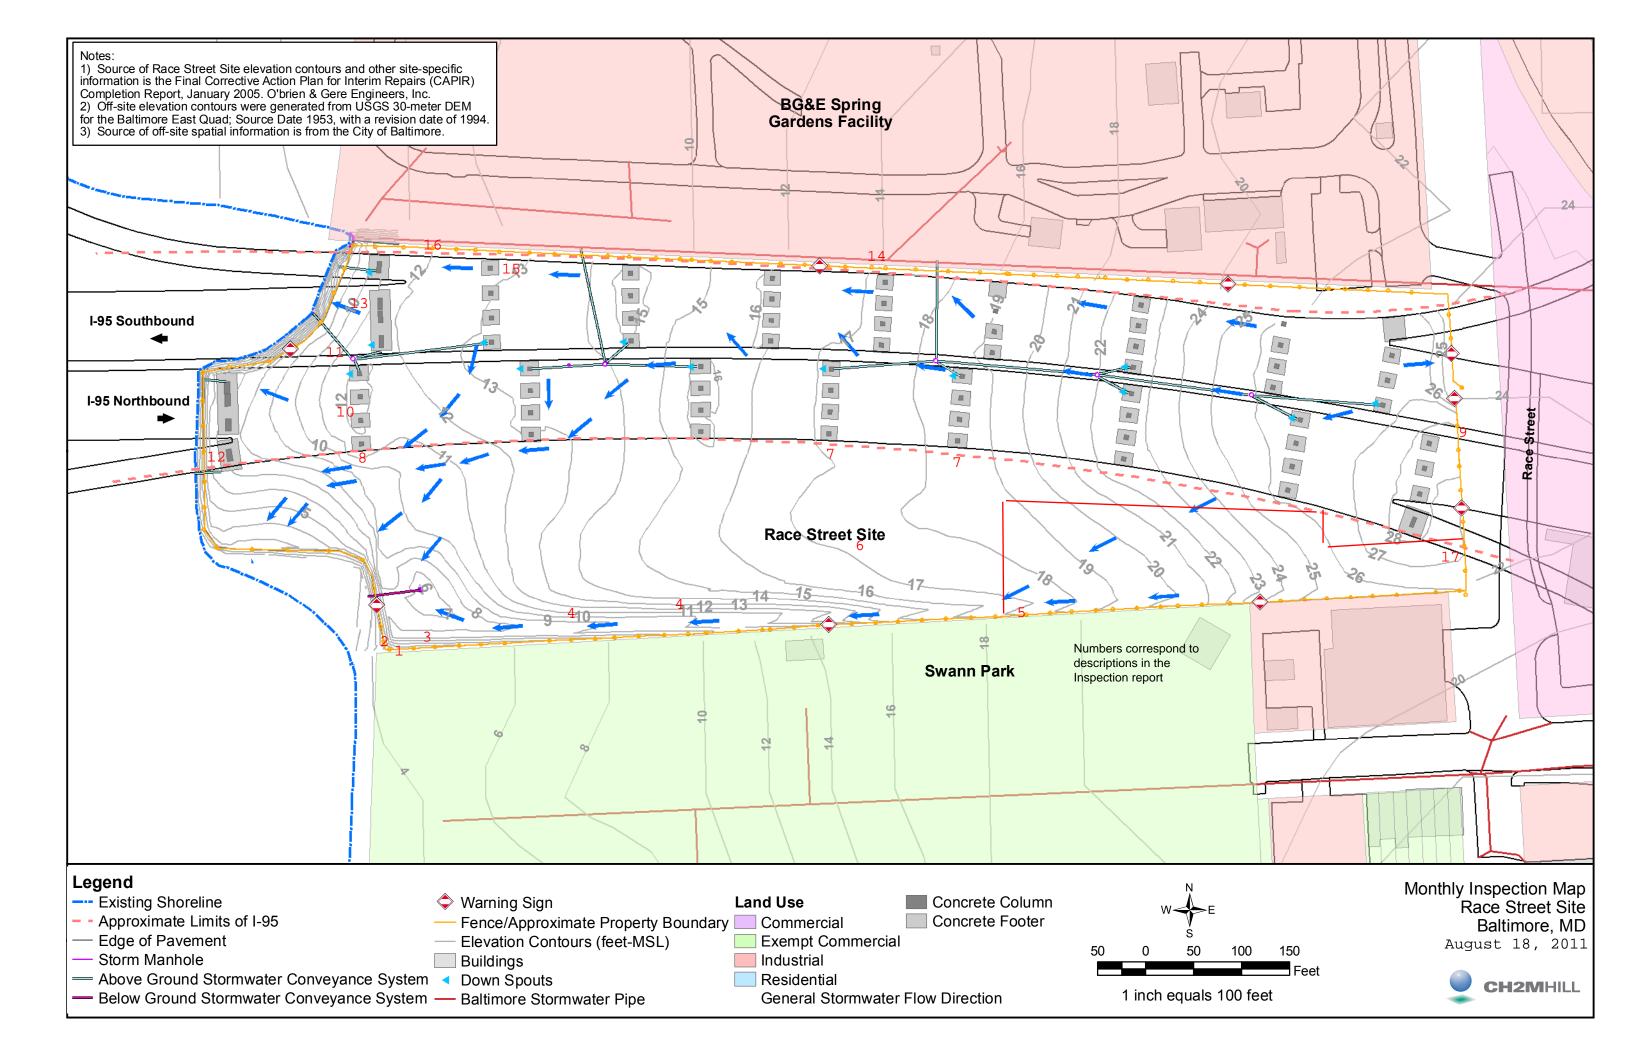
3. Engineered Cap	T			
Inspect cap for alligator cracking. Identify estimated	None	None	NA	NA
area of cracking and location via description or on				
Site Plan (attach to Monthly Site Inspection				
Checklist)				
Inspect cap for holes. Identify number of holes, width	None	None	NA	NA
and depth, and location via description of on Site				
Plan (attach to Monthly Site Inspection Checklist)				
Leavest and for any lades they O.F. independent	Adv Allianten and a	None	TDD	A sub-alt associated by a sufficient discount of a succion
Inspect cap for cracks less than 0.5 inches wide.	11) Alligator cracks	None	TBD	Asphalt repairs to be performed as part of ongoing 2011 O&M activities.
Note number of cracks. Identify location of cracks via				2011 O&W activities.
description or on Site Plan (attach to Monthly Site Inspection Checklist).				
Inspect cap for cracks greater than 0.5 inches wide.	3) Cracks ~ 30' offset	None	TBD	Asphalt repairs to be performed as part of ongoing

Note number of cracks. Identify location of cracks via	-,	None	טפו	2011 O&M activities
description or on Site Plan (attach to Monthly Site				2011 Odivi activities
Inspection Checklist).				
Inspect cap for any signs of ponding of water	None	None	NA	NA
inspect cap for any signs of ponding of water	TVOTO	TVOTE	100	
Inspect shorefront embankment for evidence of	9) localized surface erosion near entrance	None	NA	Eroded areas to be addressed as part of 2011
erosion or releases	gate			O&M activities.

14) localized erosion of drainage feature			
Identify any other observations related to the	8) Localized surface cracking	None	NA	(8) cracked asphalt and (15) localized settlement
condition of the cap and potential for cap damage	13) Soil stockpile			areas to be addressed as part of ongoing 2011

15) localized settlement			O&M activities
	,			
4. Fence		•	•	
Inspect fence for holes. Note number of holes.	1) Temporary fence repair remains intact	None	NA	Section of fence was noted to be damaged during
Identify location of holes via description or on Site				previous inspections and repaired by the City.
Plan (attach to Monthly Site Inspection Checklist).				
·

Site Inspection	Results			
Task	Observations	Actions Taken	Date Completed	Comments/Additional Observations
Inspect fence to determine if there is any erosion compromising the integrity of the fence	None	None	NA	NA
Inspect fence to determine if barbed wire is in good condition	None	None	NA	NA
Inspect gates, chains, and locks for damage	5) gates between Race Street and parking area is open; 17) Vehicle entrance gate to Race Street parking area is damaged	None	TBD	17) Gate damaged by BGE vehicle; BGE to pay for gate repair.
Inspect fence to determine if any vegetation is damaging or otherwise compromising fence	2) dead vegetation on fence	None	NA	City previously performed vegetation control activities at the site.
Inspect fence to determine if there is any burrowing beneath fence	16) ~6" diameter hole at edge of asphalt cap	None	NA	Localized erosion to repaired as part of ongoing 2011 O&M activities.

5. Aboveground Stormwater Conveyance System				
Inspect aboveground stormwater conveyance system including piping, downspouts, and drain in southwest corner of site for proper operation	12) Drain leader detached	None	NA	MDTA notified of need to repair pipe leader.

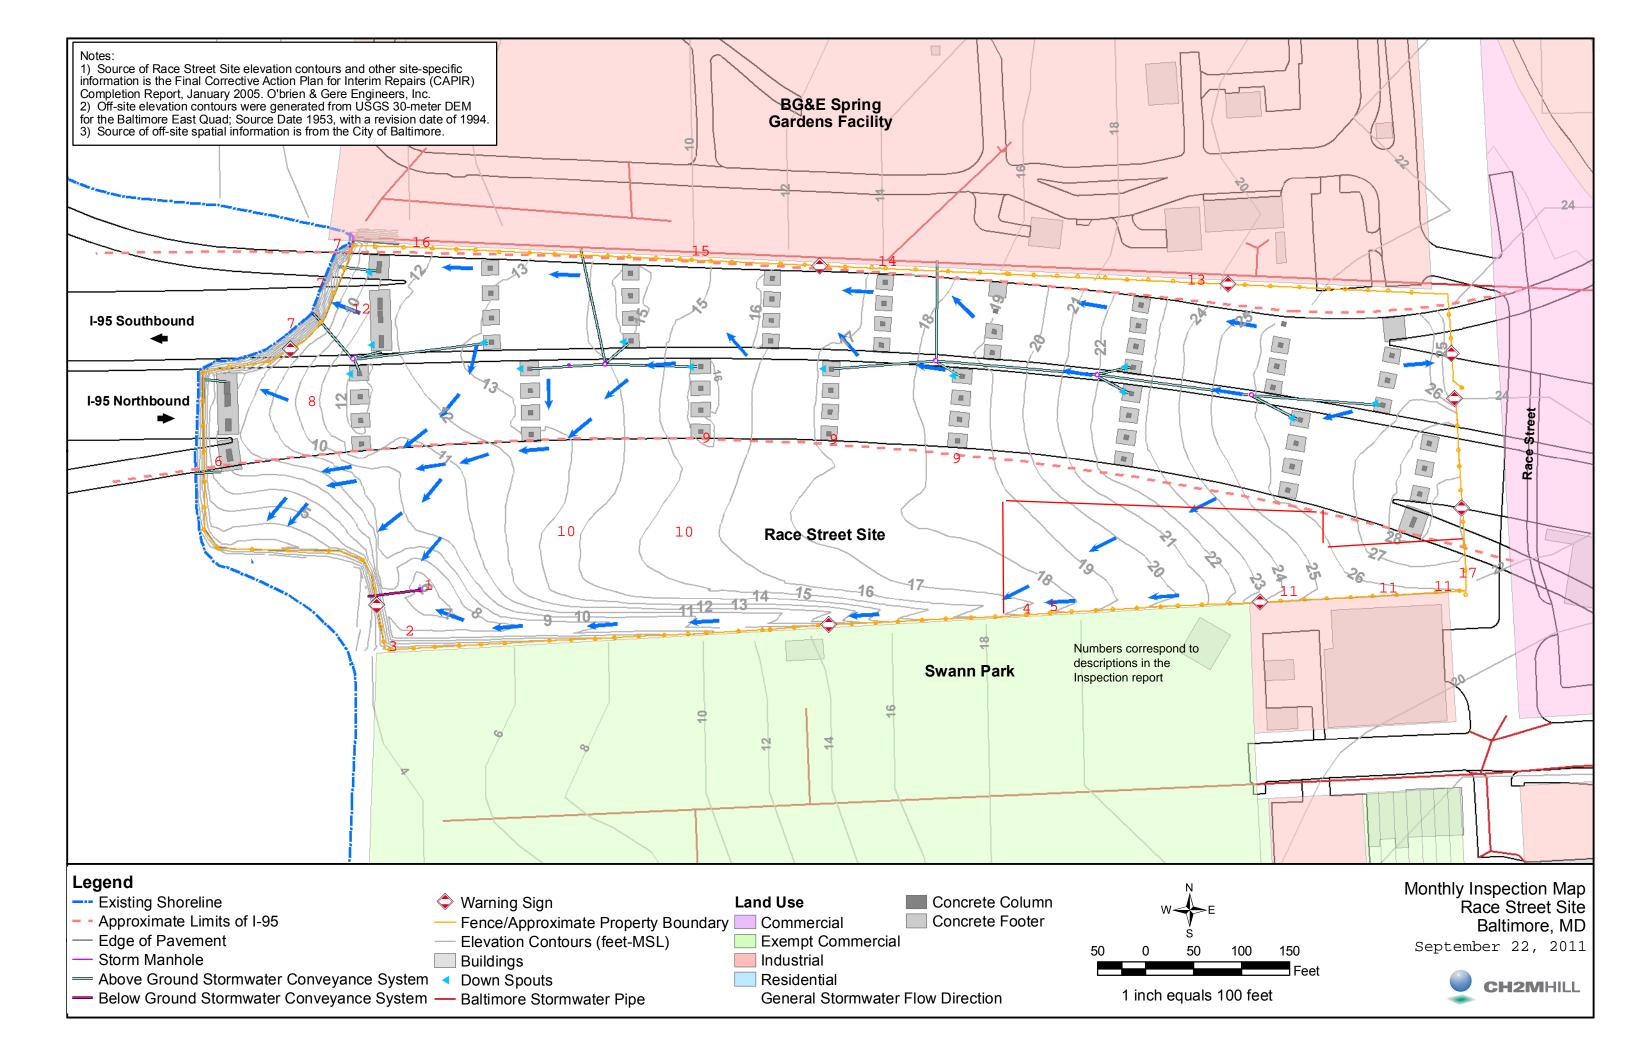
Site Inspection	Results			
Task	Observations	Actions Taken	Date Completed	Comments/Additional Observations
1. General	o book vallono	, totterio i atteri	Date Completed	Commonda Cocontano
Inspect site for presence of surface debris. Identify	None	None	NA	INA
type, approximate volume of debris, and location via		. 16.116		
description or on Site Plan (attach to Monthly Site				
Inspection Checklist).				
Inspect site for presence of vegetation. Identify	9) Vegetation around pier base	None	TBD	Asphalt repairs to be performed as part of ongoing
estimated amount and location of vegetation via	10) Vegetation in asphalt cracks			2011 O&M activities.
description or on Site Plan (attach to Monthly Site	1,g			
Inspection Checklist)

3. Engineered Cap	<u> </u>	<u> </u>	<u> </u>	
Inspect cap for alligator cracking. Identify estimated	None	None	NA	INA
area of cracking and location via description or on	None	None	1471	
Site Plan (attach to Monthly Site Inspection				
Checklist)				
Inspect cap for holes. Identify number of holes, width	15) Asphalt damage/perimeter erosion	None	TBD	Asphalt repairs to be performed as part of ongoing
and depth, and location via description of on Site	13) Aspiral damage/perimeter erosion	None	100	2011 O&M activities
Plan (attach to Monthly Site Inspection Checklist)				2011 Odivi activities
Than (attach to Monthly Oile Inspection Oncomist)				
Inspect cap for cracks less than 0.5 inches wide.	None	None	NA	NA
Note number of cracks. Identify location of cracks via	None	None	1471	
description or on Site Plan (attach to Monthly Site				
Inspection Checklist).				
Inspect cap for cracks greater than 0.5 inches wide.	None	None	NA	NA

Note number of cracks. Identify location of cracks via	None	None	1471	
description or on Site Plan (attach to Monthly Site				
Inspection Checklist).				
Inspect cap for any signs of ponding of water	None	None	NA	NA
mopost dap for any digital of portaining of water	110110	THORIE .	147.	
Inspect shorefront embankment for evidence of	3) Slight erosion along sea wall where Swan	None	TBD	City to perform site O&M of park property.
erosion or releases	Park abuts site	THORIO .		only to ponorm one cam of park property.
01001011 01 10100000	14) Localized erosion			
Identify any other observations related to the	8) Damaged cap at former test pit location.	Repair work scheduled	TBD	Surface cover repair to be performed as part of
condition of the cap and potential for cap damage	bamagea cap at former test pit location.	Repair Work Scheduled	100	field activities to be performed in November 2011.
condition of the cap and potential for cap damage				included to be performed in November 2011.

4. Fence	<u> </u>	1		<u> </u>
Inspect fence for holes. Note number of holes.	2) Temporary repair remains intact	None	NA NA	Section of fence was noted to be damaged during
Identify location of holes via description or on Site	12) Temporary repair remains intact	INOTIC	INA	previous inspections and was repaired by the City.
Plan (attach to Monthly Site Inspection Checklist).				previous inspections and was repaired by the City.
That (attach to Monthly Site inspection Checklist).				
		<u> </u>		<u> </u>

Site Inspection	Results			
Task	Observations	Actions Taken	Date Completed	Comments/Additional Observations
Inspect fence to determine if there is any erosion compromising the integrity of the fence	None	None	NA	NA
Inspect fence to determine if barbed wire is in good condition	None	None	NA	NA
Inspect gates, chains, and locks for damage	4) Gate unlocked 5) Gate open 17) Vehicle entrance gate to Race Street parking area is damaged	City notified	TBD	17) Gate damaged by BGE vehicle; BGE to pay for gate repair.
Inspect fence to determine if any vegetation is damaging or otherwise compromising fence	11) Vegetation on fence 13) Vine on fence	None	TBD	City performs vegetation control as part of ongoing O&M activities.
Inspect fence to determine if there is any burrowing beneath fence	16) ~6" diameter hole at edge of asphalt cap	None	TBD	Localized erosion to repaired as part of ongoing 2011 site O&M activities.

5. Aboveground Stormwater Conveyance System	<u> </u>			<u> </u>
Inspect aboveground stormwater conveyance system including piping, downspouts, and drain in southwest corner of site for proper operation	6) Down spout pipe leader disconnected	None	TBD	MDTA notified of need to reattach pipe leader.

8. Miscellaneous Items				
Any interaction with people on or adjacent to the site? If yes, identify who, title, organization, contact information, and content of interaction	Josh Floyd (ERM) and Jim Leizear (MDE) ons	ite during site walk.		
Other Comments/Observations?	Trash and debris at storm drain inlet Petroleum sheen on surface water off-short Soil pile	e adjacent to Baltimore Gas and	Electric (BGE) Spring G	arden facility.
