Re: Transmittal of Quarterly Site Progress Report, Third Quarter 2017, 2000 Race Street Site, Baltimore, Maryland

Third Quarter 2017 Race Street Quarterly Site Progress Report, 2000 Race Street, Baltimore, Maryland

Inspector:	Bill Morris	Date of Inspection:	20-Jul-17	
Title:	Environmental Engineer	Date of Last Inspection:	25-May-17	
Organization:	CH2M HILL	Weather:		Sunny, warm
Site Inspection		A cita a Talla a	Data Occupiated	0
Task 1. General	Observations	Actions Taken	Date Completed	Comments/Additional Observations
Inspect site for presence of surface debris. Identify type, approximate volume of debris, and location via description or on Site Plan (attach to Monthly Site Inspection Checklist).	7: Trash and debris accumulation. 2: Sediment and debris accumulation.	None	NA	Sediment, debris, and vegetation to be removed as part of site maintenance performed by the City.
Inspect site for presence of vegetation. Identify estimated amount and location of vegetation via description or on Site Plan (attach to Monthly Site Inspection Checklist)	None	None	NA	None

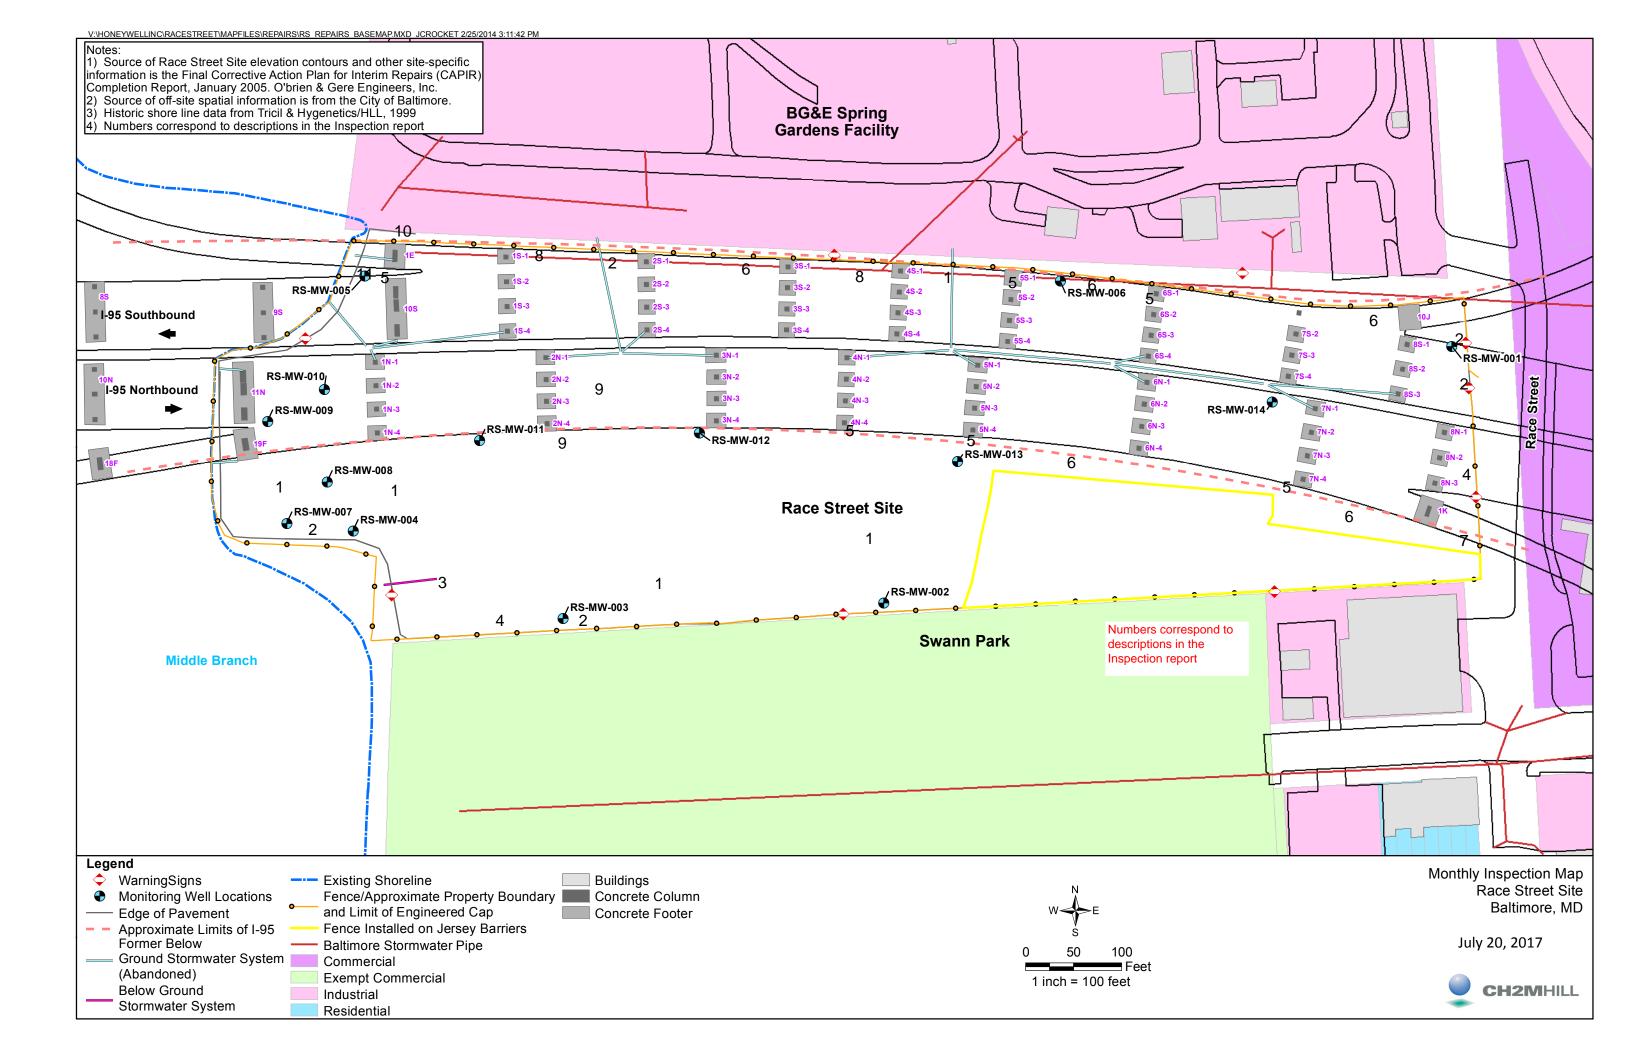
3. Engineered Cap				
Inspect cap for alligator cracking. Identify estimated area of cracking and location via description or on Site Plan (attach to Monthly Site Inspection Checklist)	8: Alligator cracking in asphalt near fence line.	None	NA	Surface cover repairs to be performed as part of cap maintenance during Q4 2017.
Inspect cap for holes. Identify number of holes, width and depth, and location via description of on Site Plan (attach to Monthly Site Inspection Checklist)	10: Hole in asphalt outside of fence line.	None	NA	Surface cover repairs to be performed as part of cap maintenance during Q4 2017.
Inspect cap for cracks less than 0.5 inches wide. Note number of cracks. Identify location of cracks via description or on Site Plan (attach to Monthly Site Inspection Checklist).	3: Crack with vegetation between inlet grate and asphalt. 1: Sealed cracks with vegetation growth. 5: Crack with vegetation between pier footing and asphalt. 6: Crack with vegetation.	None	NA	Vegetation to be treated as part of site maintenance performed by City during Q3 2017. Surface cover repairs to be performed as part of cap maintenance during Q4 2017.

Inspect cap for cracks greater than 0.5 inches wide. Note number of cracks. Identify location of cracks via description or on Site Plan (attach to Monthly Site Inspection Checklist).	None	None	NA	NA
Inspect cap for any signs of ponding of water	9: Ponding water on asphalt	None	NA	Surface cover repairs to be performed as part of cap maintenance during Q4 2017.
Inspect shorefront embankment for evidence of erosion or releases	None	None	NA	NA
Identify any other observations related to the condition of the cap and potential for cap damage	None	None	NA	NA

6. Vandalism			•	
Inspect site for any vandalism including any dumped material on-site and damage to monitoring wells	11: Damage to well lid.	None	NA	NA
Identify any other observations related to vandalism on the site	None	None	NA	NA

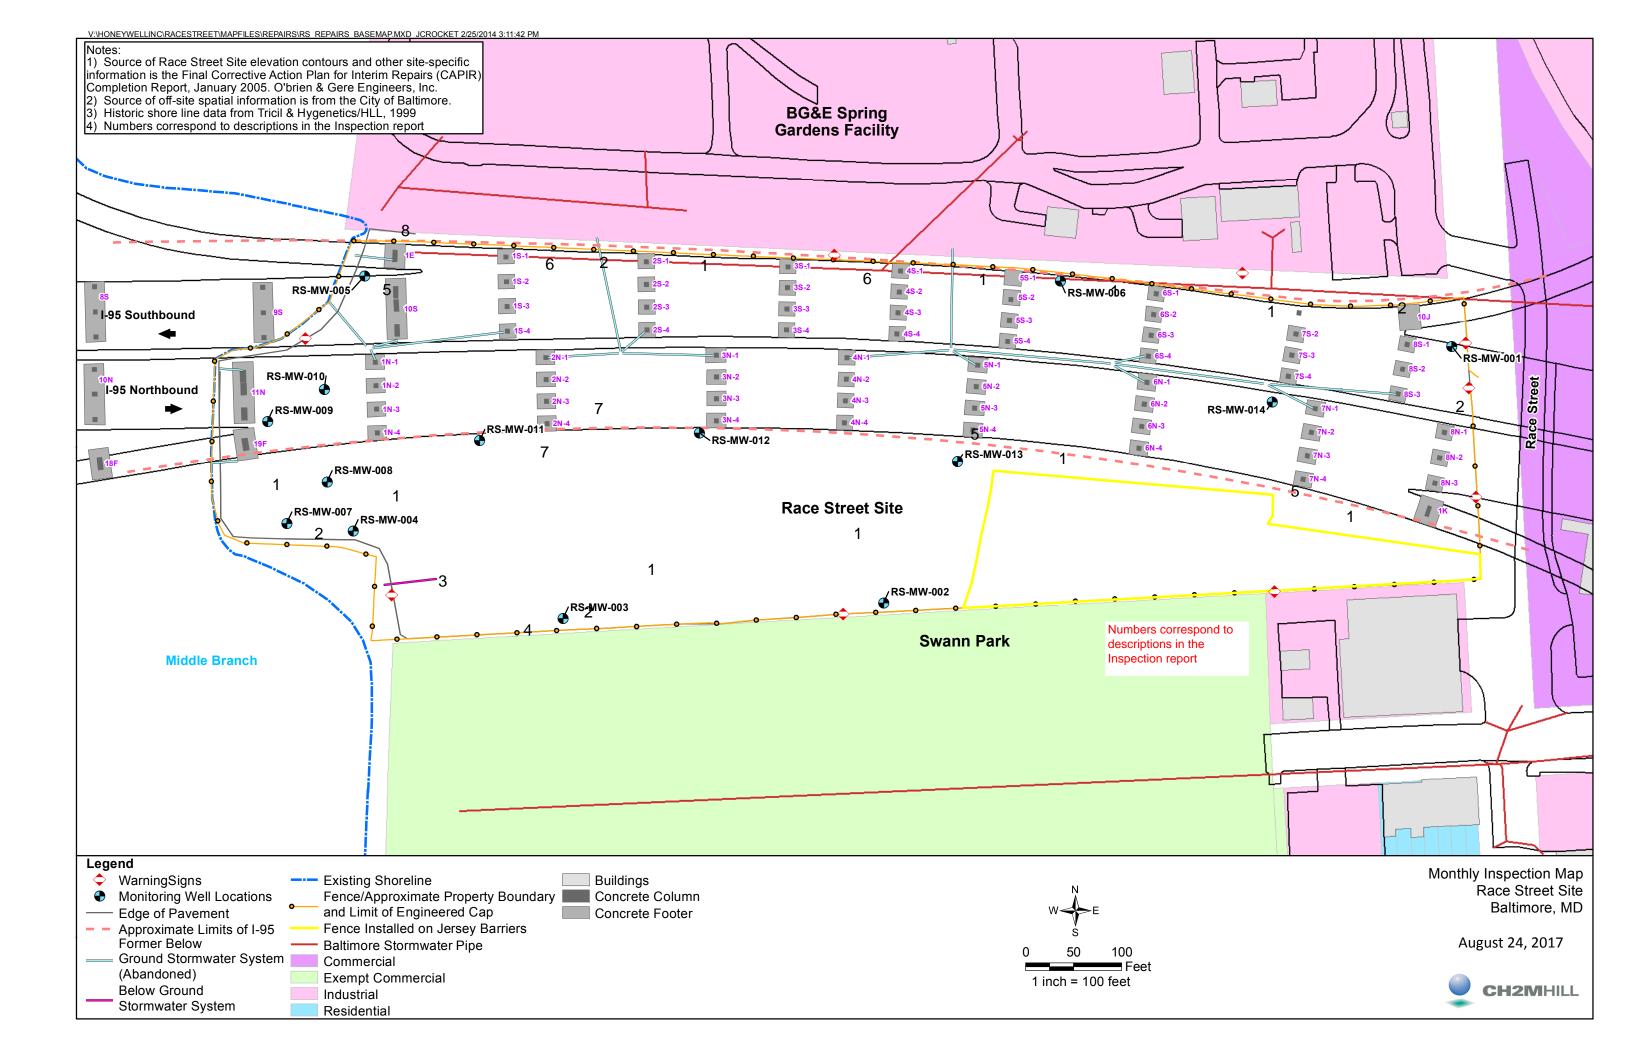
1. General	Observations	7 tollotto Takeri	Date Completed	Comments// teathorial Observations
Inspect site for presence of surface debris. Identify type, approximate volume of debris, and location via description or on Site Plan (attach to Monthly Site Inspection Checklist).	2: Sediment and debris accumulation.	City performed vegetation removal from crack, fence line and western shoreline.	10-Aug-17	Sediment, debris, and vegetation to be removed as part of cap maintenance performed by the City.
Inspect site for presence of vegetation. Identify estimated amount and location of vegetation via description or on Site Plan (attach to Monthly Site Inspection Checklist)	None	None	NA	None

3. Engineered Cap		I	1	
Inspect cap for alligator cracking. Identify estimated area of cracking and location via description or on Site Plan (attach to Monthly Site Inspection Checklist)	6: Alligator cracking in asphalt near fence line.	None	NA	Surface cover repairs to be performed as part of cap maintenance during Q4 2017.
Inspect cap for holes. Identify number of holes, width and depth, and location via description of on Site Plan (attach to Monthly Site Inspection Checklist)	8: Hole in asphalt outside of fence line. 4: Damage to asphalt covered slope.	None	NA	Surface cover repairs to be performed as part of cap maintenance during Q4 2017.
Inspect cap for cracks less than 0.5 inches wide. Note number of cracks. Identify location of cracks via description or on Site Plan (attach to Monthly Site Inspection Checklist).	3: Crack with vegetation between inlet grate and asphalt. 1: Crack in asphalt 5: Crack between pier footing and asphalt.	None	NA	Surface cover repairs to be performed as part of cap maintenance during Q4 2017.

Inspect cap for cracks greater than 0.5 inches wide. Note number of cracks. Identify location of cracks via description or on Site Plan (attach to Monthly Site Inspection Checklist).	None	None	NA	NA
Inspect cap for any signs of ponding of water	7: Ponding water on asphalt	None	NA	Surface cover repairs to be performed as part of cap maintenance during Q4 2017.
Inspect shorefront embankment for evidence of erosion or releases	None	None	NA	NA

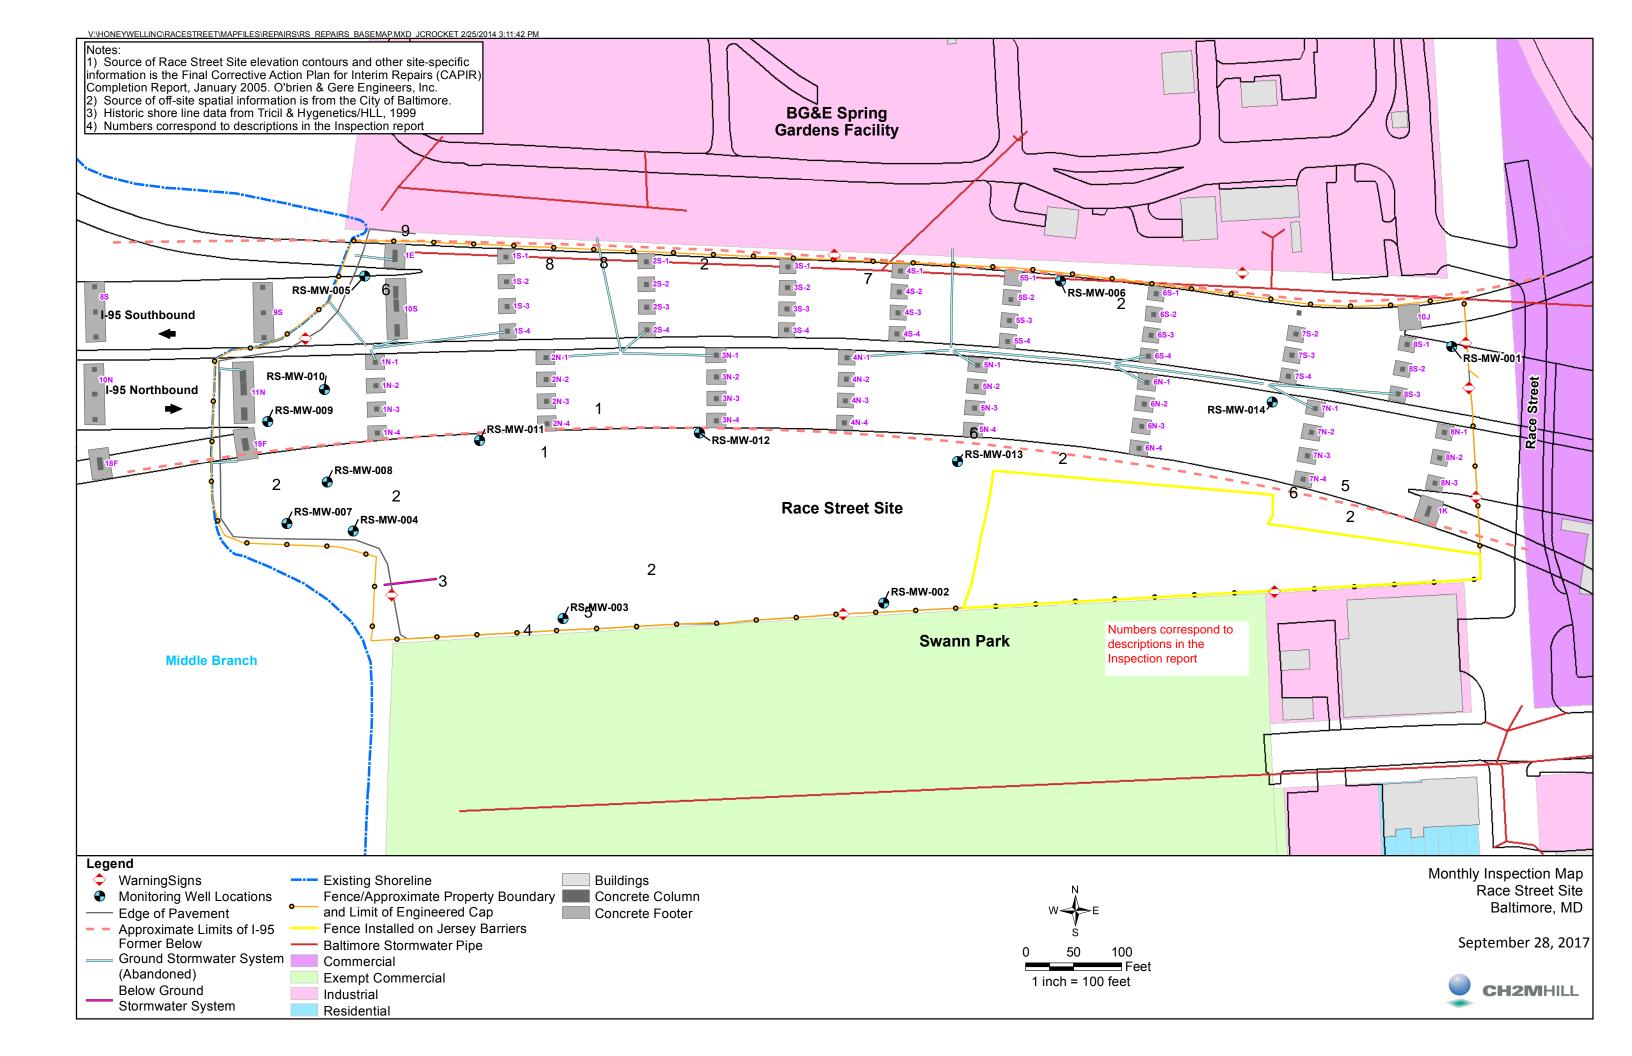
1. General				
Inspect site for presence of surface debris. Identify	5: Sediment and debris accumulation.	None	NA	Sediment, debris, and vegetation to be removed
type, approximate volume of debris, and location	8: Sediment and debris accumulation with			as part of cap maintenance to be performed by
via description or on Site Plan (attach to Monthly	vegetation growth.			the City.
Site Inspection Checklist).	Jogetanen gremm			and only.
Inspect site for presence of vegetation. Identify	None	None	NA	None
estimated amount and location of vegetation via	1.10.10			
description or on Site Plan (attach to Monthly Site				
Inspection Checklist)

3. Engineered Cap	I=	Ta .	1	
Inspect cap for alligator cracking. Identify	7: Alligator cracking in asphalt near fence	None	NA	Surface cover repairs to be performed as part of
estimated area of cracking and location via	line.			cap maintenance during Q4 2017.
description or on Site Plan (attach to Monthly Site				
Inspection Checklist)				
Inspect cap for holes. Identify number of holes,	9: Hole in asphalt outside of fence line.	None	NA	Surface cover repairs to be performed as part of
width and depth, and location via description of on	4: Damage to asphalt covering slope.			cap maintenance during Q4 2017.
Site Plan (attach to Monthly Site Inspection				
Checklist)				
Inspect cap for cracks less than 0.5 inches wide.	3: Crack with vegetation between inlet grate	None	NA	Surface cover repairs to be performed as part of
Note number of cracks. Identify location of cracks	and asphalt.			cap maintenance during Q4 2017

via description or on Site Plan (attach to Monthly	2: Crack in asphalt with vegetation growth.			
Site Inspection Checklist).	6: Crack between pier footing and asphalt.			
Inspect cap for cracks greater than 0.5 inches	None	None	NA	NA
wide. Note number of cracks. Identify location of		110110	1 1/1	1773
cracks via description or on Site Plan (attach to				
Monthly Site Inspection Checklist).

1: Ponding water on asphalt.	None	NA	Surface cover repairs to be performed as sert of
Inspect cap for any signs of ponding of water	The origing water on asphalt.	INOHE	INC	Surface cover repairs to be performed as part of cap maintenance during Q4 2017.
				cap maintenance during Q4 2017.
Inspect shorefront embankment for evidence of	None	None	NA	NA
erosion or releases
