Re: Transmittal of Quarterly Site Progress Report, First Quarter 2018, 2000 Race Street Site, Baltimore, Maryland

First Quarter 2018 Race Street Quarterly Site Progress Report, 2000 Race Street, Baltimore, Maryland

Appendix A Site Inspection Reports

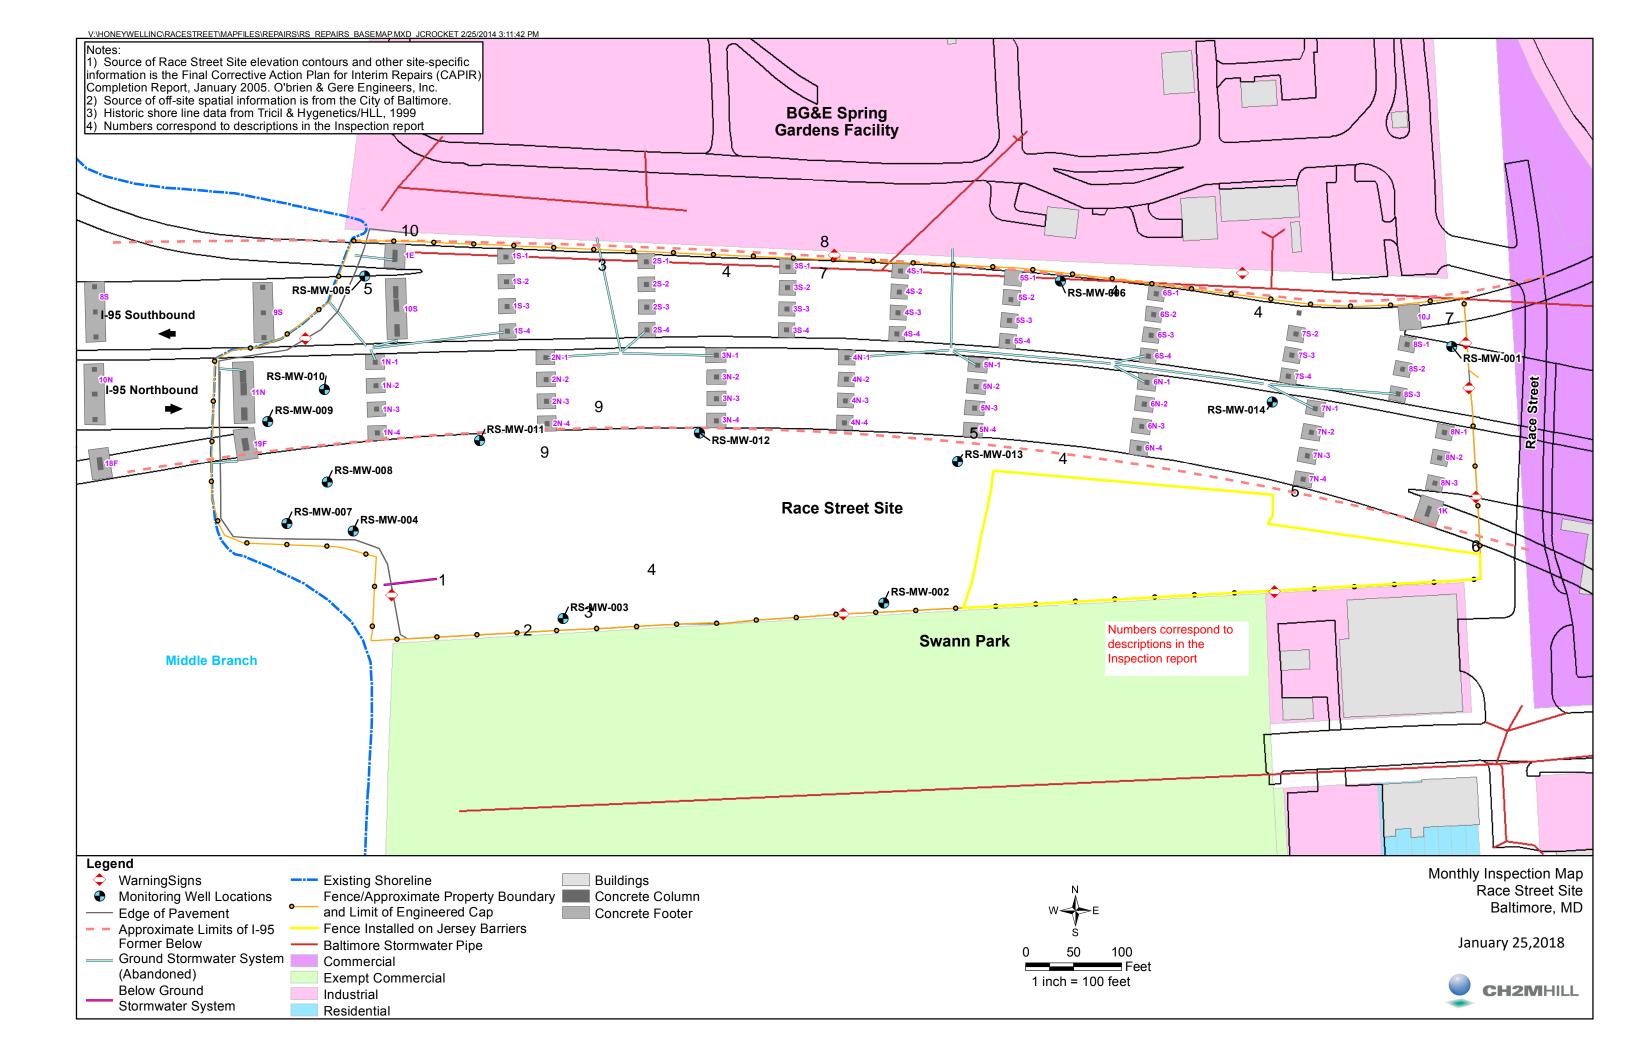
3. Engineered Cap					
Inspect cap for alligator cracking. Identify estimated area of cracking and location via description or on Site Plan (attach to Monthly Site Inspection Checklist)	7: Alligator cracking in asphalt near fence line.	None	NA	Surface cover repairs to be addressed during Q2 2018 as part of scheduled site maintenance and cap repairs.	
Inspect cap for holes. Identify number of holes, width and depth, and location via description of on Site Plan (attach to Monthly Site Inspection Checklist)	10: Hole in asphalt outside of fence 2: Damage to asphalt covering slope. 8: Erosion in grass covered slope.	None	NA	Surface cover repairs to be addressed during Q2 2018 as part of scheduled site maintenance and cap repairs.	
Inspect cap for cracks less than 0.5 inches wide. Note number of cracks. Identify location of cracks via description or on Site Plan (attach to Monthly Site Inspection Checklist).	Crack with vegetation between inlet grate and asphalt. Crack in asphalt with vegetation growth 5,: Crack between pier footing and asphalt.	None	NA	Surface cover repairs to be addressed during Q2 2018 as part of scheduled site maintenance and cap repairs.

Inspect cap for cracks greater than 0.5 inches wide. Note number of cracks. Identify location of cracks via description or on Site Plan (attach to Monthly Site Inspection Checklist).	None	None	NA	NA .	
Inspect cap for any signs of ponding of water	9: Ponding water on asphalt	None	NA	Surface cover repairs to be addressed during Q2 2018 as part of scheduled site maintenance and cap repairs.	
Inspect shorefront embankment for evidence of erosion or releases	None	None	NA	NA

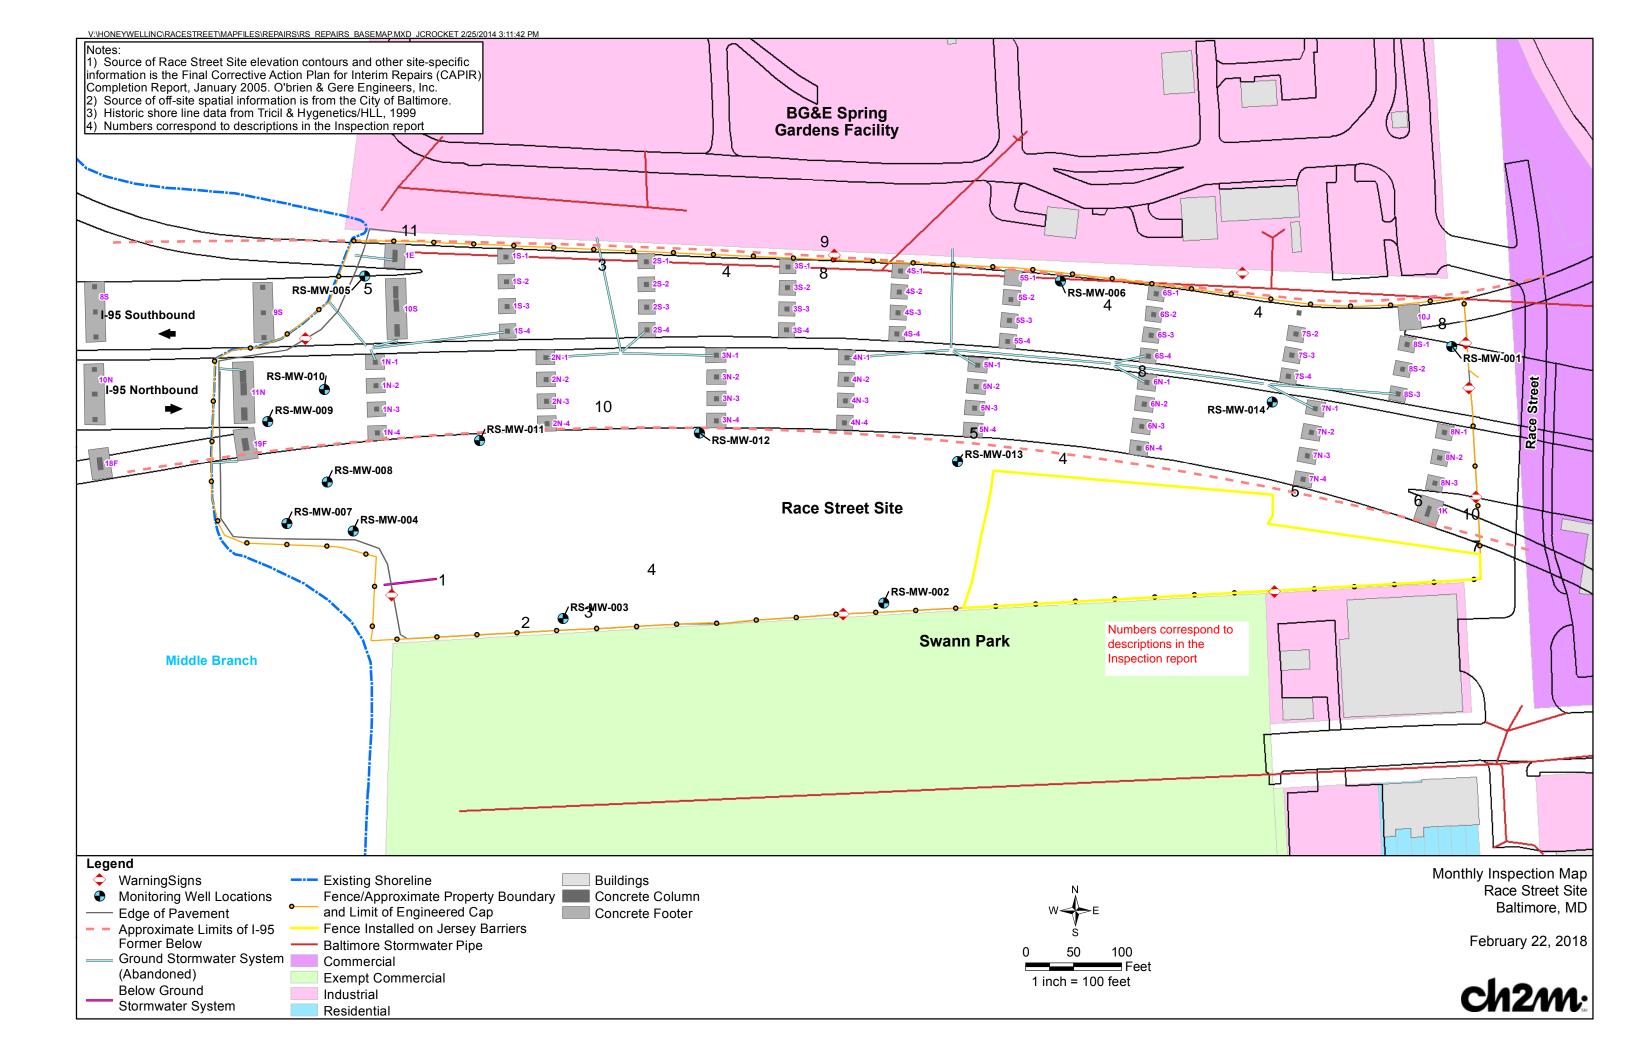
1. General				
Site Inspection Checklist).	Sediment and debris accumulation. Trash accumulation Metal debris	City representatives onsite during inspection.	NA	Sediment, debris, and vegetation to be removed during Q2 2018 as part of scheduled site maintenance and cap repairs
Inspect site for presence of vegetation. Identify estimated amount and location of vegetation via description or on Site Plan (attach to Monthly Site Inspection Checklist)	None	None	NA	NA

3. Engineered Cap			1	
Inspect cap for alligator cracking. Identify estimated area of cracking and location via description or on Site Plan (attach to Monthly Site Inspection Checklist)	8: Alligator cracking in asphalt near fence line.	None	NA	Surface cover repairs to be addressed during Q2 2018 as part of scheduled site maintenance and cap repairs.

11: Hole in asphalt outside of fence 2: Damage to asphalt covering slope. 9: Erosion in grass covered slope.	None	NA	Surface cover repairs to be addressed in 2018 as part of scheduled site maintenance and cap repairs.
	Crack with vegetation between inlet grate and asphalt. Crack in asphalt with vegetation growth 5: Crack between pier footing and asphalt.	None	NA	Surface cover repairs to be addressed during Q2 2018 as part of scheduled site maintenance and cap repairs.
Inspect cap for cracks greater than 0.5 inches wide. Note number of cracks. Identify location of cracks via description or on Site Plan (attach to Monthly Site Inspection Checklist).	None	None	NA	NA
Inspect cap for any signs of ponding of water	10: Ponding water on asphalt	None	NA	Surface cover repairs to be addressed during 2018 as part of scheduled site maintenance and cap repairs.
Inspect shorefront embankment for evidence of erosion or releases	None	None	NA	NA

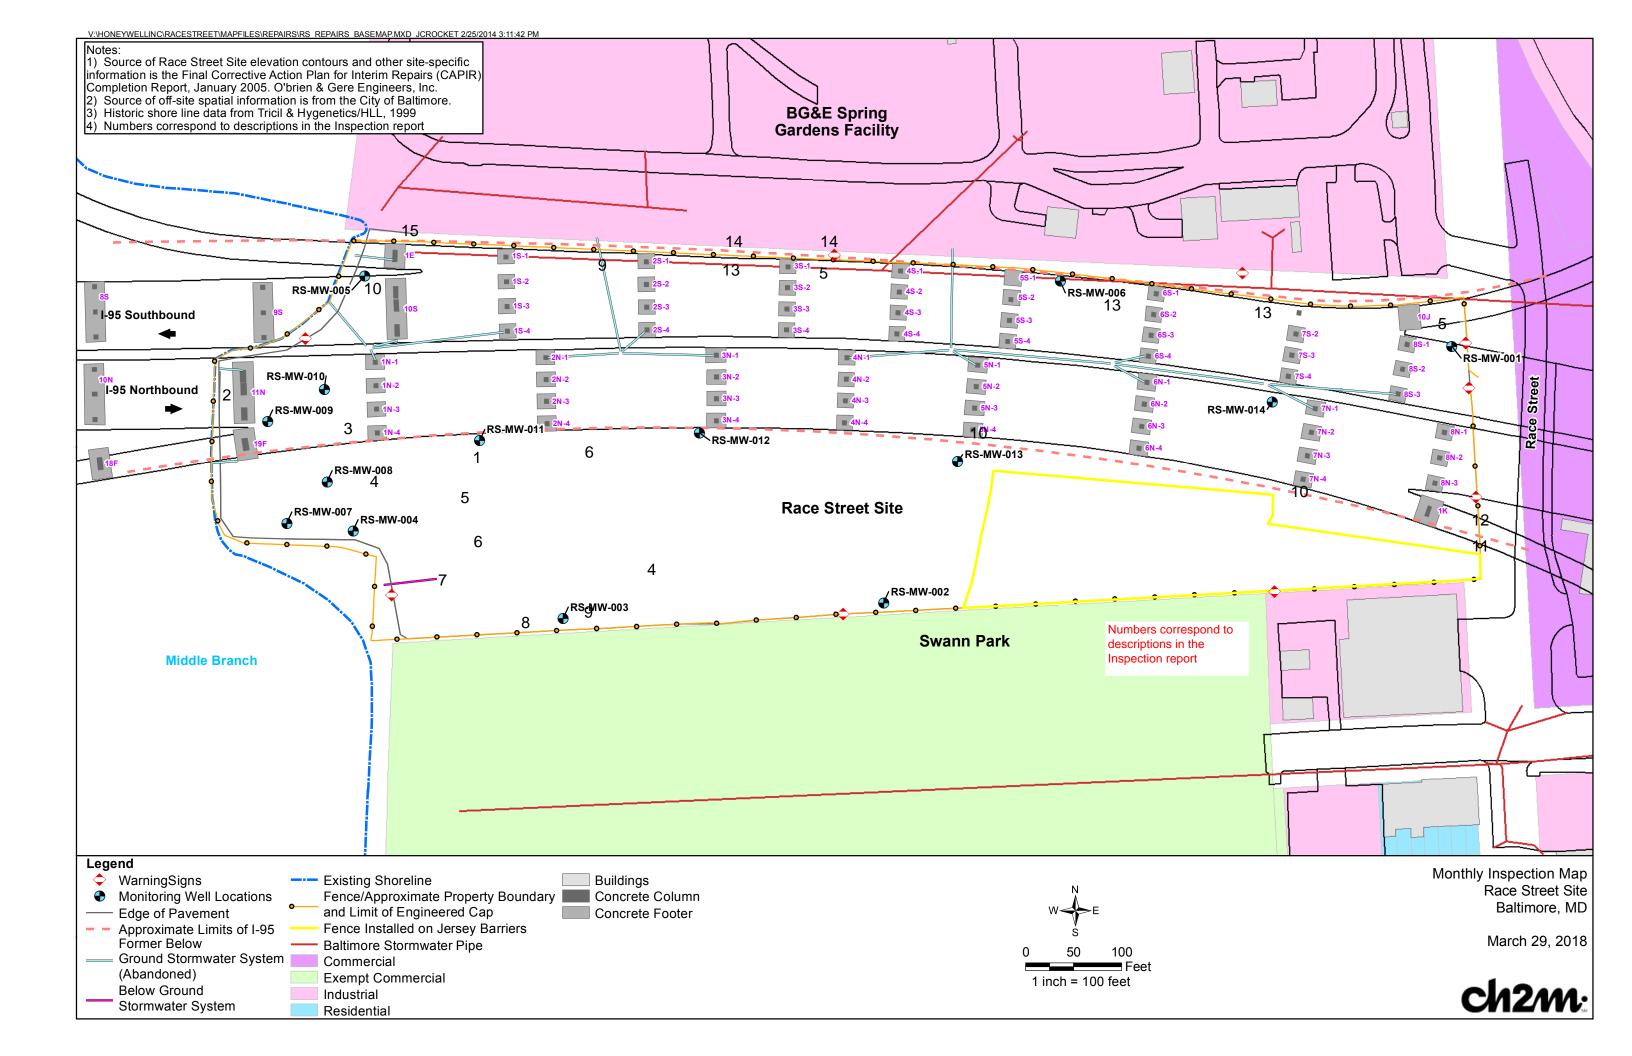
3. Engineered Cap					
Inspect cap for alligator cracking. Identify estimated area of cracking and location via description or on Site Plan (attach to Monthly Site Inspection Checklist)	5: Alligator cracking in asphalt	None	NA	Surface cover repairs to be addressed during Q2 2018 as part of scheduled site maintenance and cap repairs.	
Inspect cap for holes. Identify number of holes, width and depth, and location via description of on Site Plan (attach to Monthly Site Inspection Checklist)	15: Hole in asphalt outside of fence 8: Damage to asphalt covering slope. 14: Erosion in grass covered slope.	None	NA	Surface cover repairs to be addressed during Q2 2018 as part of scheduled site maintenance and cap repairs.	
Inspect cap for cracks less than 0.5 inches wide. Note number of cracks. Identify location of cracks via description or on Site Plan (attach to Monthly Site Inspection Checklist).	7: Crack with vegetation between inlet grate and asphalt. 13: Crack in asphalt with vegetation growth 10: Crack between pier footing and asphalt.	None	NA	Surface cover repairs to be addressed during Q2 2018 as part of scheduled site maintenance and cap repairs.

Inspect cap for cracks greater than 0.5 inches wide. Note number of cracks. Identify location of cracks via description or on Site Plan (attach to Monthly Site Inspection Checklist).	4: Crack in asphalt with vegetation growth	None	NA	NA	
Inspect cap for any signs of ponding of water	6: Ponding water on asphalt	None	NA	Surface cover repairs to be addressed in 2018 as part of scheduled site maintenance and cap repairs.	
Inspect shorefront embankment for evidence of erosion or releases	None	None	NA	NA

Site Inspection	Results			
Task	Observations	Actions Taken	Date Completed	Comments/Additional Observations
Identify any other observations related to the condition of the cap and potential for cap damage	3: Damage to asphalt	None	NA	Surface cover repairs to be addressed during Q2 2018 as part of scheduled site maintenance and cap repairs.

4. Fence				
Inspect fence for holes. Note number of holes. Identify location of holes via description or on Site Plan (attach to Monthly Site Inspection Checklist).	None	None	NA	NA
Inspect fence to determine if there is any erosion compromising the integrity of the fence	None	None	NA	NA
Inspect fence to determine if barbed wire is in good condition	None	None	NA	NA
Inspect gates, chains, and locks for damage	None	None	NA	lna
Inspect fence to determine if any vegetation is damaging or otherwise compromising fence	None	None	NA	NA
Inspect fence to determine if there is any burrowing beneath fence	None	None	NA	NA
Identify any other observations related to the condition of the fence and potential for fence damage (e.g., points of weakness, corrosion)	12: Fence corroded	None	NA	NA

6. Vandalism		<u> </u>	I	
Inspect site for any vandalism including any dumped material on-site and damage to monitoring wells	None	None	NA	NA
Identify any other observations related to vandalism on the site	2: Spray paint on pile cap 11N	None	NA	NA

8. Miscellaneous Items	<u> </u>			<u>I</u>
Any interaction with people on or adjacent to the site? If yes, identify who, title, organization, contact information, and content of interaction	Al Simkins of MDE was onsite for the	monthly inspection. A Maryland Trans	portation Authority crew	was onsite to add a new lock to front gate.
Other Comments/Observations?	1: Damage to well and bollards. Well will be repaired as part of site maintenance.
