# Re: Transmittal of Quarterly Site Progress Report, Third Quarter 2018, 2000 Race Street Site, Baltimore, Maryland

## THIRD QUARTER 2018 RACE STREET QUARTERLY SITE PROGRESS REPORT

2000 RACE STREET BALTIMORE, MARYLAND

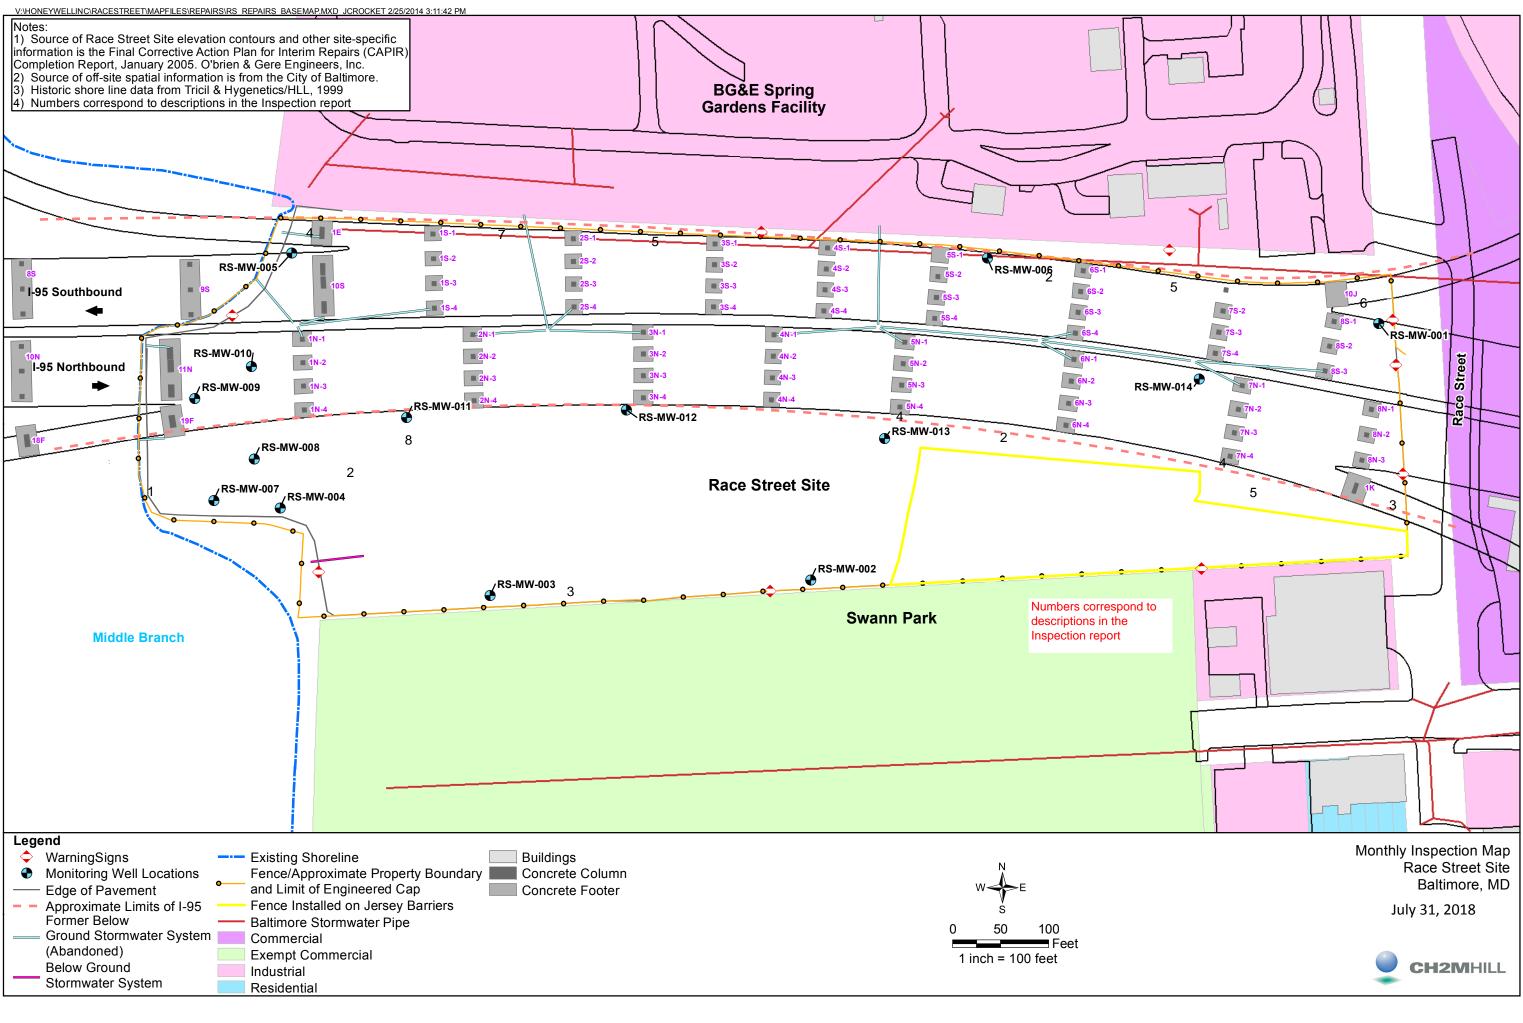
1. General		-	-	
Inspect site for presence of surface debris. Identify type, approximate volume of debris, and location via description or on Site Plan (attach to Monthly Site Inspection Checklist).	7: Sediment and debris accumulation with vegetation growth	None	NA	COB to remove sediment, debris, and vegetation as part of scheduled site maintenance.
Inspect site for presence of vegetation. Identify estimated amount and location of vegetation via description or on Site Plan (attach to Monthly Site Inspection Checklist)	None	None	NA	NA

3. Engineered Cap		-	-	-
Inspect cap for alligator cracking. Identify estimated area of cracking and location via description or on Site Plan (attach to Monthly Site Inspection Checklist)	None	None	NA	NA
Inspect cap for holes. Identify number of holes, width and depth, and location via description of on Site Plan (attach to Monthly Site Inspection Checklist)	6: Vegetation growth through asphalt	None	NA	COB to remove sediment, debris, and vegetation as part of scheduled site maintenance.

5: Crack in asphalt with vegetation growth 4: Crack between pier footing and asphalt.	None	NA	Surface cover repairs to be performed as part of scheduled site maintenance and cap repairs.
Inspect cap for cracks greater than 0.5 inches wide. Note number of cracks. Identify location of cracks via description or on Site Plan (attach to Monthly Site Inspection Checklist).	2: Wide crack in asphalt with vegetation growth	None	NA	COB to remove sediment, debris, and vegetation as part of scheduled site maintenance.
Inspect cap for any signs of ponding of water	None	None	NA	NA
Inspect shorefront embankment for evidence of erosion or releases	None	None	NA	NA
Identify any other observations related to the condition of the cap and potential for cap damage	None	None	NA	NA

8. Miscellaneous Items		•		·
Any interaction with people on or adjacent to the site? If yes, identify who, title, organization, contact information, and content of interaction	Al Simkins of MDE was on site for the month	ly inspection.		
Other Comments/Observations?	8: Damage to well bollard - to be addressed 1: Well cover missing bolt - to be addressed

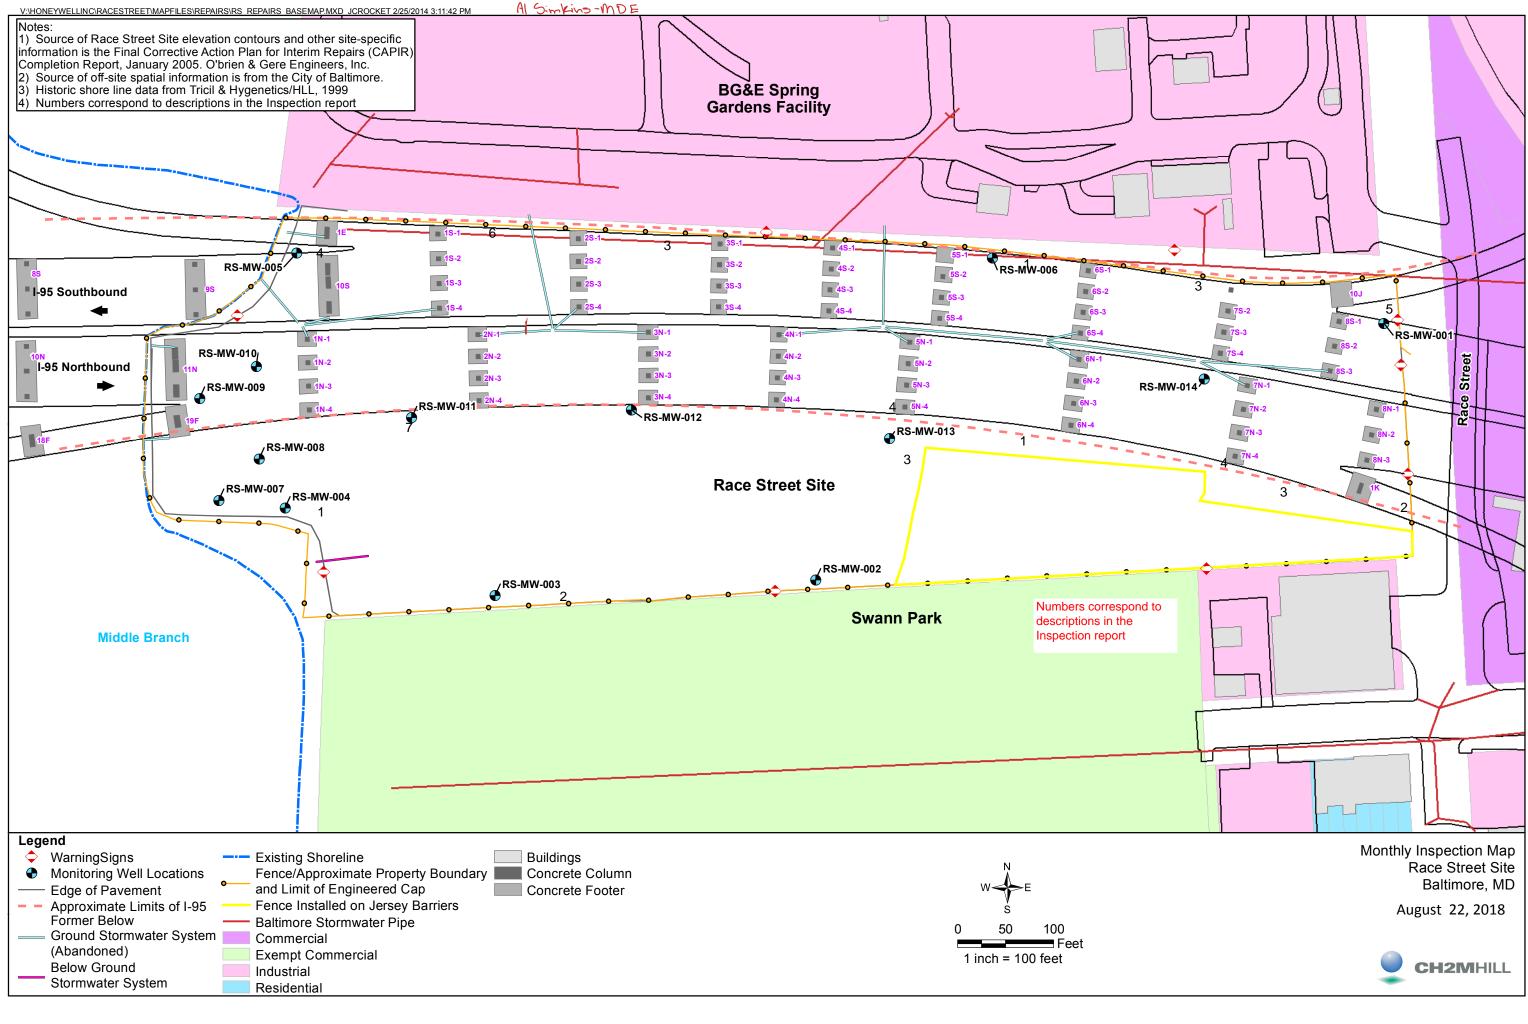
1. General				
Inspect site for presence of surface debris. Identify type, approximate volume of debris, and location via description or on Site Plan (attach to Monthly Site Inspection Checklist).	6: Sediment and debris accumulation with vegetation growth	None	NA	COB to remove sediment, debris, and vegetation as part of scheduled site maintenance.
Inspect site for presence of vegetation. Identify estimated amount and location of vegetation via description or on Site Plan (attach to Monthly Site Inspection Checklist)	None	None	NA	NA

3. Engineered Cap		-	-	
Inspect cap for alligator cracking. Identify estimated area of cracking and location via description or on Site Plan (attach to Monthly Site Inspection Checklist)	None	None	NA	NA
Inspect cap for holes. Identify number of holes, width and depth, and location via description of on Site Plan (attach to Monthly Site Inspection Checklist)	5: Vegetation growth through asphalt	None	NA	COB to remove sediment, debris, and vegetation as part of scheduled site maintenance.
Inspect cap for cracks less than 0.5 inches wide. Note number of cracks. Identify location of cracks via description or on Site Plan (attach to Monthly Site Inspection Checklist).	3: Crack in asphalt with vegetation growth 4: Crack between pier footing and asphalt.	None	NA	Surface cover repairs to be addressed as part of scheduled site maintenance and cap repairs.
Inspect cap for cracks greater than 0.5 inches wide. Note number of cracks. Identify location of cracks via description or on Site Plan (attach to Monthly Site Inspection Checklist).	1: Wide crack in asphalt with vegetation growth	None	NA	COB to remove sediment, debris, and vegetation as part of scheduled site maintenance.

8. Miscellaneous Items	1			·
Any interaction with people on or adjacent to the site? If yes, identify who, title, organization, contact information, and content of interaction	Al Simkins of MDE was on site for the month	ly inspection.		
Other Comments/Observations?	7: Damage to well/bollard - to be addressed	as part of well installation in 2019

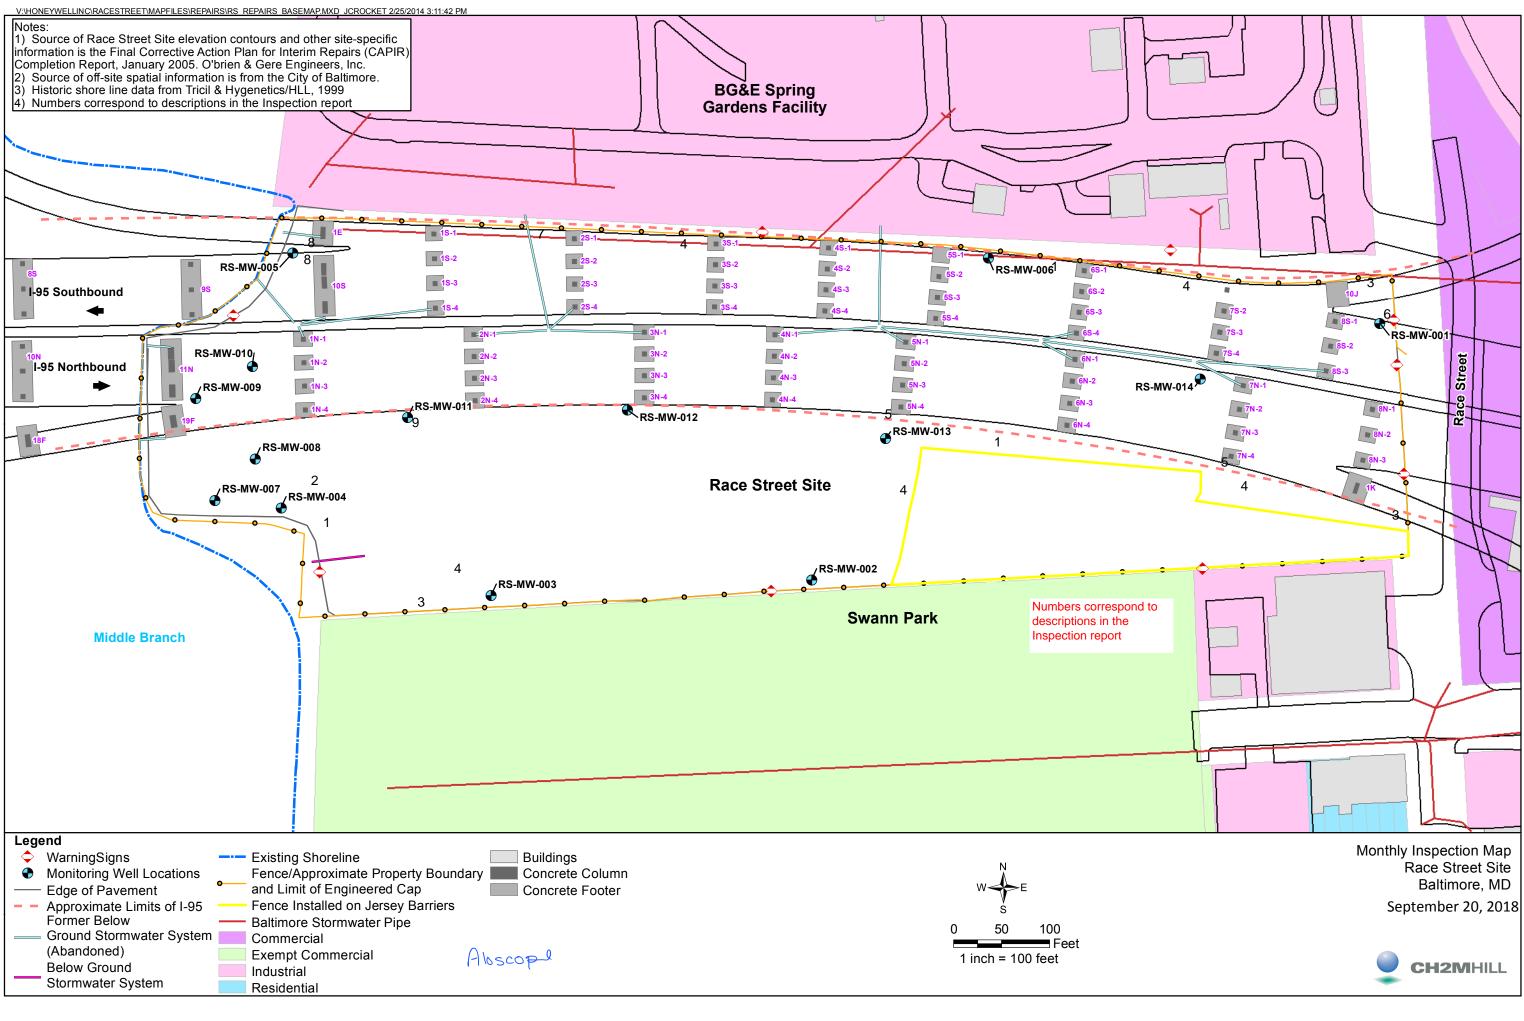
1. General				
Inspect site for presence of surface debris. Identify type, approximate volume of debris, and location via description or on Site Plan (attach to Monthly Site Inspection Checklist).	7: Sediment and debris accumulation with vegetation growth	None	NA	COB to remove sediment, debris, and vegetation as part of scheduled site maintenance.
Inspect site for presence of vegetation. Identify estimated amount and location of vegetation via description or on Site Plan (attach to Monthly Site Inspection Checklist)	None	None	NA	NA

3. Engineered Cap	1	1		
Inspect cap for alligator cracking. Identify estimated area of cracking and location via description or on Site Plan (attach to Monthly Site Inspection Checklist)	None	None	NA	NA
Inspect cap for holes. Identify number of holes, width and depth, and location via description of on Site Plan (attach to Monthly Site Inspection Checklist)	2: Small hole in asphalt. 6: Vegetation growth through asphalt	None	NA	COB to remove sediment, debris, and vegetation as part of scheduled site maintenance.
Inspect cap for cracks less than 0.5 inches wide. Note number of cracks. Identify location of cracks via description or on Site Plan (attach to Monthly Site Inspection Checklist).	4: Crack in asphalt with vegetation growth 5: Crack between pier footing and asphalt with vegetation growth	None	NA	Surface cover repairs to be addressed as part of scheduled site maintenance and cap repairs.

Inspect cap for cracks greater than 0.5 inches wide. Note number of cracks. Identify location of cracks via description or on Site Plan (attach to Monthly Site Inspection Checklist).	1: Wide crack in asphalt with vegetation growth 8: Crack between pier footing and asphalt with vegetation growth	None	NA	COB to remove sediment, debris, and vegetation as part of scheduled site maintenance.
Inspect cap for any signs of ponding of water	None	None	NA	NA
Inspect shorefront embankment for evidence of erosion or releases	None	None	NA	NA
Identify any other observations related to the condition of the cap and potential for cap damage	None	None	NA	NA

8. Miscellaneous Items	•	•	•	·
Any interaction with people on or adjacent to the site? If yes, identify who, title, organization, contact information, and content of interaction	Al Simkins of MDE and Ravic Miller with the preparing equipment for shipment.	City of Baltimore DOT were on site f	or the monthly insp	ection. Workers with Abscope were on site
Other Comments/Observations?	9: Damage to well/bollard - to be addressed a	as part of well installation in 2019
