Re: Transmittal of Quarterly Site Progress Report, First Quarter 2019, 2000 Race Street Site, Baltimore, Maryland

# FIRST QUARTER 2019 RACE STREET QUARTERLY SITE PROGRESS REPORT

# $2000\,\mathrm{RACE}\,\mathrm{STREET}$ BALTIMORE, MARYLAND

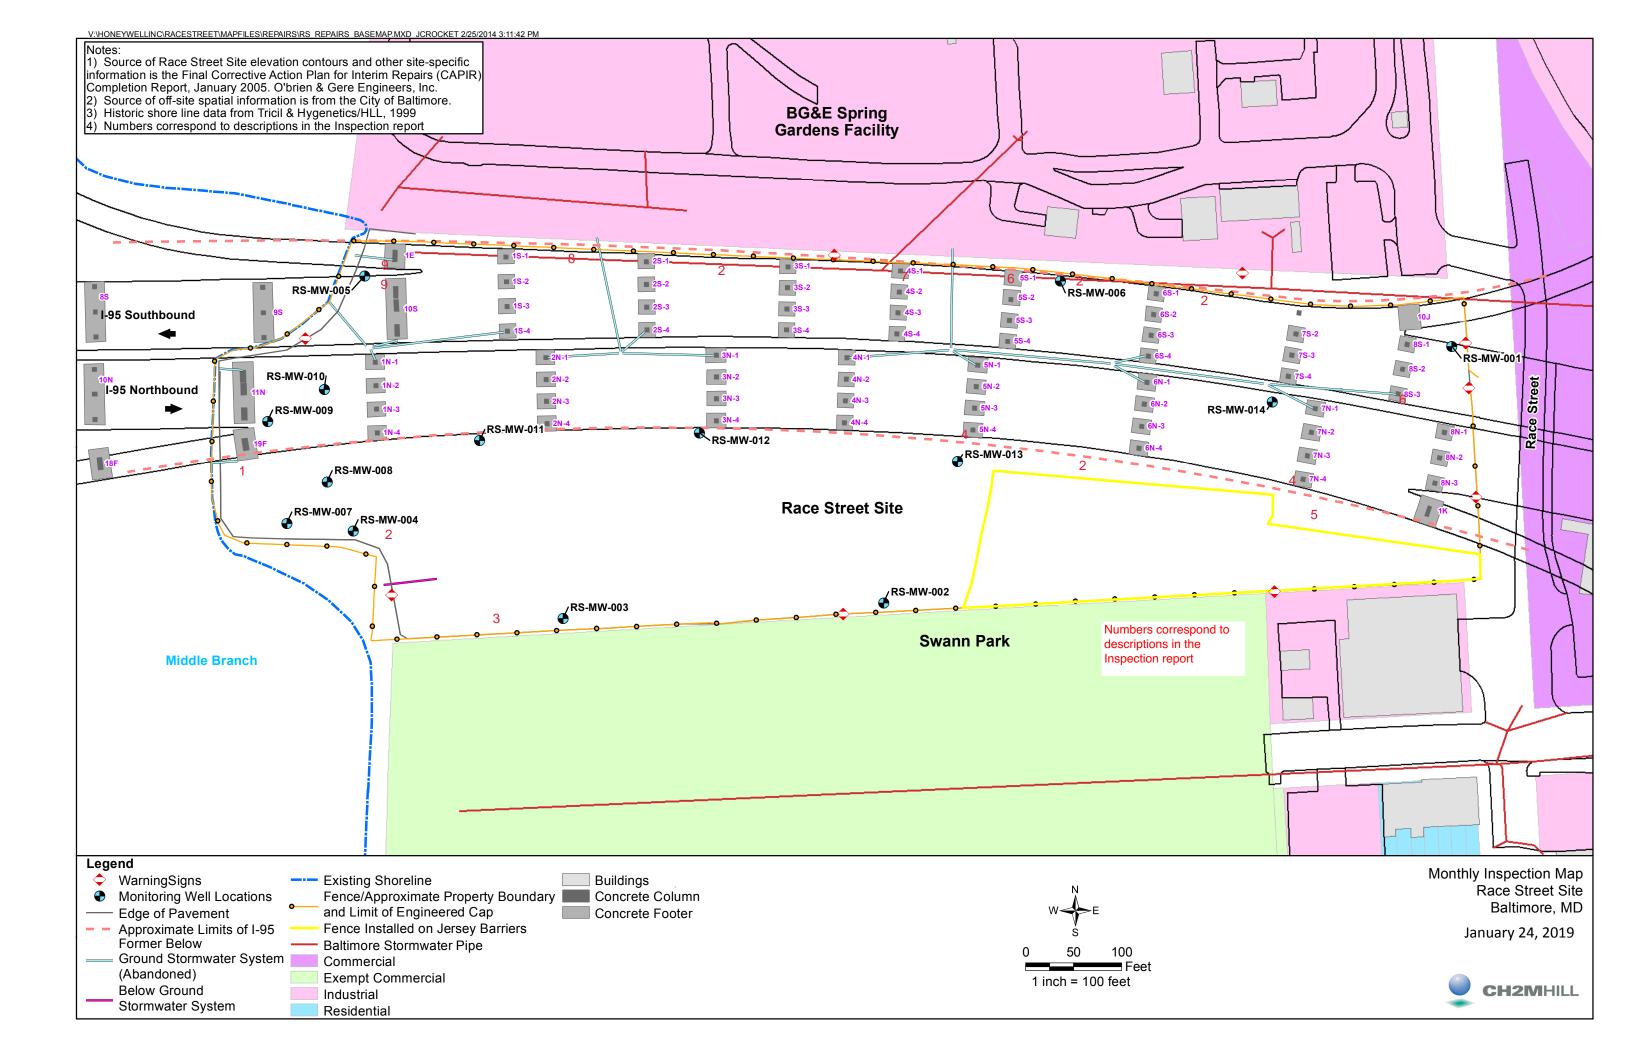
3. Engineered Cap				
Inspect cap for alligator cracking. Identify estimated area of cracking and location via description or on Site Plan (attach to Monthly Site Inspection Checklist)	None	None	NA	NA
Inspect cap for holes. Identify number of holes, width and depth, and location via description of on Site Plan (attach to Monthly Site Inspection Checklist)	None	None	NA	NA
Inspect cap for cracks less than 0.5 inches wide.  Note number of cracks. Identify location of cracks via description or on Site Plan (attach to Monthly Site Inspection Checklist).	Crack in asphalt with vegetation growth     Crack between pier footing and asphalt     with vegetation growth	None		Surface cover repairs to be addressed in 2019 as part of scheduled site maintenance and cap repairs.
Inspect cap for cracks greater than 0.5 inches wide. Note number of cracks. Identify location of cracks via description or on Site Plan (attach to Monthly Site Inspection Checklist).	Wide crack in asphalt with vegetation growth     Crack between pier footing and asphalt with vegetation growth	None	NA	Sediment, debris, and vegetation to be removed in 2019 as part of scheduled site maintenance.

5. Aboveground Stormwater Conveyance System	n		•			
Inspect aboveground stormwater conveyance system including piping, downspouts, and drain in southwest corner of site for proper operation	Disconnected downspout     Hole in downspout piping     Leak conveyance piping under elevated highway	MDTA notified of need for repairs to downspouts and piping	1/25/2019

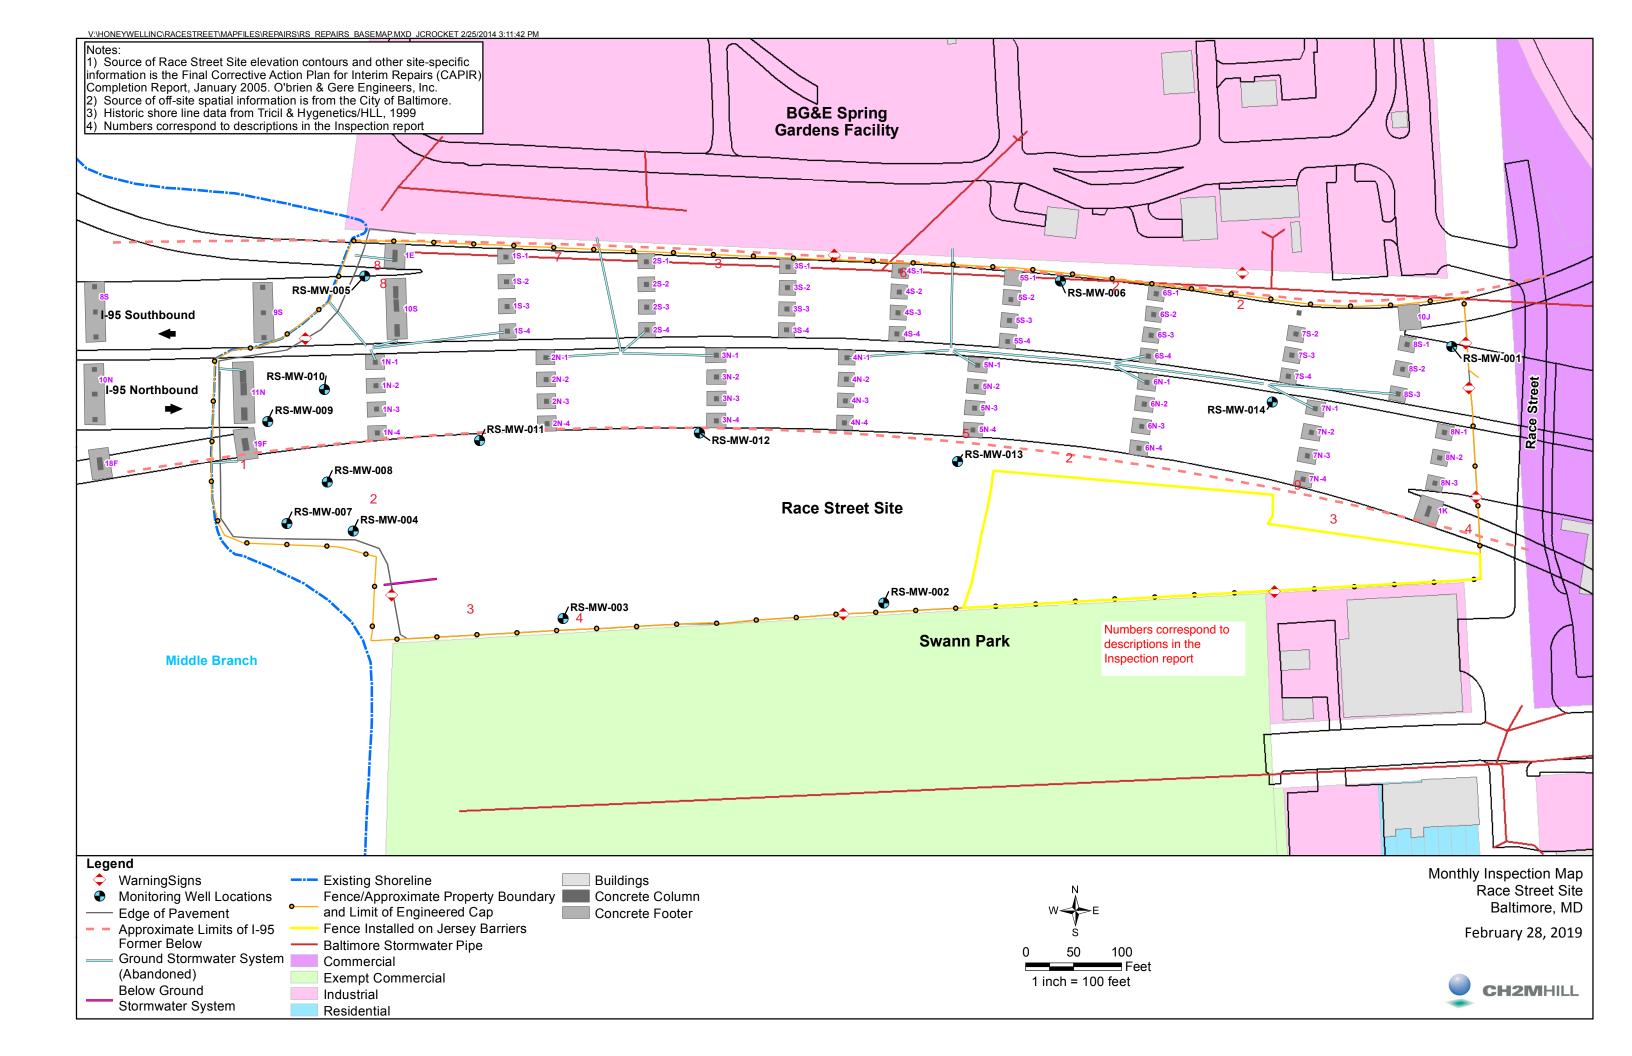
1. General	0200174410110	Actions Taken	Bate Completed	Commence, additional Operivations
Inspect site for presence of surface debris. Identify type, approximate volume of debris, and location via description or on Site Plan (attach to Monthly Site Inspection Checklist).	7: Sediment and debris accumulation with vegetation growth	None		Sediment, debris, and vegetation to be removed in 2019 as part of scheduled site maintenance.
Inspect site for presence of vegetation. Identify estimated amount and location of vegetation via description or on Site Plan (attach to Monthly Site Inspection Checklist)	None	None	NA	NA

3. Engineered Cap				
Inspect cap for alligator cracking. Identify estimated area of cracking and location via description or on Site Plan (attach to Monthly Site Inspection Checklist)	None	None	NA	NA .
Inspect cap for holes. Identify number of holes, width and depth, and location via description of on Site Plan (attach to Monthly Site Inspection Checklist)	None	None	NA	NA
Inspect cap for cracks less than 0.5 inches wide.  Note number of cracks. Identify location of cracks via description or on Site Plan (attach to Monthly Site Inspection Checklist).	Crack in asphalt with vegetation growth     Crack between pier footing and asphalt     with vegetation growth	None		Surface cover repairs to be addressed in 2019 as part of scheduled site maintenance and cap repairs.
Inspect cap for cracks greater than 0.5 inches wide. Note number of cracks. Identify location of cracks via description or on Site Plan (attach to Monthly Site Inspection Checklist).	Wide crack in asphalt with vegetation growth     Crack between pier footing and asphalt with vegetation growth	None	NA	Sediment, debris, and vegetation to be removed in 2019 as part of scheduled site maintenance.

5. Aboveground Stormwater Conveyance System					
Inspect aboveground stormwater conveyance system including piping, downspouts, and drain in southwest corner of site for proper operation	Disconnected downspout     Hole in downspout piping	MDTA notified of need for repairs to downspouts and piping	1/25/2019	NA

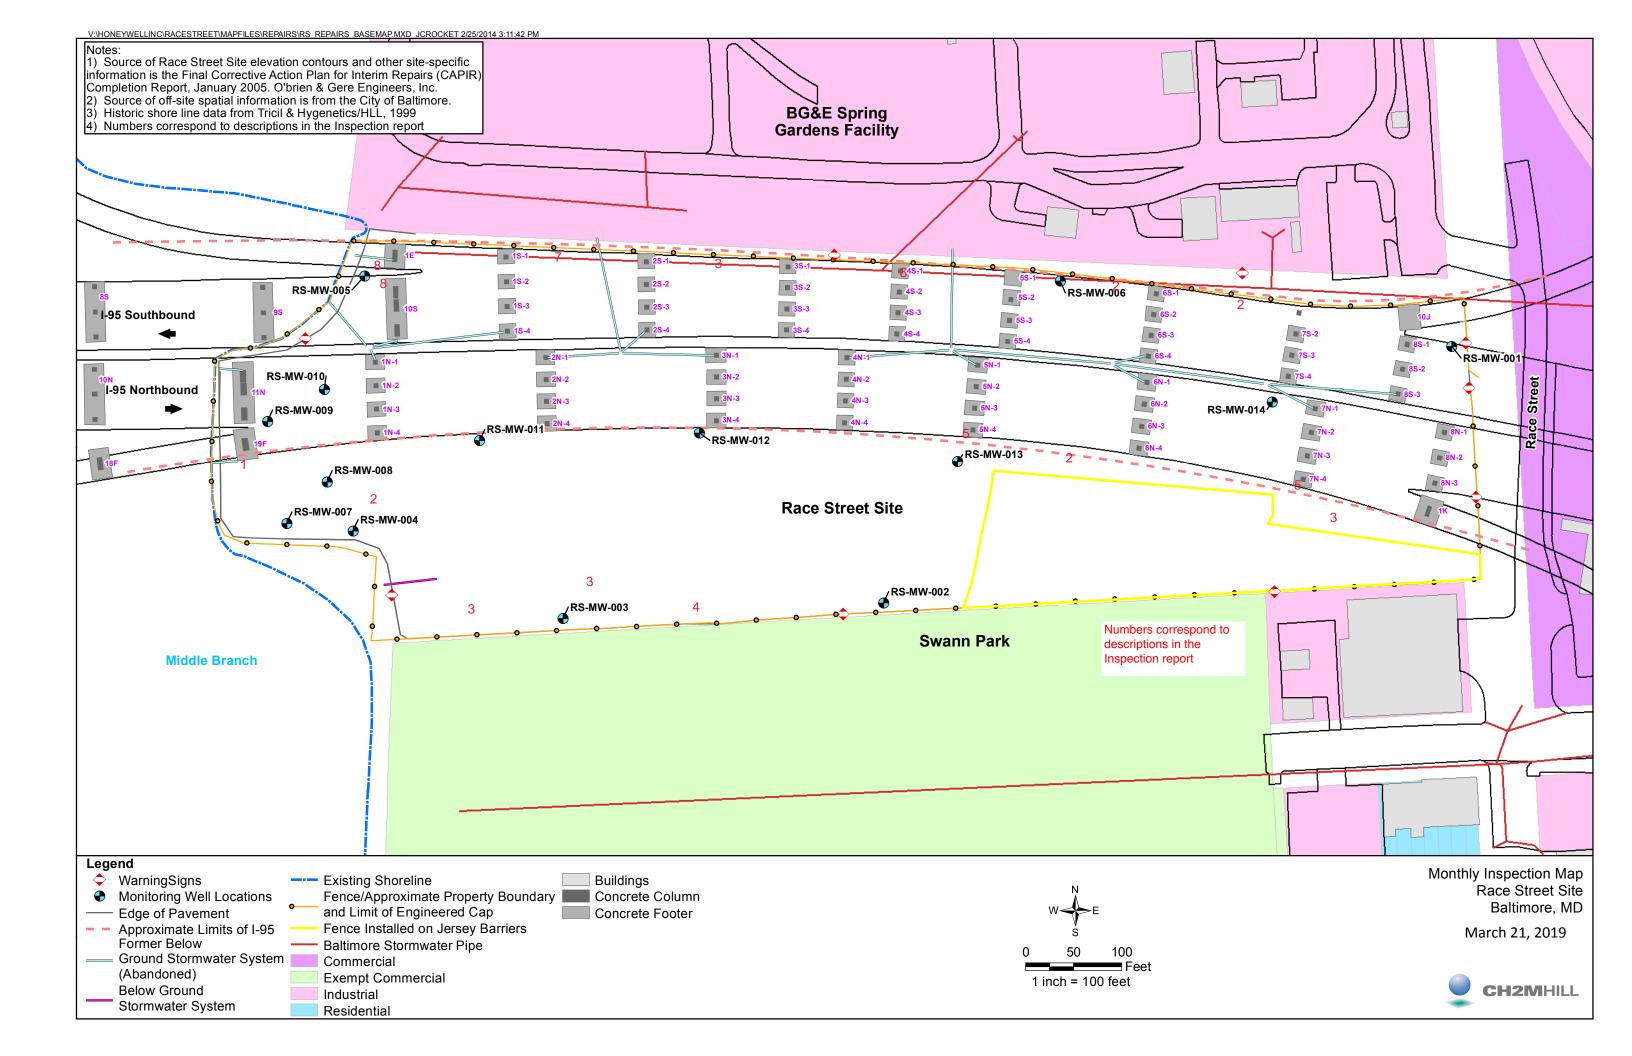
1. General	Observations	Actions Taken	Date Completed	Comments/Additional Observations			
Inspect site for presence of surface debris. Identify type, approximate volume of debris, and location via description or on Site Plan (attach to Monthly Site Inspection Checklist).	7: Sediment and debris accumulation with vegetation growth	None	NA	Sediment, debris, and vegetation to be removed in 2019 as part of scheduled site maintenance.			
Inspect site for presence of vegetation. Identify estimated amount and location of vegetation via description or on Site Plan (attach to Monthly Site Inspection Checklist)	None	None	NA	NA

3. Engineered Cap							
Inspect cap for alligator cracking. Identify estimated area of cracking and location via description or on Site Plan (attach to Monthly Site Inspection Checklist)	None	None	NA	NA			
Inspect cap for holes. Identify number of holes, width and depth, and location via description of on Site Plan (attach to Monthly Site Inspection Checklist)	None	None	NA	NA			
	Crack in asphalt with vegetation growth     Crack between pier footing and asphalt     with vegetation growth	None	NA	Surface cover repairs to be addressed in 2019 as part of scheduled site maintenance and cap repairs.			
Inspect cap for cracks greater than 0.5 inches wide. Note number of cracks. Identify location of cracks via description or on Site Plan (attach to Monthly Site Inspection Checklist).	Wide crack in asphalt with vegetation growth     Crack between pier footing and asphalt with vegetation growth	None	NA	Sediment, debris, and vegetation to be removed in 2019 as part of scheduled site maintenance.

5. Aboveground Stormwater Conveyance System					
Inspect aboveground stormwater conveyance system including piping, downspouts, and drain in southwest corner of site for proper operation	Disconnected downspout     Hole in downspout piping	MDTA notified of need for repairs to downspouts and piping	1/25/2019	NA
