Re: Transmittal of Quarterly Site Progress Report, Third Quarter 2019, 2000 Race Street Site, Baltimore, Maryland

THIRD QUARTER 2019 RACE STREET QUARTERLY SITE PROGRESS REPORT

2000 RACE STREET BALTIMORE, MARYLAND

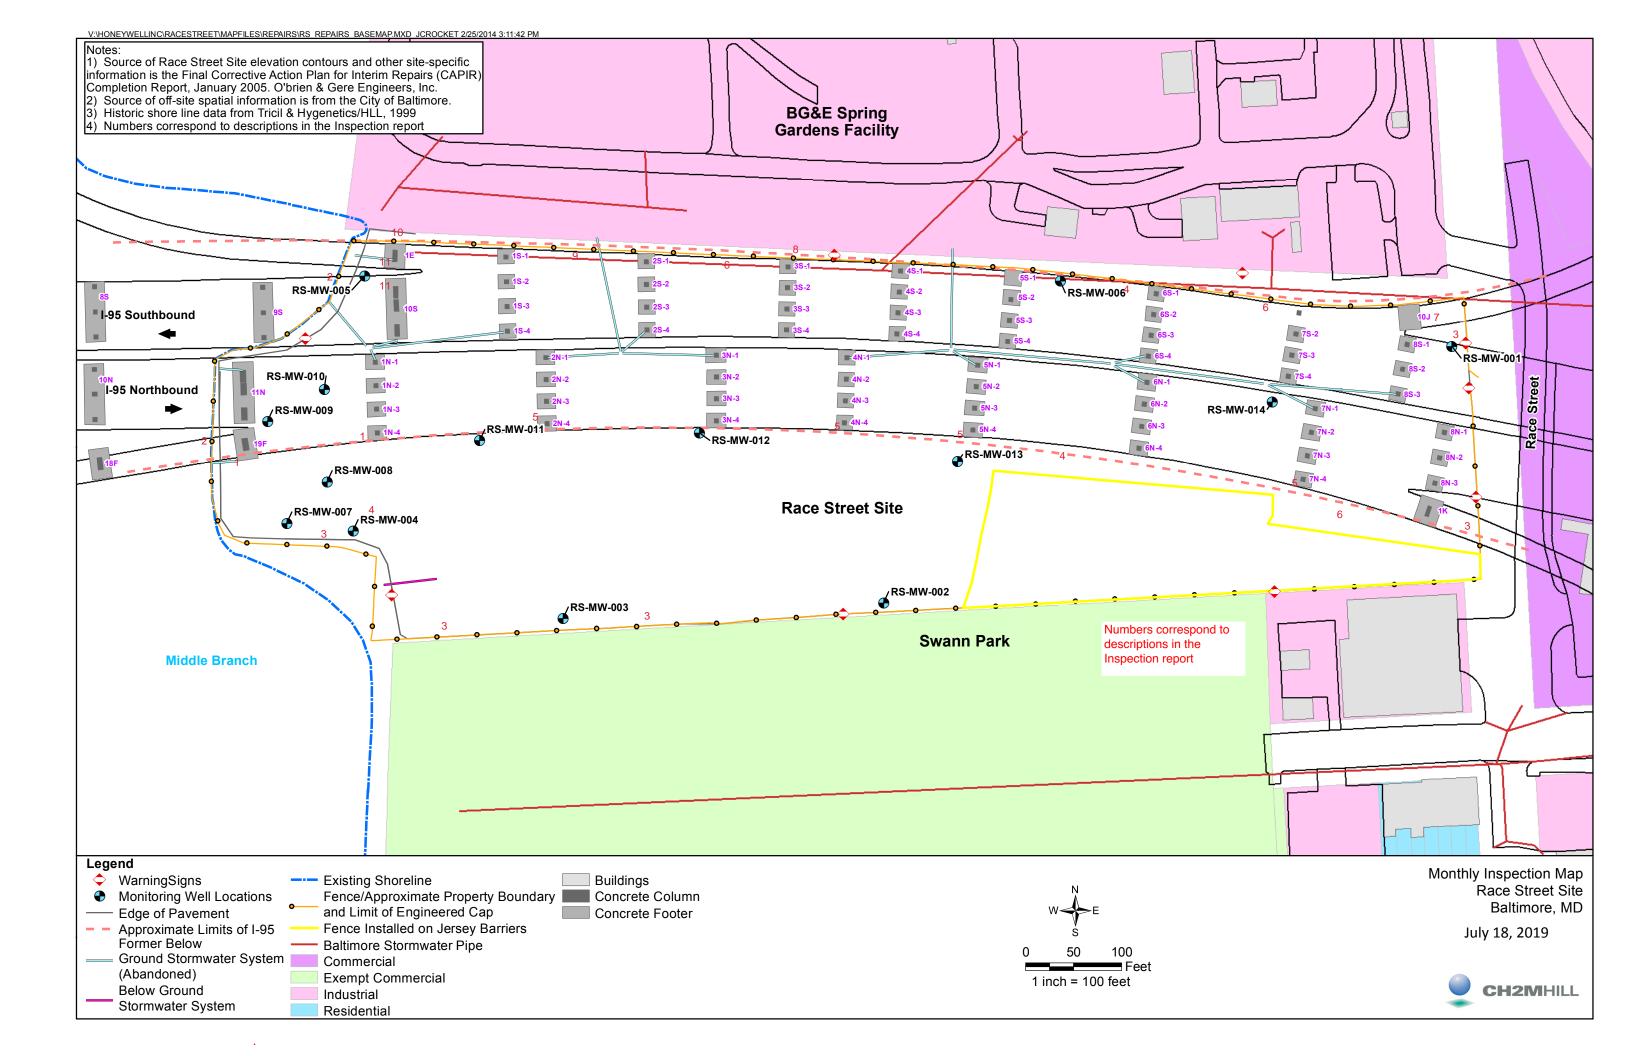
,			
Inspector:	Bill Morris	Date of Inspection:	18-Jul-19	
Title:	Environmental Engineer	Date of Last Inspection:	20-Jun-19	
Organization:	CH2M HILL	Weather:		Hot, sunny
Site Inspection				
Task 1. General	Observations	Actions Taken	Date Completed	Comments/Additional Observations
Inspect site for presence of surface debris. Identify	9: Sediment and debris accumulation with	None	NA	Sediment, debris, and vegetation to be removed in
type, approximate volume of debris, and location via description or on Site Plan (attach to Monthly Site Inspection Checklist).	vegetation growth	Notic		2019 as part of site maintenance before the installation of a new asphalt cap during Q4 2019.
Inspect site for presence of vegetation. Identify estimated amount and location of vegetation via description or on Site Plan (attach to Monthly Site Inspection Checklist)	2: Vegetation growth along shoreline	None	NA	Vegetation removal scheduled to be performed as part of site maintenance before the installation of a new asphalt cap during Q4 2019

2. Interstate 95 Footings and Joints				
Inspect around pier footings for settlement. Identify settlement off-set from grade and location via description or on Site Plan (attach to Monthly Site Inspection Checklist)	Signs of asphalt settlement around pier footing	None	NA	Asphalt leveling to be performed as part of the new cap installation to be performed during Q4 2019.
	None	None	NA	NA

3. Engineered Cap	<u></u>	<u></u>		,
Inspect cap for alligator cracking. Identify estimated area of cracking and location via description or on Site Plan (attach to Monthly Site Inspection Checklist)	7: Alligator cracking in asphalt with vegetation growth	None	NA	Surface cover repairs to be addressed as part of new cap installation during Q4 2019.
Inspect cap for holes. Identify number of holes, width and depth, and location via description of on Site Plan (attach to Monthly Site Inspection Checklist)	10: Groundhog borrow hole through asphalt	None	NA	Surface cover repairs to be addressed as part of new cap installation during Q4 2019.
	Crack in asphalt with vegetation growth Crack between pier footing and asphalt with vegetation growth	None	NA	Surface cover repairs to be addressed as part of new cap installation during Q4 2019.
Inspect cap for cracks greater than 0.5 inches wide. Note number of cracks. Identify location of cracks via description or on Site Plan (attach to Monthly Site Inspection Checklist).	4: Wide crack in asphalt with vegetation growth 11: Crack between pier footing and asphalt with vegetation growth	None	NA	Surface cover repairs to be addressed as part of new cap installation during Q4 2019.

8. Miscellaneous Items			L	
Any interaction with people on or adjacent to the site? If yes, identify who, title, organization, contact information, and content of interaction	Al Simkins of MDE on site for the montl	nly inspection.		
Other Comments/Observations?	8: Erosion at edge of stormwater let do	wn on slope. Cap repairs to be perfor	med as part of the insta	llation of the new cap during Q4 2019.

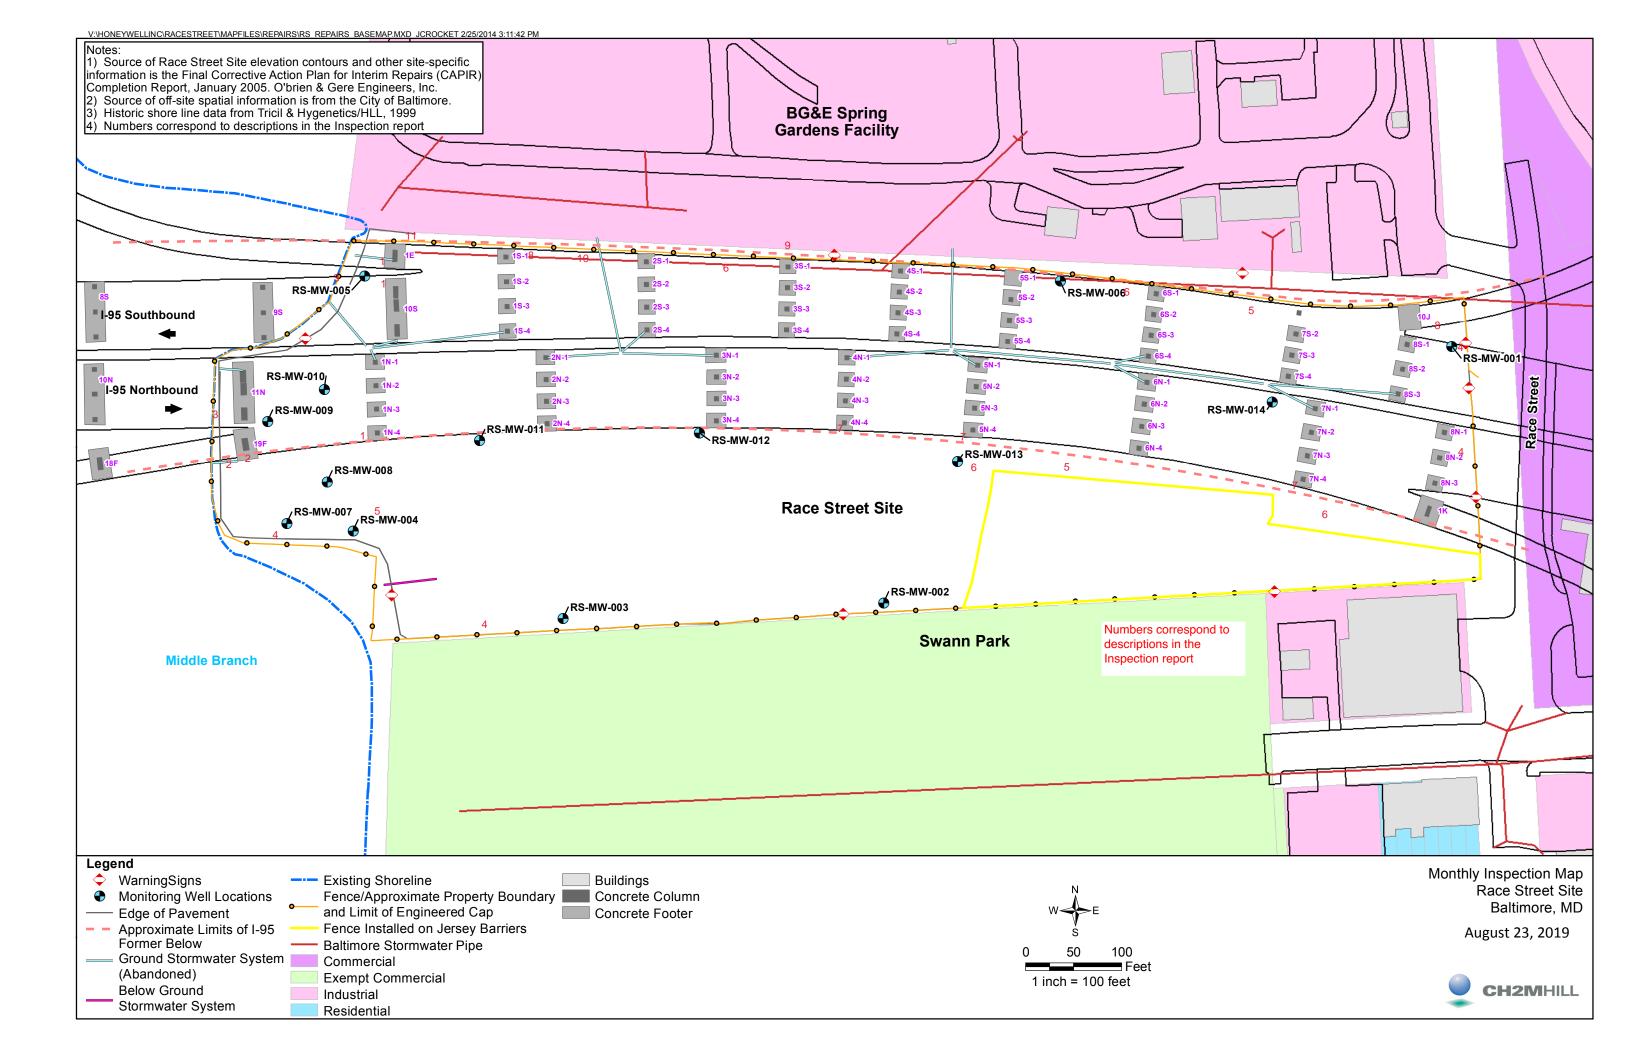
1. General		I	1	
Inspect site for presence of surface debris. Identify type, approximate volume of debris, and location via description or on Site Plan (attach to Monthly Site Inspection Checklist).	10: Sediment and debris accumulation with vegetation growth	None	NA	Sediment, debris, and vegetation to be removed in 2019 as part of site maintenance before the installation of a new asphalt cap during Q4 2019.
Inspect site for presence of vegetation. Identify estimated amount and location of vegetation via description or on Site Plan (attach to Monthly Site Inspection Checklist)	3: Vegetation growth along shoreline	None	NA	Vegetation removal scheduled to be performed as part of site maintenance before the installation of a new asphalt cap during Q4 2019

2. Interstate 95 Footings and Joints	•	•	•	
Inspect around pier footings for settlement. Identify settlement off-set from grade and location via description or on Site Plan (attach to Monthly Site Inspection Checklist)	Signs of asphalt settlement around pier footing	None	NA	Asphalt leveling to be performed as part of the new cap installation to be performed during Q4 2019.
	None	None	NA	NA

3. Engineered Cap		•		
Inspect cap for alligator cracking. Identify estimated area of cracking and location via description or on Site Plan (attach to Monthly Site Inspection Checklist)	Alligator cracking in asphalt with vegetation growth	None	NA	Surface cover repairs to be addressed as part of new cap installation during Q4 2019.
Inspect cap for holes. Identify number of holes, width and depth, and location via description of on Site Plan (attach to Monthly Site Inspection Checklist)	11: Groundhog borrow hole through asphalt	None	NA	Surface cover repairs to be addressed as part of new cap installation during Q4 2019.
Inspect cap for cracks less than 0.5 inches wide. Note number of cracks. Identify location of cracks via description or on Site Plan (attach to Monthly Site Inspection Checklist).	6: Crack in asphalt with vegetation growth 7: Crack between pier footing and asphalt with vegetation growth	None	NA	Surface cover repairs to be addressed in 2019 as part of scheduled site maintenance and cap repairs.

Inspect cap for cracks greater than 0.5 inches wide. Note number of cracks. Identify location of cracks via description or on Site Plan (attach to Monthly Site Inspection Checklist).	5: Wide crack in asphalt with vegetation growth 1: Crack between pier footing and asphalt with vegetation growth	None	NA	Surface cover repairs to be addressed as part of new cap installation during Q4 2019.
Inspect cap for any signs of ponding of water	None	None	NA	NA
Inspect shorefront embankment for evidence of erosion or releases	None	None	NA	NA
Identify any other observations related to the condition of the cap and potential for cap damage	None	None	NA	NA

7. Signage	1		I	
	None	None	NA	NA
8. Miscellaneous Items	I	'		1
Any interaction with people on or adjacent to the site? If yes, identify who, title, organization, contact information, and content of interaction	Al Simkins of MDE on site for the monthly in	spection. Surveyors from RK&K on	site.	
Other Comments/Observations?	9: Erosion at edge of stormwater let down o	n slope. Cap repairs to be performe	d as part of the installa	tion of the new cap during Q4 2019.

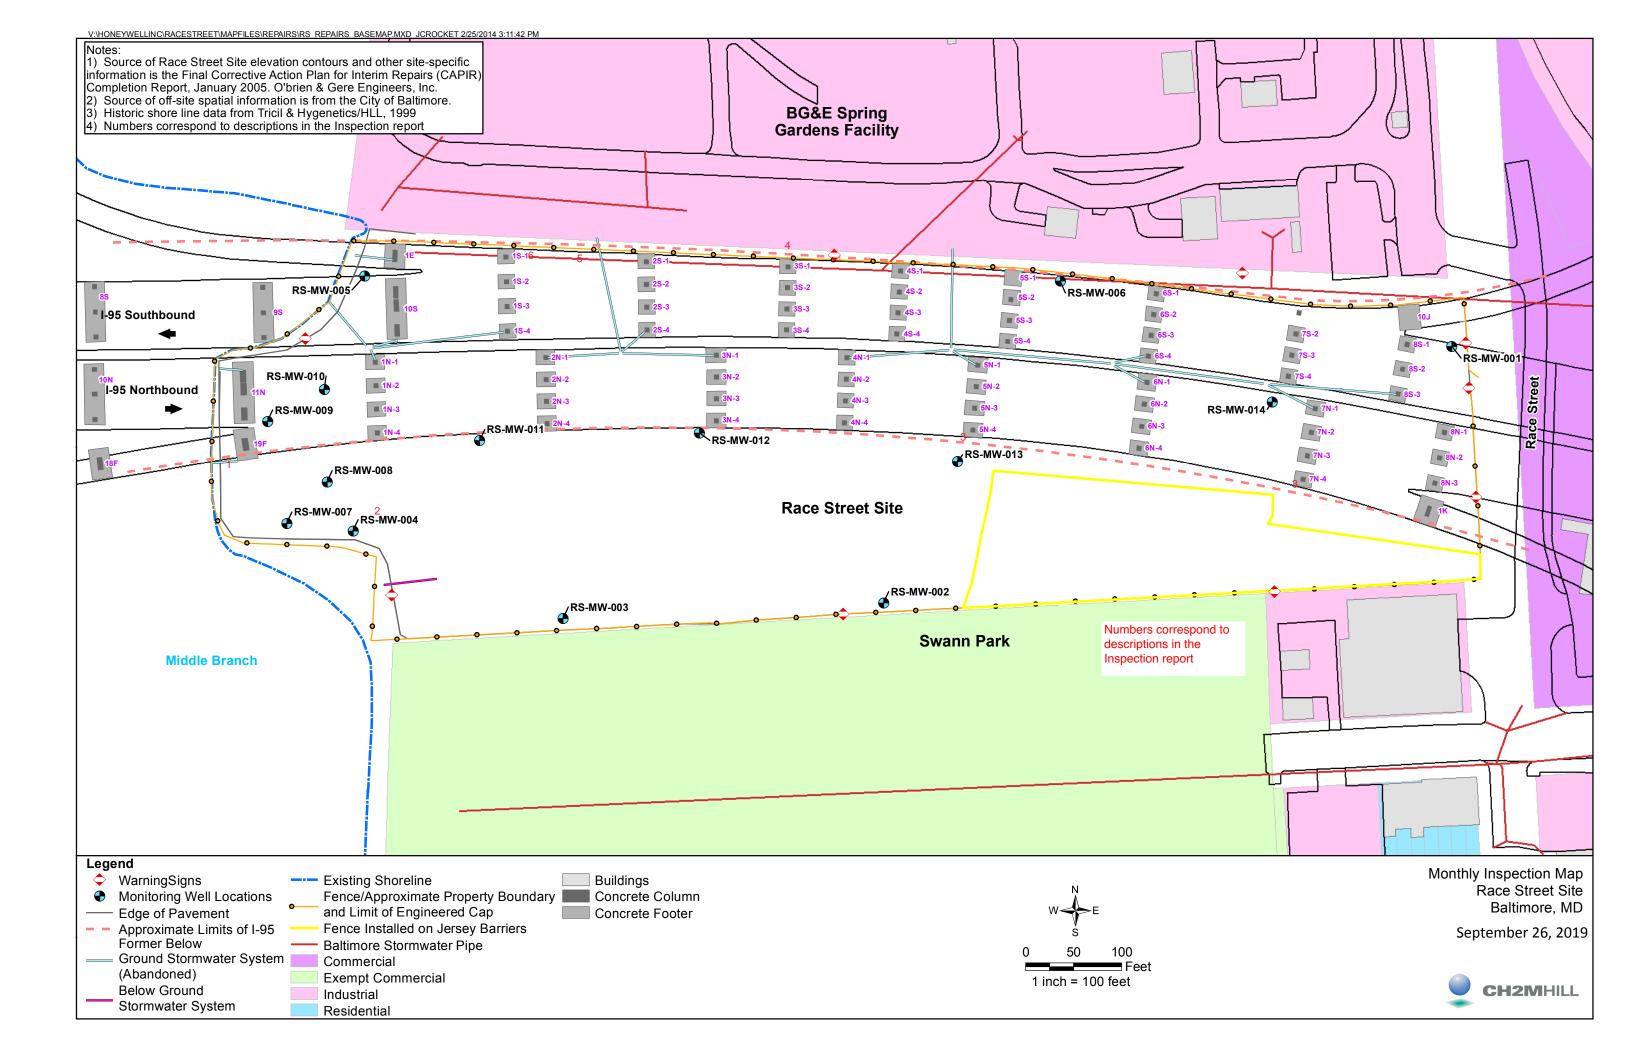
1. General				
Inspect site for presence of surface debris. Identify type, approximate volume of debris, and location via description or on Site Plan (attach to Monthly Site Inspection Checklist).	5: Sediment and debris accumulation with vegetation growth	City performed site-wide vegetation control	9/3/2019	Sediment, debris, and vegetation to be removed in 2019 as part of site maintenance before the installation of a new asphalt cap during Q4 2019.
Inspect site for presence of vegetation. Identify estimated amount and location of vegetation via description or on Site Plan (attach to Monthly Site Inspection Checklist)	None	None	NA	NA

2. Interstate 95 Footings and Joints				
Inspect around pier footings for settlement. Identify settlement off-set from grade and location via description or on Site Plan (attach to Monthly Site Inspection Checklist)	Signs of asphalt settlement around pier footing	None	NA	Asphalt leveling to be performed as part of the new cap installation to be performed during Q4 2019.
	None	None	NA	NA

3. Engineered Cap				
Inspect cap for alligator cracking. Identify estimated area of cracking and location via description or on Site Plan (attach to Monthly Site Inspection Checklist)	6: Alligator cracking in asphalt.	None	NA	Surface cover repairs to be addressed as part of new cap installation during Q4 2019.
Inspect cap for holes. Identify number of holes, width and depth, and location via description of on Site Plan (attach to Monthly Site Inspection Checklist)	None	None	NA	NA
Inspect cap for cracks less than 0.5 inches wide. Note number of cracks. Identify location of cracks via description or on Site Plan (attach to Monthly Site Inspection Checklist).	3: Crack between pier footing and asphalt with vegetation growth	City performed site-wide vegetation control	3-Sep-19	Surface cover repairs to be addressed as part of new cap installation during Q4 2019.
Inspect cap for cracks greater than 0.5 inches wide. Note number of cracks. Identify location of cracks via description or on Site Plan (attach to Monthly Site Inspection Checklist).	2: Wide crack in asphalt with vegetation growth	City performed site-wide vegetation control	3-Sep-19	Surface cover repairs to be addressed as part of new cap installation during Q4 2019.

8. Miscellaneous Items				
Any interaction with people on or adjacent to the site? If yes, identify who, title, organization, contact information, and content of interaction	Sylvie Osias of MDE on site for the monthly	y inspection. Crews from Parratt Wo	lf and Flanigan on s	ite preparing for site construction.
Other Comments/Observations?	4: Erosion at edge of stormwater let down	on slope. Cap repairs to be performe	ed as part of the ins	tallation of the new cap during Q4 2019.
