**Re: Transmittal of Quarterly Site Progress Report, Third Quarter 2025, 2000 Race Street Site, Baltimore, Maryland**

# Third Quarter 2025 Site Progress Report

2000 Race Street  
Baltimore, Maryland

### Surface Cover Repair Photo Log

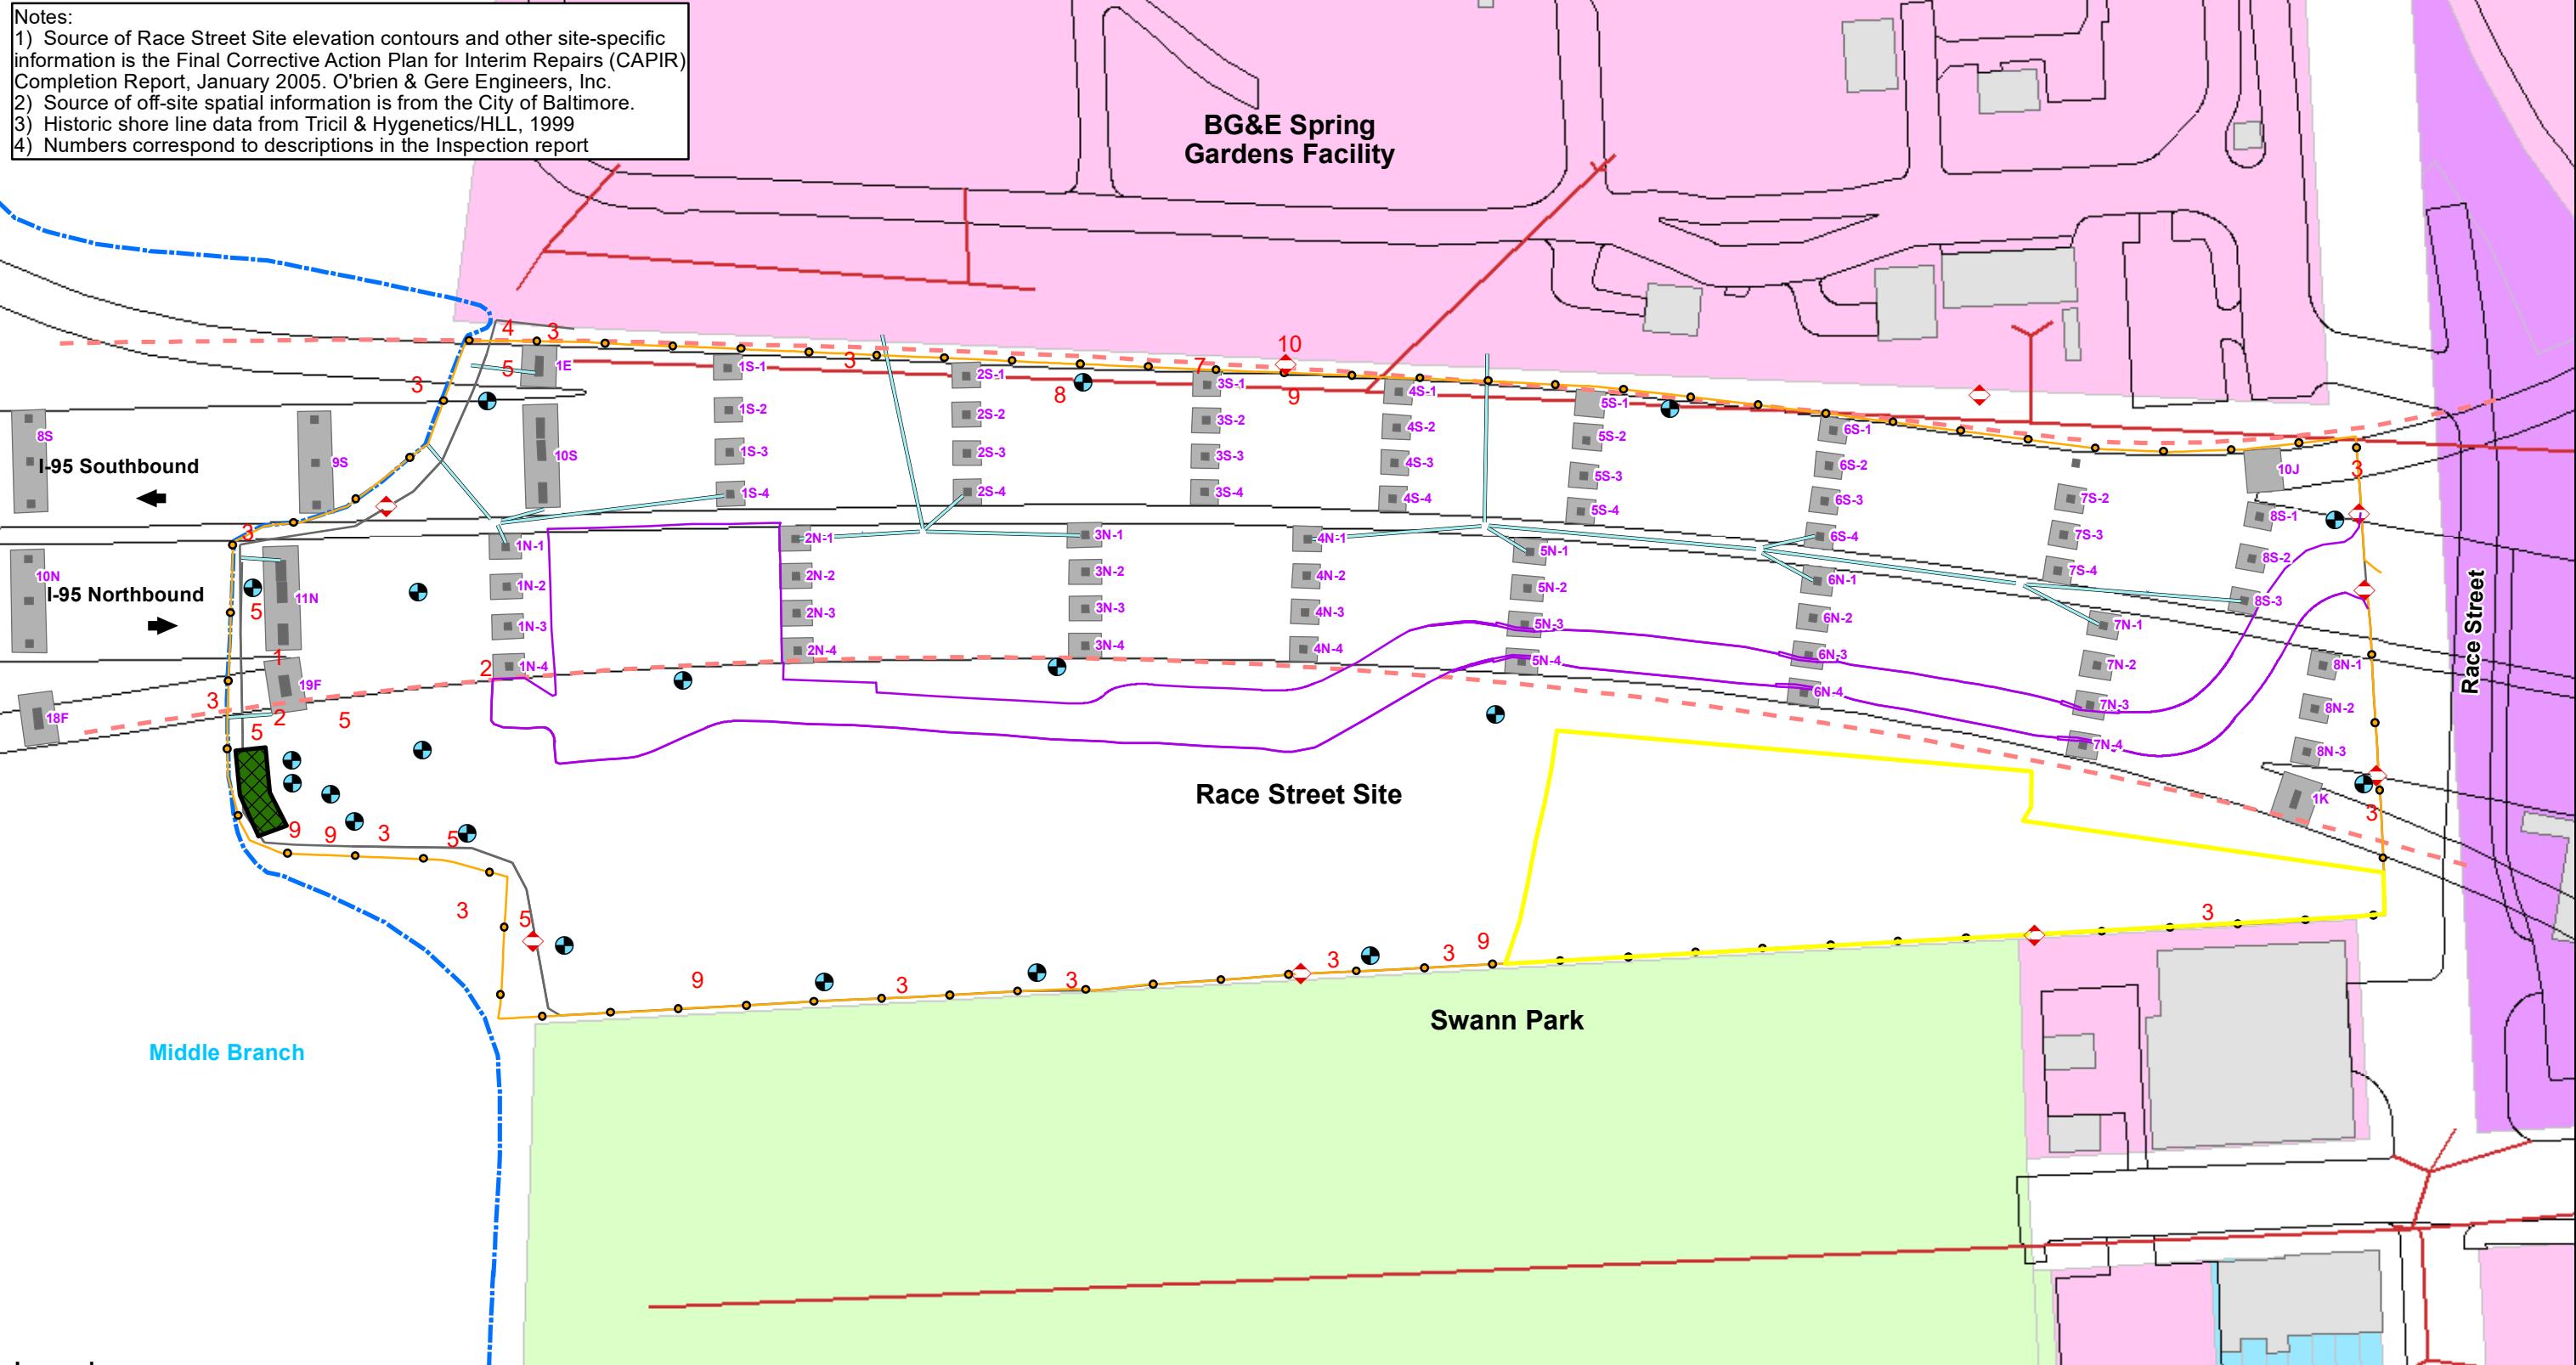
Monthly Inspection Map  
 Race Street Site  
 Baltimore, MD  
 July 24, 2025

<b>2. Interstate 95 Footings and Joints</b>				
Inspect around pier footings for settlement. Identify settlement off-set from grade and location via description or on Site Plan (attach to Monthly Site Inspection Checklist)	2: Asphalt settlement adjacent to pier footing.	Jacobs performed surface cover inspection on 9/26/24	6/26/2025	Jacobs to address in Q2-Q3 2025.
	None	None	NA	NA
<b>3. Engineered Cap</b>				
Inspect cap for alligator cracking. Identify estimated area of cracking and location via description or on Site Plan (attach to Monthly Site Inspection Checklist)	None	None	NA	NA
Inspect cap for holes. Identify number of holes, width and depth, and location via description or on Site Plan (attach to Monthly Site Inspection Checklist)	4: Hole in asphalt	Jacobs subcontractor performed surface cover repairs on 9/09/25	9/9/2025	NA
Inspect cap for cracks less than 0.5 inches wide. Note number of cracks. Identify location of cracks via description or on Site Plan (attach to Monthly Site Inspection Checklist).	5: Crack with vegetation growth. 6: Crack at asphalt seam. 7: Crack in asphalt curb	City notified of need to implement vegetation control	6/26/2025	City of Baltimore to address vegetation control as part of site maintenance.

Inspect cap for cracks greater than 0.5 inches wide. Note number of cracks. Identify location of cracks via description or on Site Plan (attach to Monthly Site Inspection Checklist).	None	None	NA	NA
Inspect cap for any signs of ponding of water	None	None	NA	NA
Inspect storefront embankment for evidence of erosion or releases	None	None	NA	NA
Identify any other observations related to the condition of the cap and potential for cap damage	8: Sediment accumulation on asphalt 9: Sediment with vegetation growth 10: Settlement on slope adjacent to asphalt.	City notified of need to implement vegetation control	6/26/2025	City of Baltimore to address vegetation control as part of site maintenance. Will address crack during asphalt repair

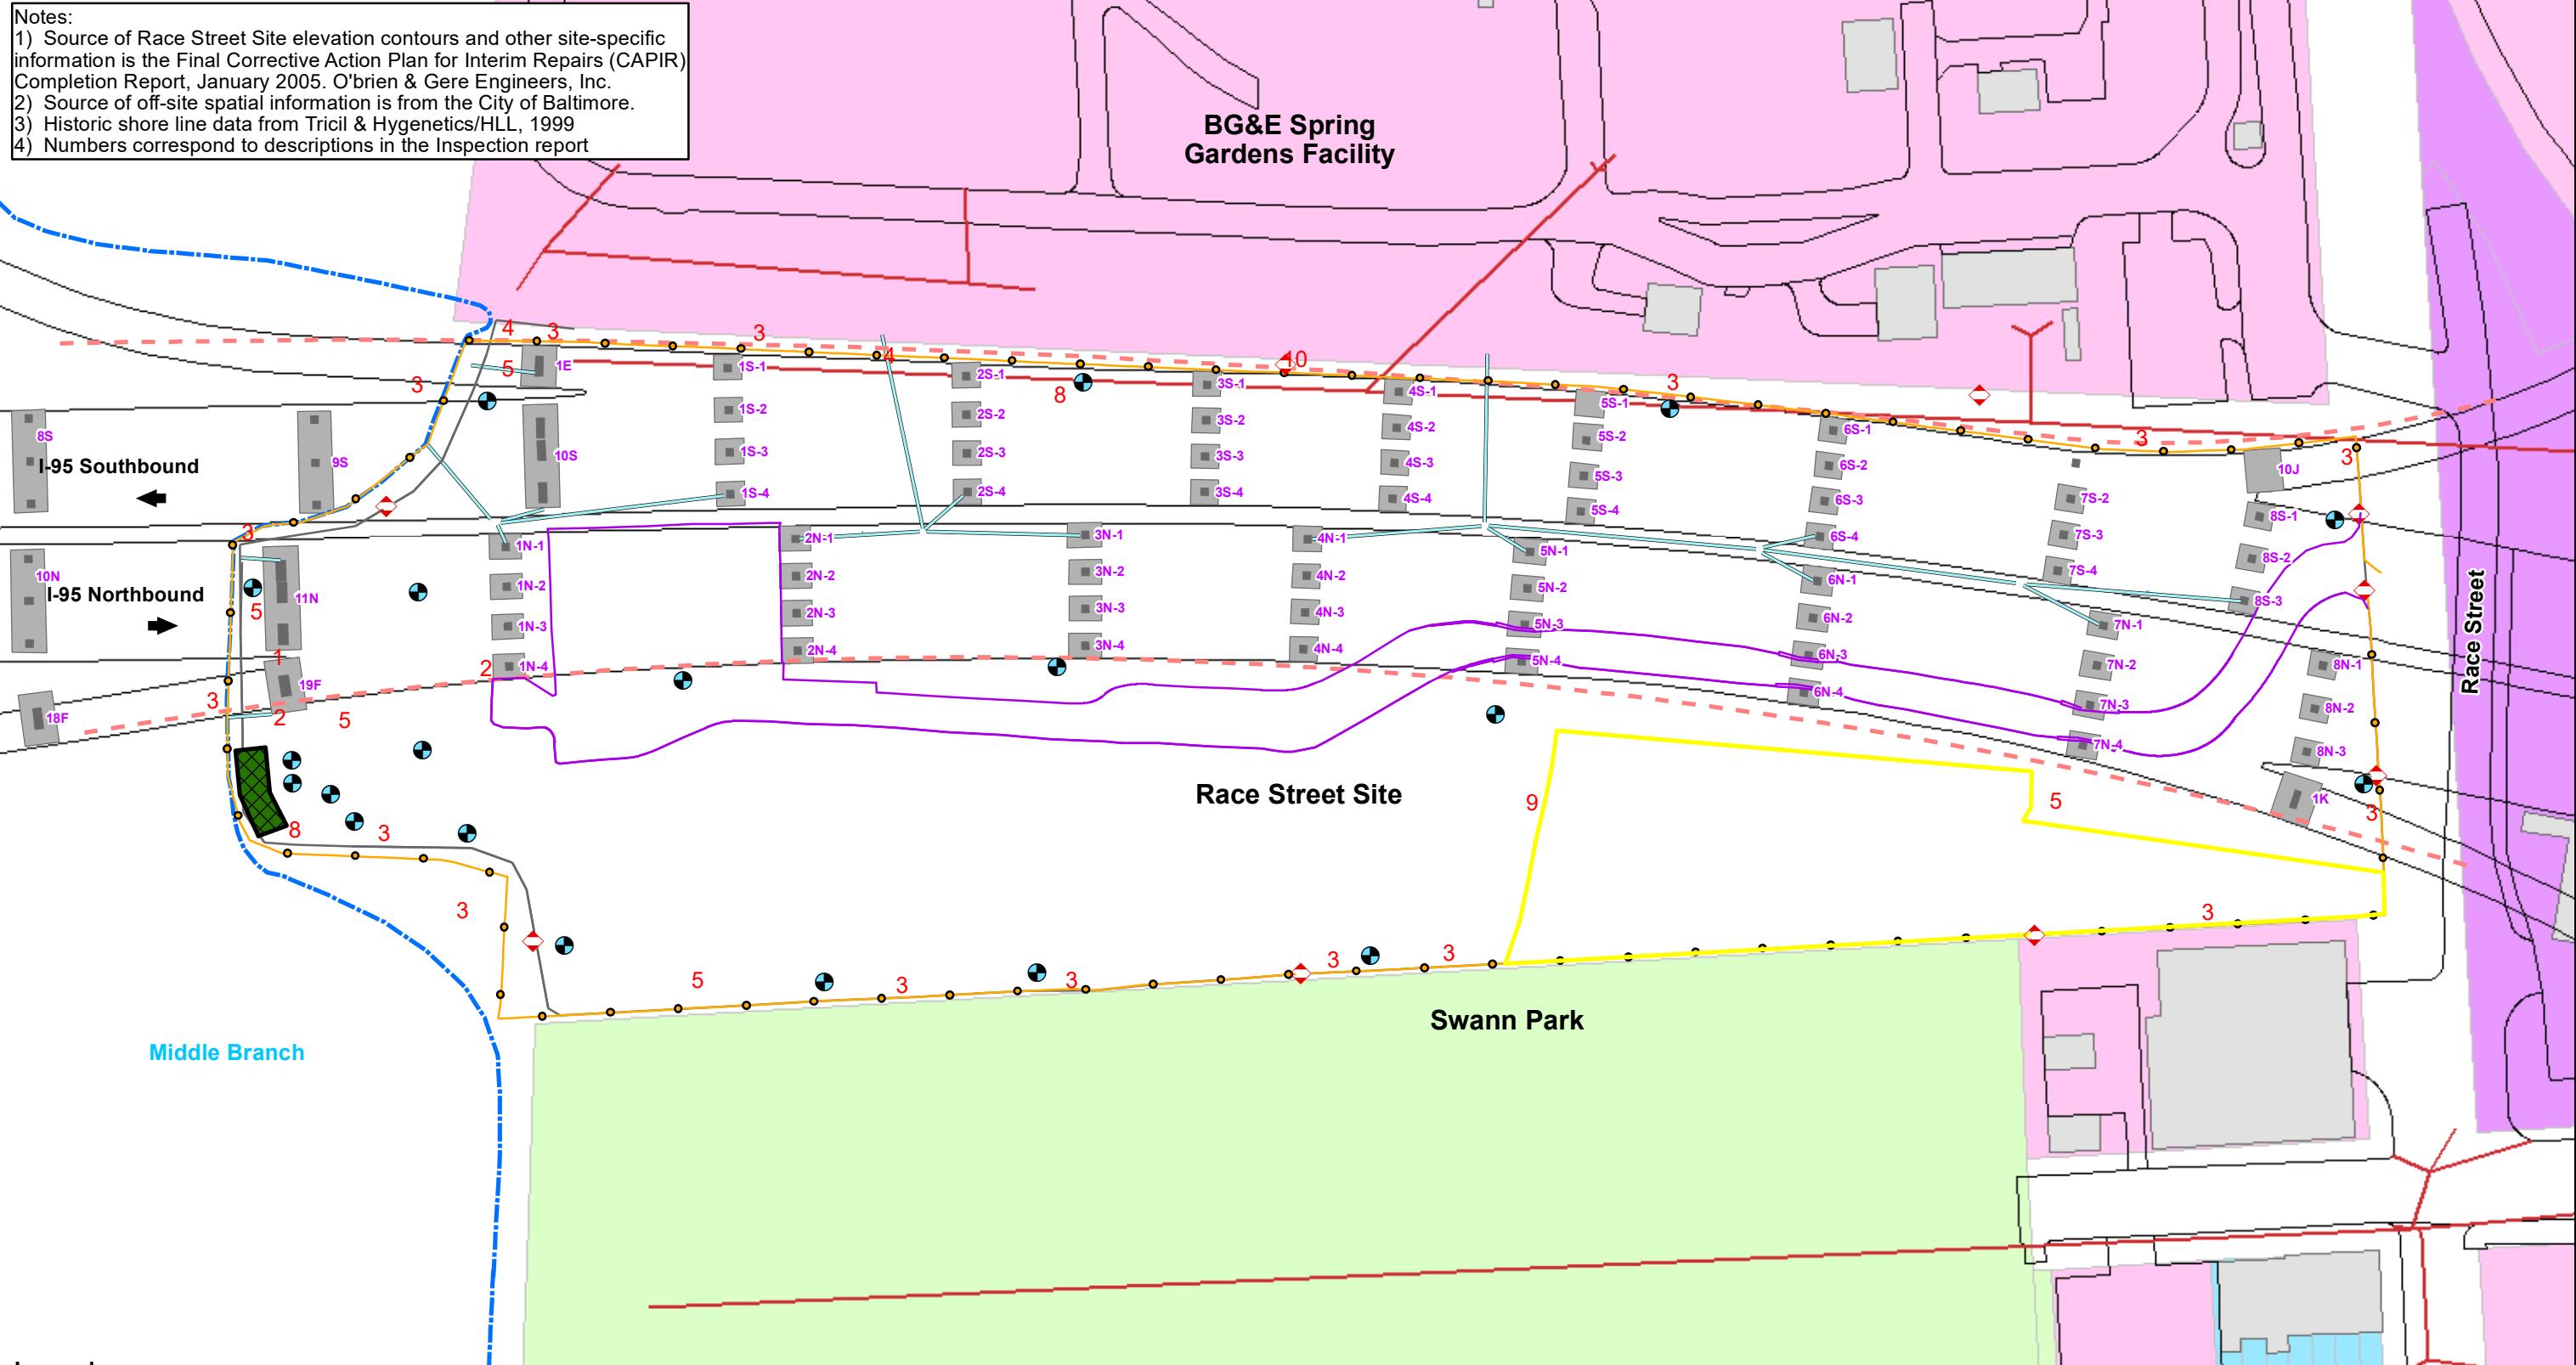
Monthly Inspection Map  
 Race Street Site  
 Baltimore, MD  
 August 27, 2025

<b>2. Interstate 95 Footings and Joints</b>				
Inspect around pier footings for settlement. Identify settlement off-set from grade and location via description or on Site Plan (attach to Monthly Site Inspection Checklist)	2: Asphalt settlement adjacent to pier footing.	Jacobs performed surface cover inspection on 9/26/24	6/26/2025	Jacobs to address in Q2-Q3 2025.
	None	None	NA	NA
<b>3. Engineered Cap</b>				
Inspect cap for alligator cracking. Identify estimated area of cracking and location via description or on Site Plan (attach to Monthly Site Inspection Checklist)	None	None	NA	NA
Inspect cap for holes. Identify number of holes, width and depth, and location via description or on Site Plan (attach to Monthly Site Inspection Checklist)	4: Hole in asphalt	Jacobs subcontractor performed surface cover repairs on 9/09/25	9/9/2025	NA
Inspect cap for cracks less than 0.5 inches wide. Note number of cracks. Identify location of cracks via description or on Site Plan (attach to Monthly Site Inspection Checklist).	5: Crack with vegetation growth. 6: Crack at asphalt seam. 7: Crack in asphalt curb	City notified of need to implement vegetation control	6/26/2025	City of Baltimore to address vegetation control as part of site maintenance.

Inspect cap for cracks greater than 0.5 inches wide. Note number of cracks. Identify location of cracks via description or on Site Plan (attach to Monthly Site Inspection Checklist).	None	None	NA	NA
Inspect cap for any signs of ponding of water	None	None	NA	NA
Inspect storefront embankment for evidence of erosion or releases	None	None	NA	NA
Identify any other observations related to the condition of the cap and potential for cap damage	8: Sediment accumulation on asphalt 9: Sediment with vegetation growth 10: Settlement on slope adjacent to asphalt.	City notified of need to implement vegetation control	6/26/2025	City of Baltimore to address vegetation control as part of site maintenance. Will address crack during asphalt repair

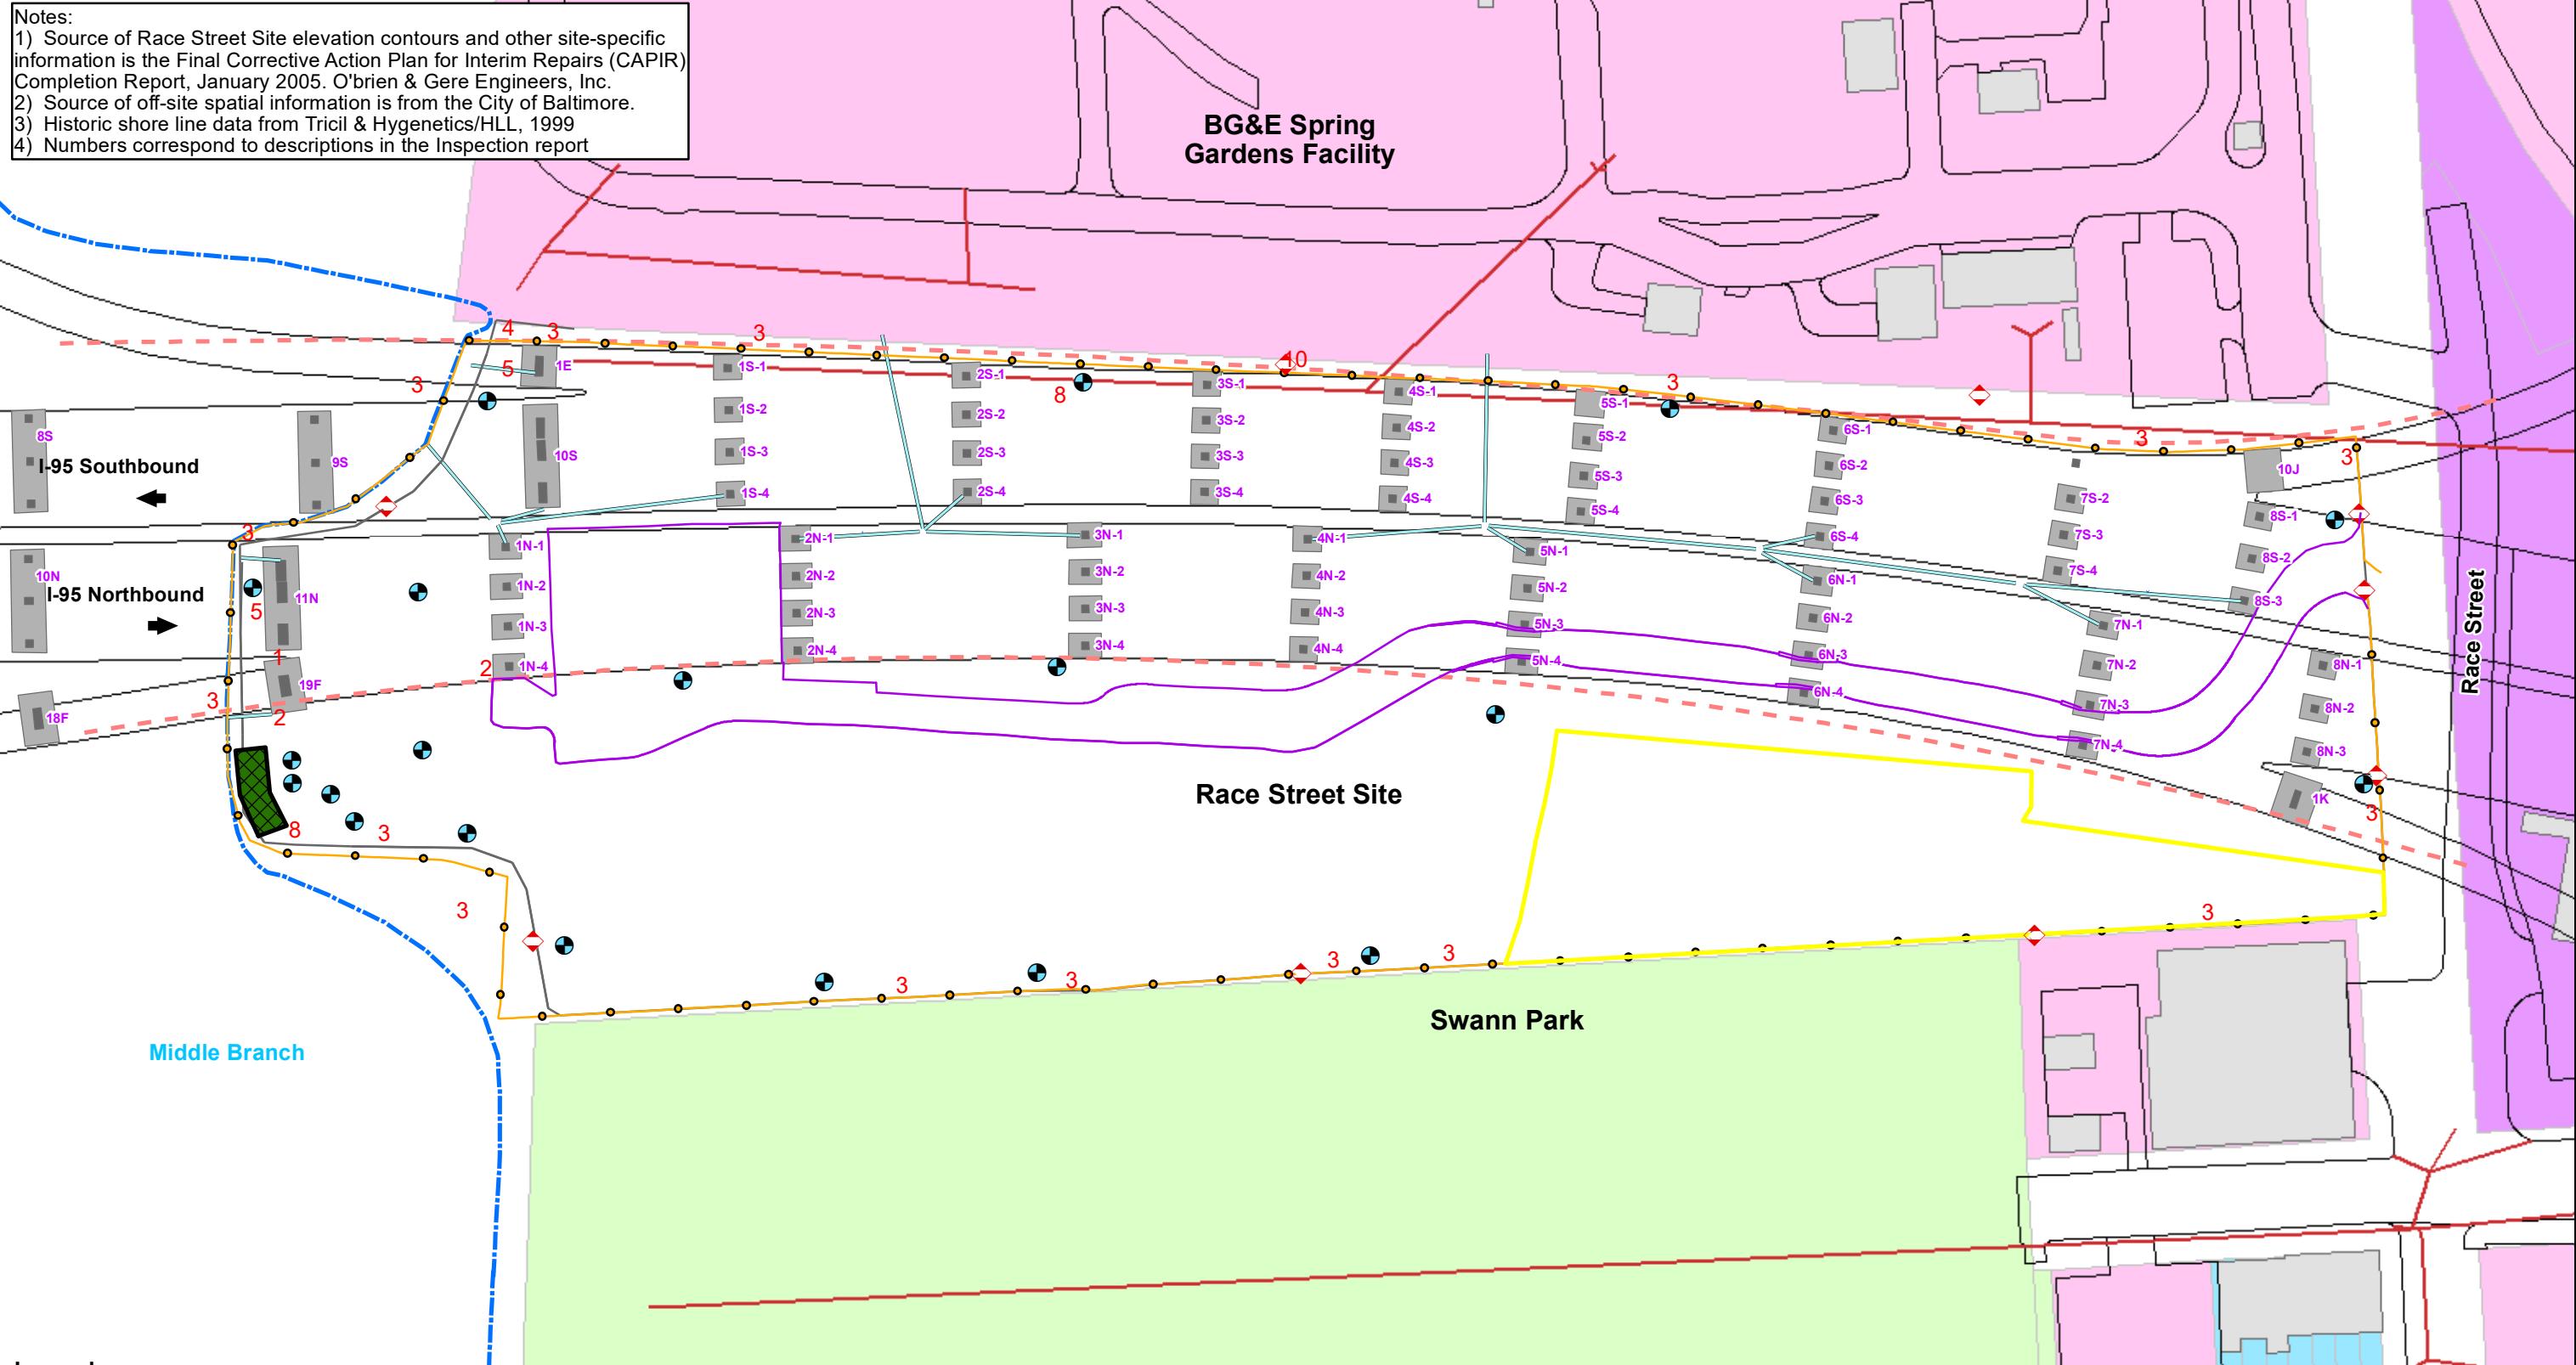
Monthly Inspection Map  
 Race Street Site  
 Baltimore, MD

<b>2. Interstate 95 Footings and Joints</b>				
Inspect around pier footings for settlement. Identify settlement off-set from grade and location via description or on Site Plan (attach to Monthly Site Inspection Checklist)	2: Asphalt settlement adjacent to pier footing.	Jacobs subcontractor performed surface cover repairs on 9/09/25	9/9/2025	NA
	None	None	NA	NA
<b>3. Engineered Cap</b>				
Inspect cap for alligator cracking. Identify estimated area of cracking and location via description or on Site Plan (attach to Monthly Site Inspection Checklist)	None	None	NA	NA
Inspect cap for holes. Identify number of holes, width and depth, and location via description or on Site Plan (attach to Monthly Site Inspection Checklist)	4: Hole in asphalt	Jacobs subcontractor performed surface cover repairs on 9/09/25	9/9/2025	NA
Inspect cap for cracks less than 0.5 inches wide. Note number of cracks. Identify location of cracks via description or on Site Plan (attach to Monthly Site Inspection Checklist).	5: Crack with vegetation growth. 6: Crack at asphalt seam. 7: Crack in asphalt curb	City notified of need to implement vegetation control. Jacobs subcontractor performed crack seal on 9/16/25	9/16/2025	City of Baltimore to address vegetation control as part of site maintenance.

Inspect cap for cracks greater than 0.5 inches wide. Note number of cracks. Identify location of cracks via description or on Site Plan (attach to Monthly Site Inspection Checklist).	None	None	NA	NA
Inspect cap for any signs of ponding of water	None	None	NA	NA
Inspect storefront embankment for evidence of erosion or releases	None	None	NA	NA
Identify any other observations related to the condition of the cap and potential for cap damage	8: Sediment accumulation on asphalt 9: Sediment with vegetation growth 10: Settlement on slope adjacent to asphalt.	City notified of need to implement vegetation control. Jacobs subcontractor performed surface cover repairs on 9/09/25	9/9/2025	City of Baltimore to address vegetation control as part of site maintenance.

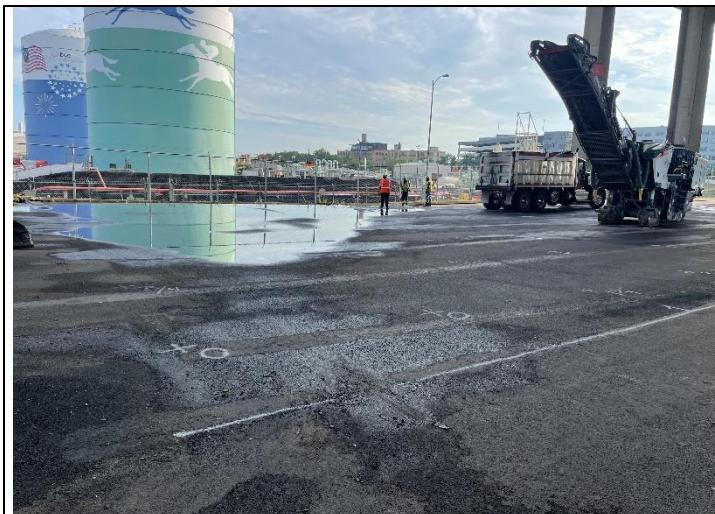
**PHOTO 1** Survey mark out for milling and paving

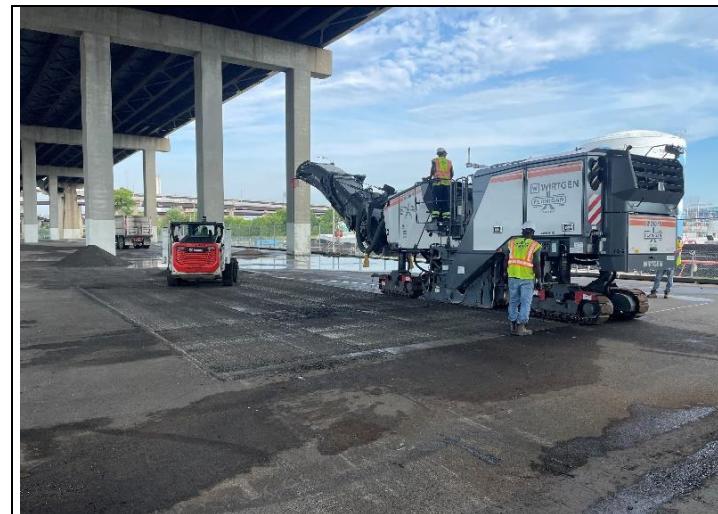
**PHOTO 2** Asphalt removal using milling machine

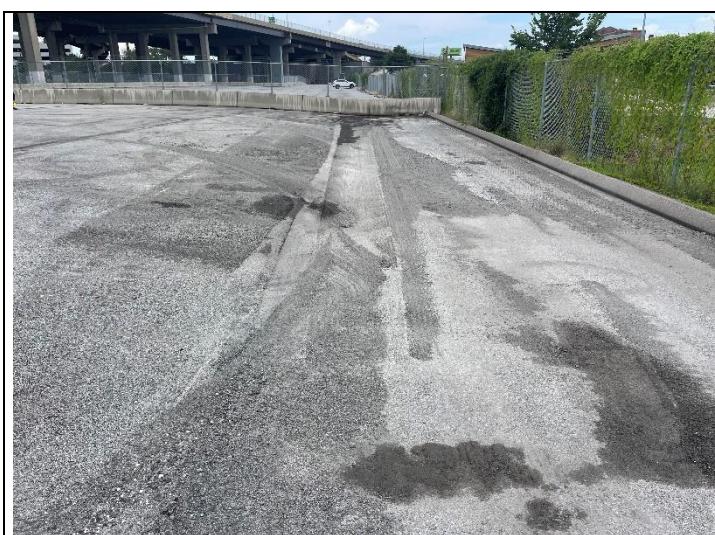
**PHOTO 5** Milled drainage channel

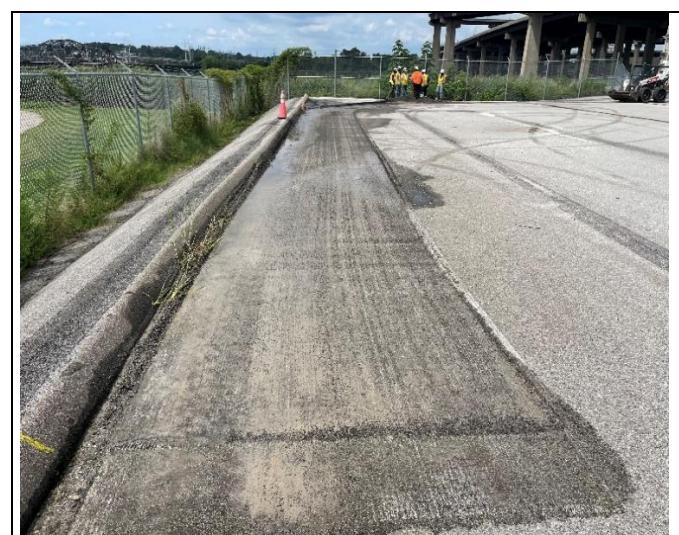
**PHOTO 6** Milled drainage channel

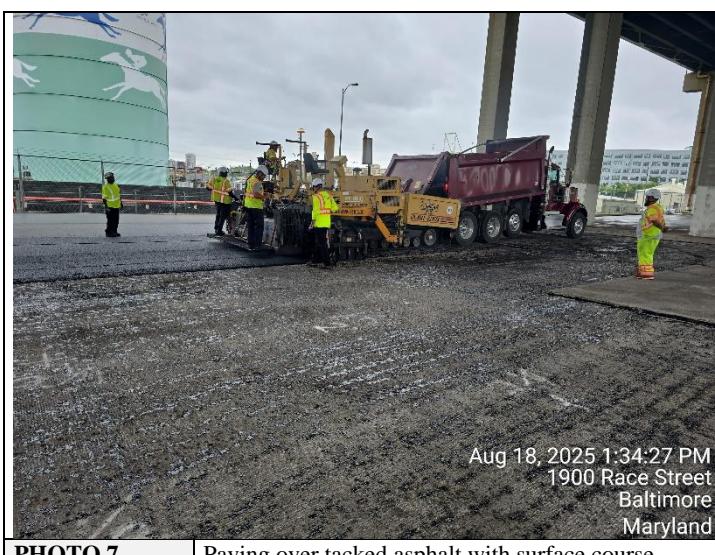
**PHOTO 7** Paving over tacked asphalt with surface course

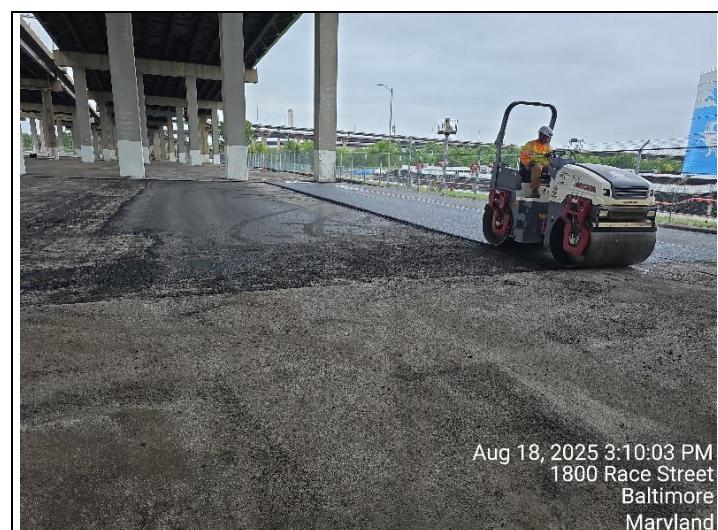
**PHOTO 8** Vibratory roller compacting surface course asphalt

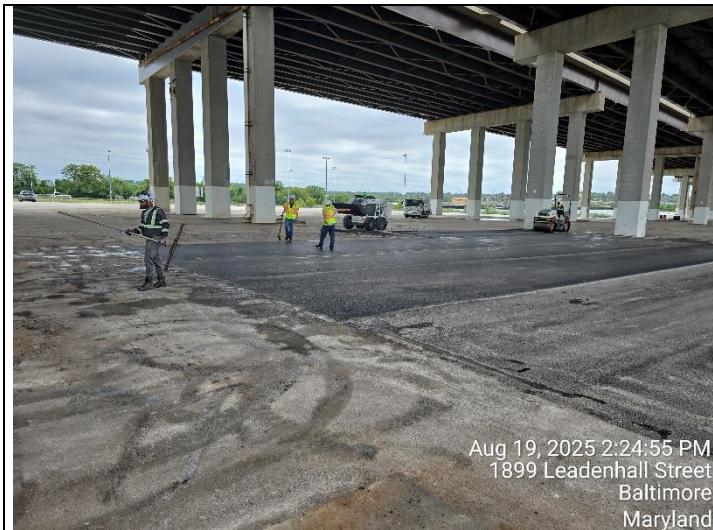
**PHOTO 9** Cleanup after paving

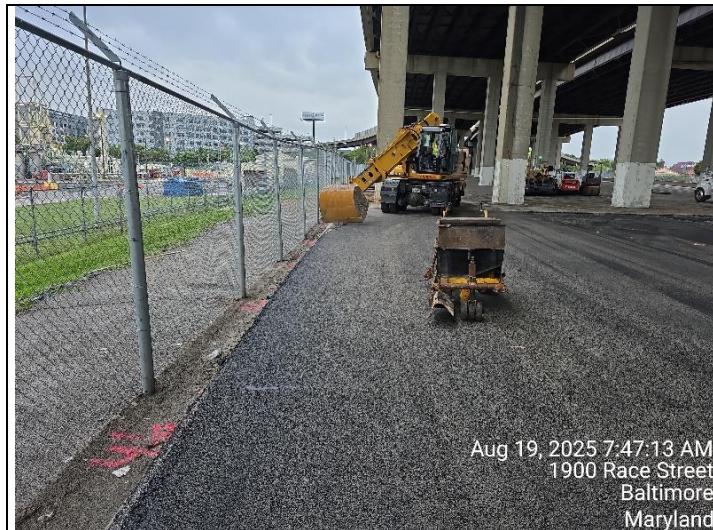
**PHOTO 10** Removal of old curb

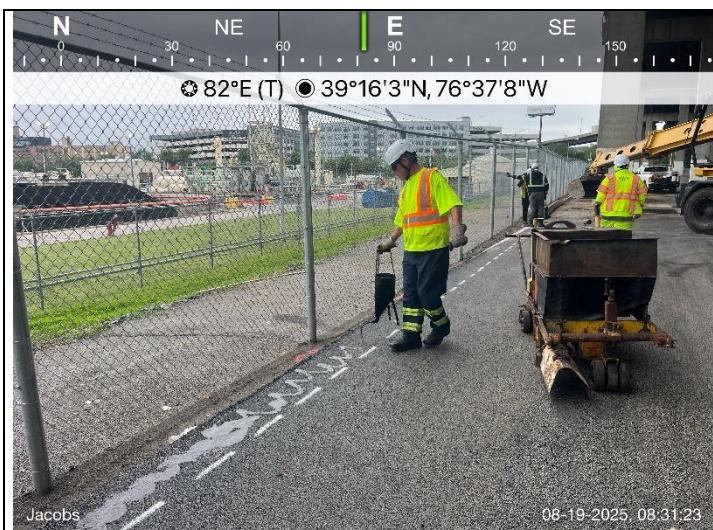
**PHOTO 11** Tack preparation for new curb

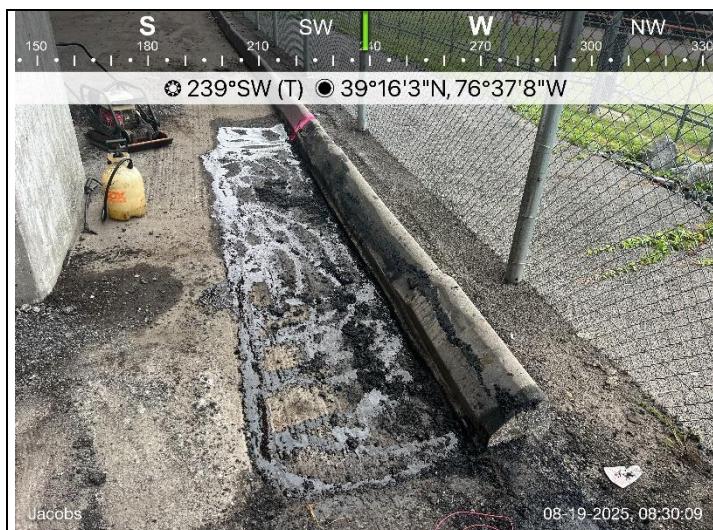
**PHOTO 12** Milled channel and new tack

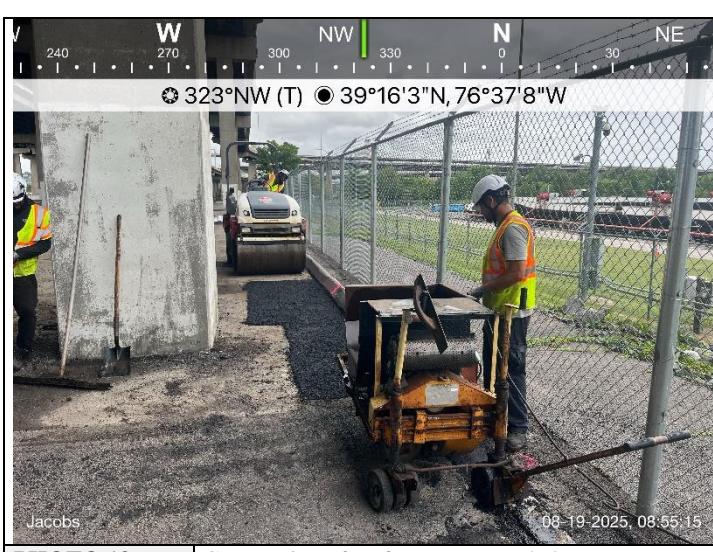
**PHOTO 13** Compaction of surface course asphalt

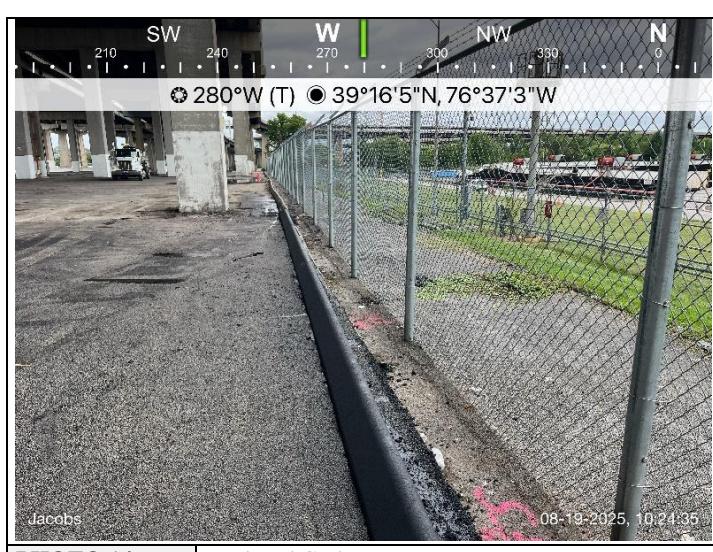
**PHOTO 14** Replaced Curb

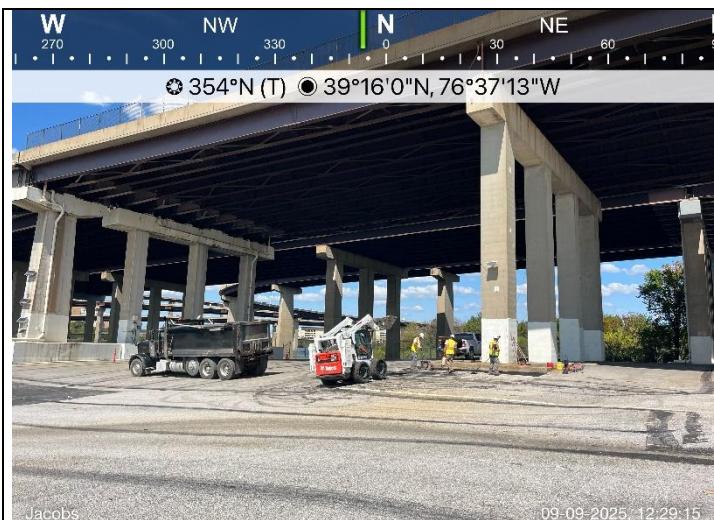
**PHOTO 15** Replacement of surface course asphalt at base of I-95 pier 1N-4

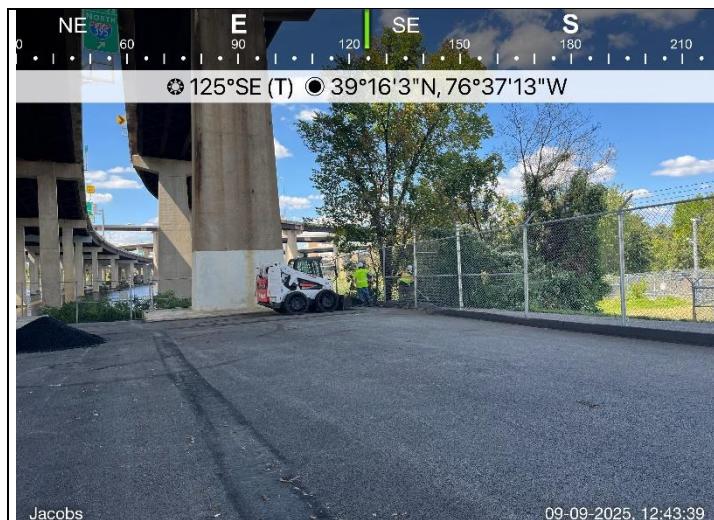
**PHOTO 16** Surface course asphalt replacement at NW corner of cap

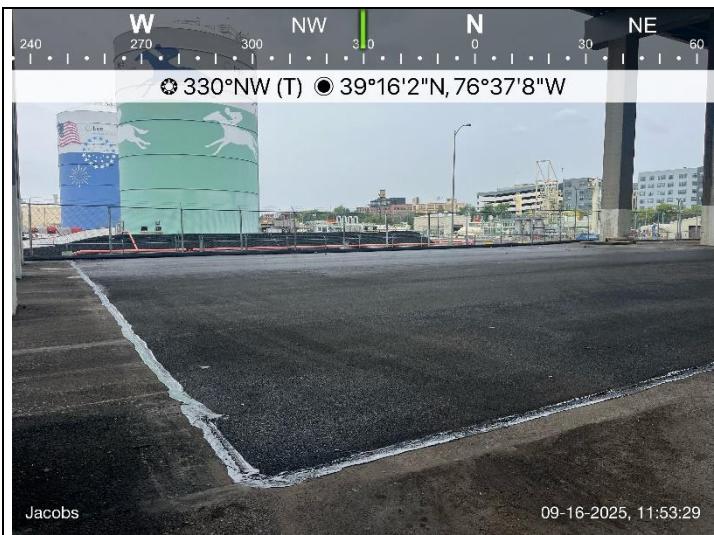
**PHOTO 17** Crack seal on asphalt seams

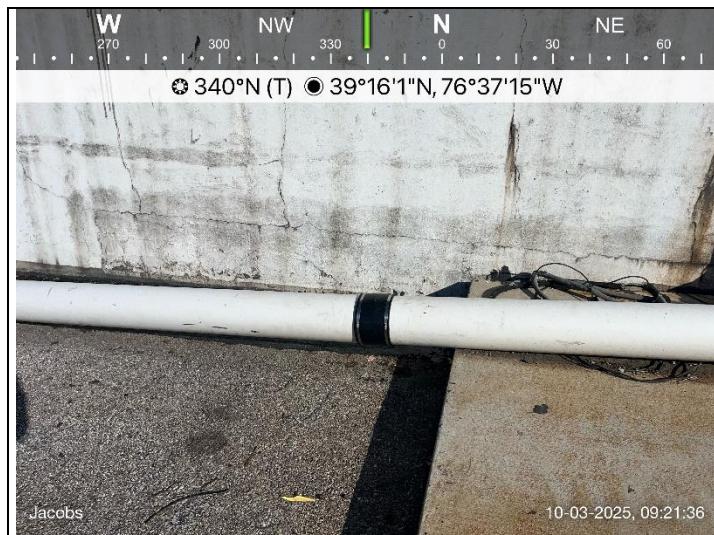
**PHOTO 18** Reinstanted I-95 drainage conveyance piping

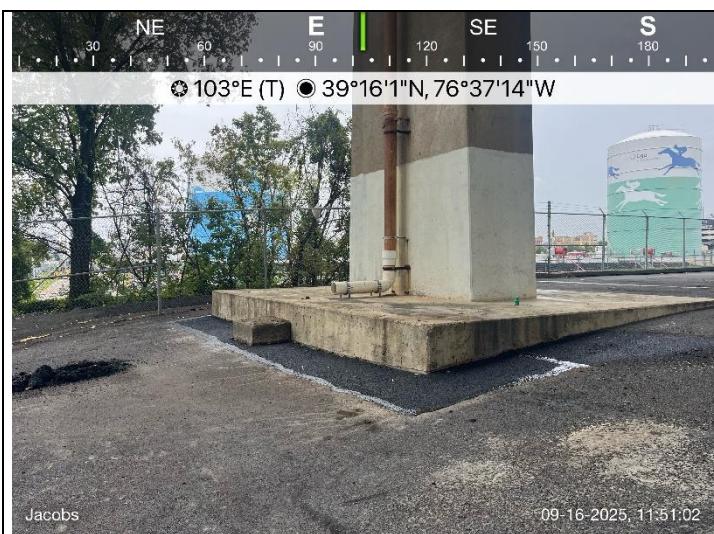
**PHOTO 19** Replacement of Dowsil crack filler at base of I-95 pier 1E

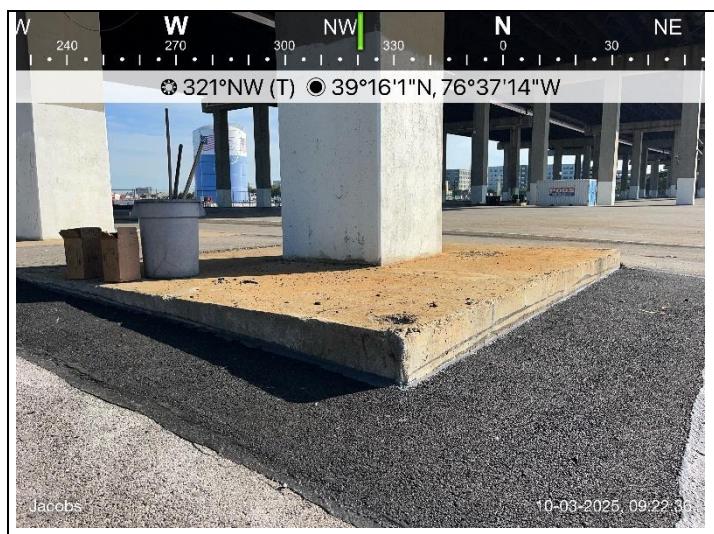
**PHOTO 20** Replacement of Asphalt and Dowsil crack filler at base of I-95 pier 1N-4
