Re: Transmittal of Quarterly Site Progress Report, First Quarter 2024, 2000 Race Street Site, Baltimore, Maryland

# First Quarter 2024 Site Progress Report

2000 Race Street Baltimore, Maryland

# Appendix A Site Inspection Reports

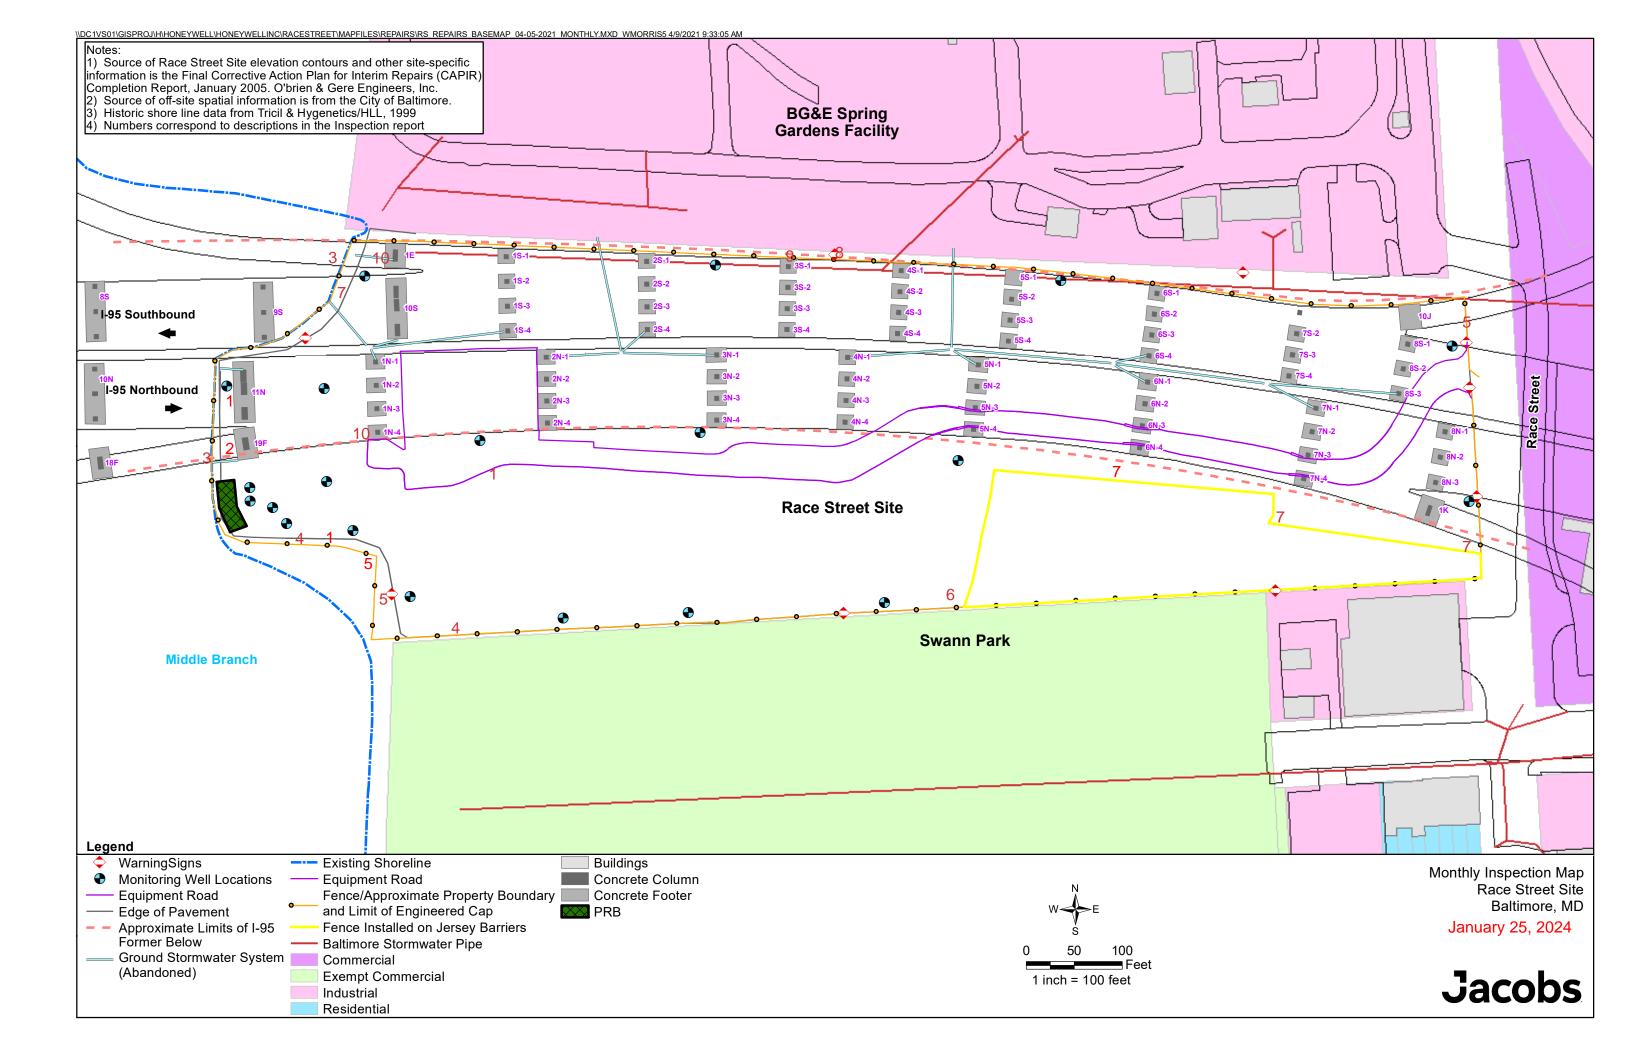
| Inspector: | Bill Morris | Date of Inspection: | | 25-Jan-24 |
|--|---|--|---|--|
| Inspect site for presence of surface debris. Identify type, approximate volume of debris, and location via description or on Site Plan (attach to Monthly Site | 7: Trash/debris accumulation | City notified of need to implement site maintenance | 1/10/2024 | City of Baltimore to address trash cleanup as part of site maintenance. |
| Inspect around pier footings for settlement. Identify settlement off-set from grade and location via description or on Site Plan (attach to Monthly Site Inspection Checklist) | 10: Asphalt settlement adjacent to pier footing. | City notified of settlement issue | 1/10/2024 | City to address settlement repair as part of site maintenance |
| Inspect cap for cracks less than 0.5 inches wide. Note number of cracks. Identify location of cracks via description or on Site Plan (attach to Monthly Site Inspection Checklist). | Crack with vegetation growth. Crack between asphalt and pier | City notified of need to implement vegetation control | 1/10/2024 | City of Baltimore to address vegetation control as part of site maintenance. |
| | 4: Sediment accumulation 6: Sediment with vegetation growth 8: Settlement along slope adjacent to asphalt 9: Crack in asphalt curb. | City notified of need to implement vegetation control, sediment cleanup and settlement issue | 1/10/2024 | City to address additional sediment cleanup along southern curb, vegetation control, and settlement repair as part of site maintenance |

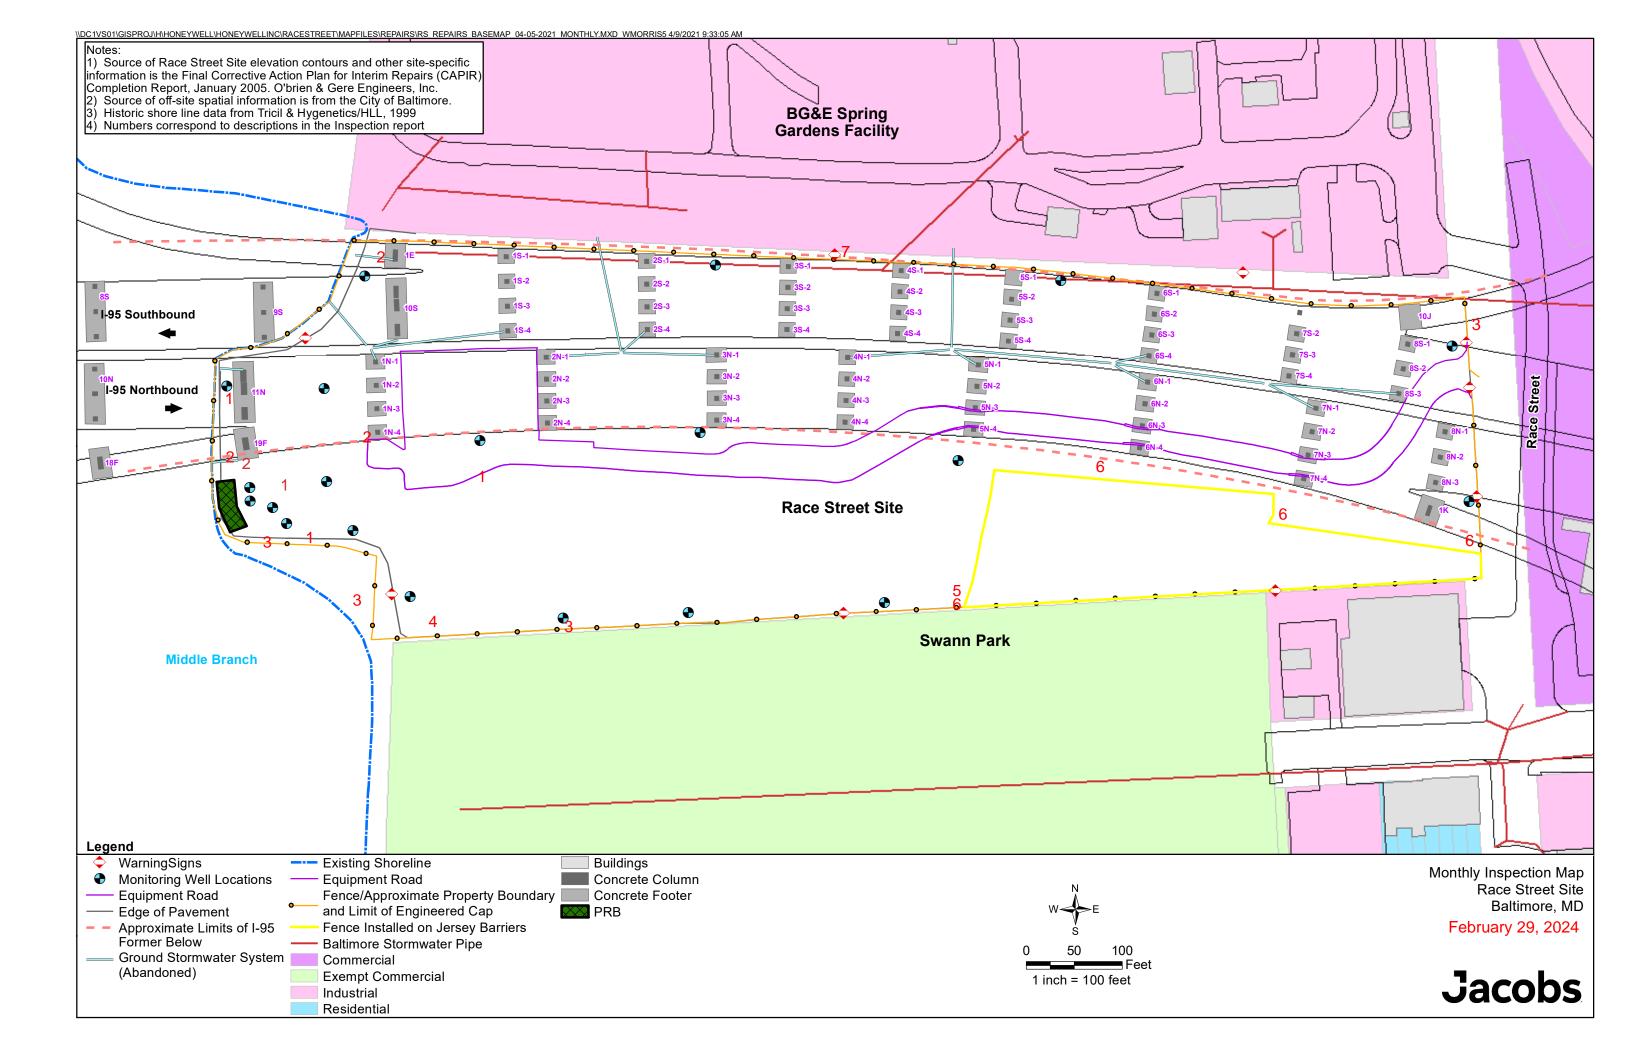
| Inspector: | | Date of Inspection: | | 29-Feb-24 |
|--|---|--|---|--|
| Inspect site for presence of surface debris. Identify type, approximate volume of debris, and location via description or on Site Plan (attach to Monthly Site Inspection Checklist). | 6: Trash/debris accumulation | City notified of need to implement site maintenance | 2/14/2024 | City of Baltimore to address trash cleanup as part of site maintenance. |
| Inspect site for presence of vegetation. Identify estimated amount and location of vegetation via description or on Site Plan (attach to Monthly Site Inspection Checklist) | 3: Vegetation growth along fence line. | City notified of need to implement vegetation control | 2/14/2024 | City of Baltimore to address vegetation control as part of site maintenance. |
| Inspect cap for cracks less than 0.5 inches wide. Note number of cracks. Identify location of cracks via description or on Site Plan (attach to Monthly Site Inspection Checklist). | 1: Crack with vegetation growth. | City notified of need to implement vegetation control | 2/14/2024 | City of Baltimore to address vegetation control as part of site maintenance. |
| Identify any other observations related to the condition of the cap and potential for cap damage | 4: Sediment accumulation 5: Sediment with vegetation growth 7: Settlement along slope adjacent to asphalt | City notified of need to implement<br>vegetation control, sediment<br>cleanup and settlement issue | 2/14/2024 | City to address additional sediment cleanup along southern curb, vegetation control, and settlement repair as part of site maintenance |

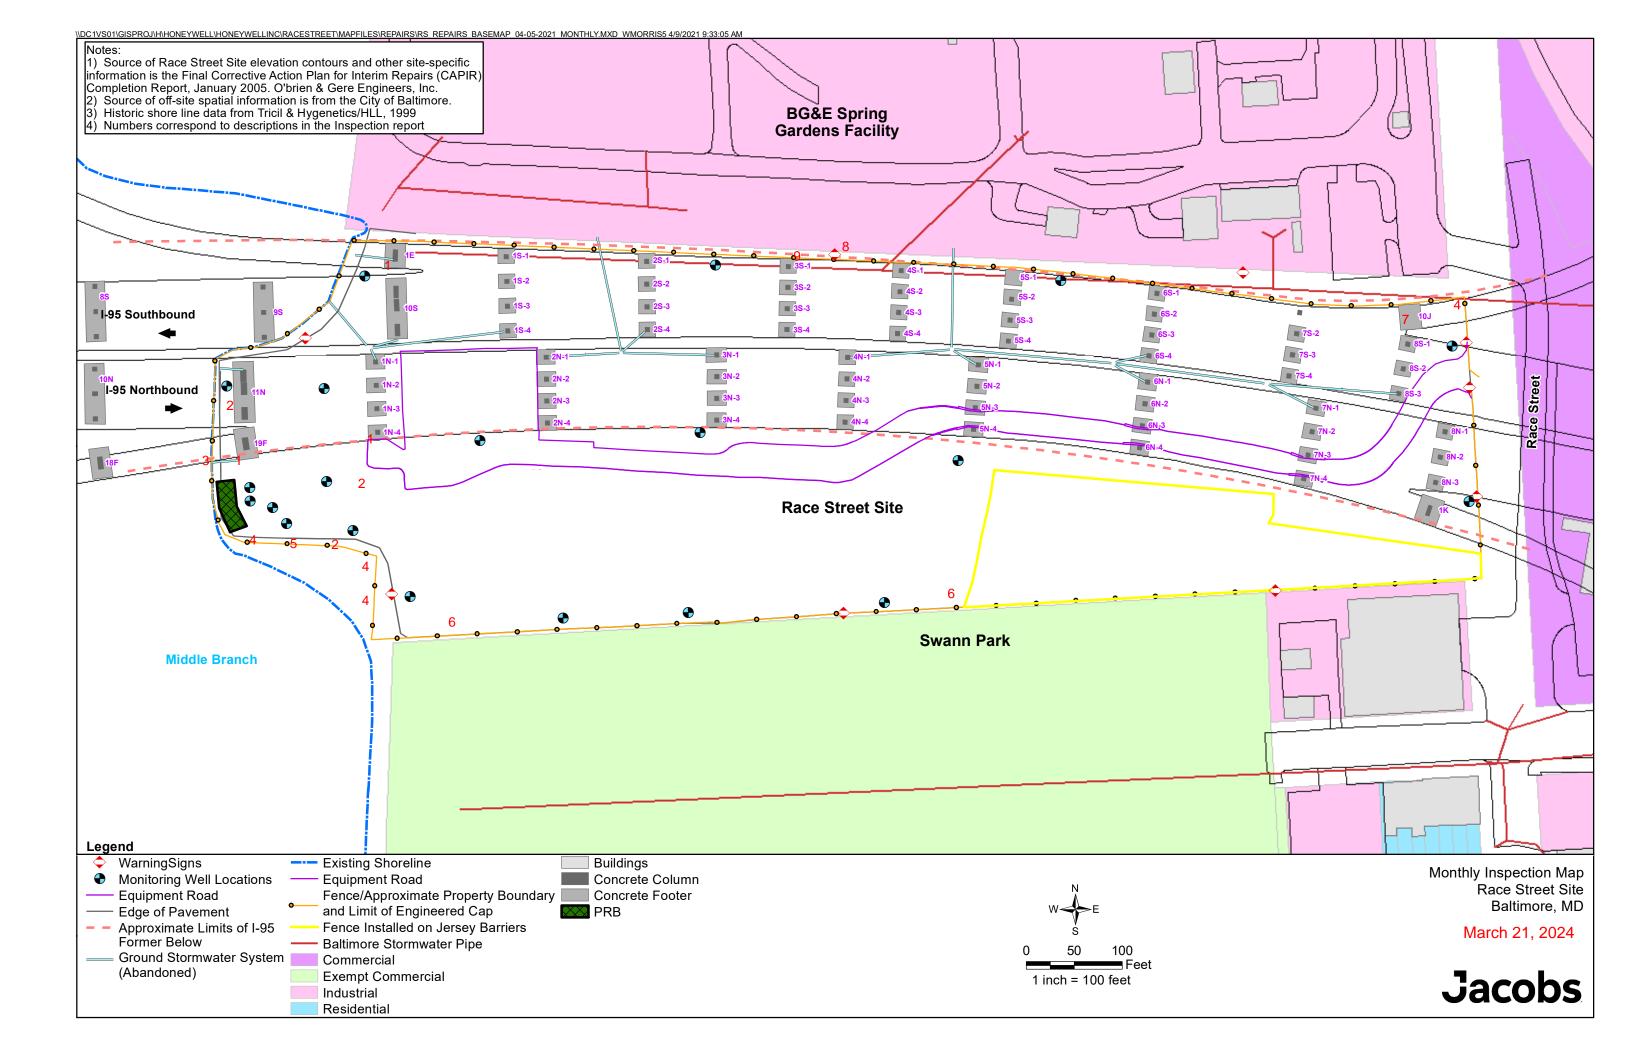
| Inspector: | Bill Morris | Date of Inspection: | | 21-Mar-24 |
|--|--|--|---|--|
| Inspect site for presence of vegetation. Identify | 2. Vegetation growth along shoreline | City potified of pood to implement | 3/13/2024 | City of Baltimara to address vagatation control of |
| Inspect cap for cracks less than 0.5 inches wide. Note number of cracks. Identify location of cracks via description or on Site Plan (attach to Monthly Site Inspection Checklist). | 2: Crack with vegetation growth. | City notified of need to implement vegetation control | 3/13/2024 | City of Baltimore to address vegetation control as part of site maintenance. |

| Site Inspection | Results | | | |
|---|--|---|---|--|
| Inspect aboveground stormwater conveyance system including piping, downspouts, and drain in southwest corner of site for proper operation | 7: Disconnected fitting at downspout | City notified of need to implement site maintenance | 3/13/2024 | City to address downspout repair as part of site maintenance |
