Subject:Transmittal of Quarterly Site Progress Report, Second Quarter 2013,
2000 Race Street Site, Baltimore, Maryland

Second Quarter 2013 Race Street Quarterly Site Progress Report, 2000 Race Street, Baltimore, Maryland

A Site Inspection Reports

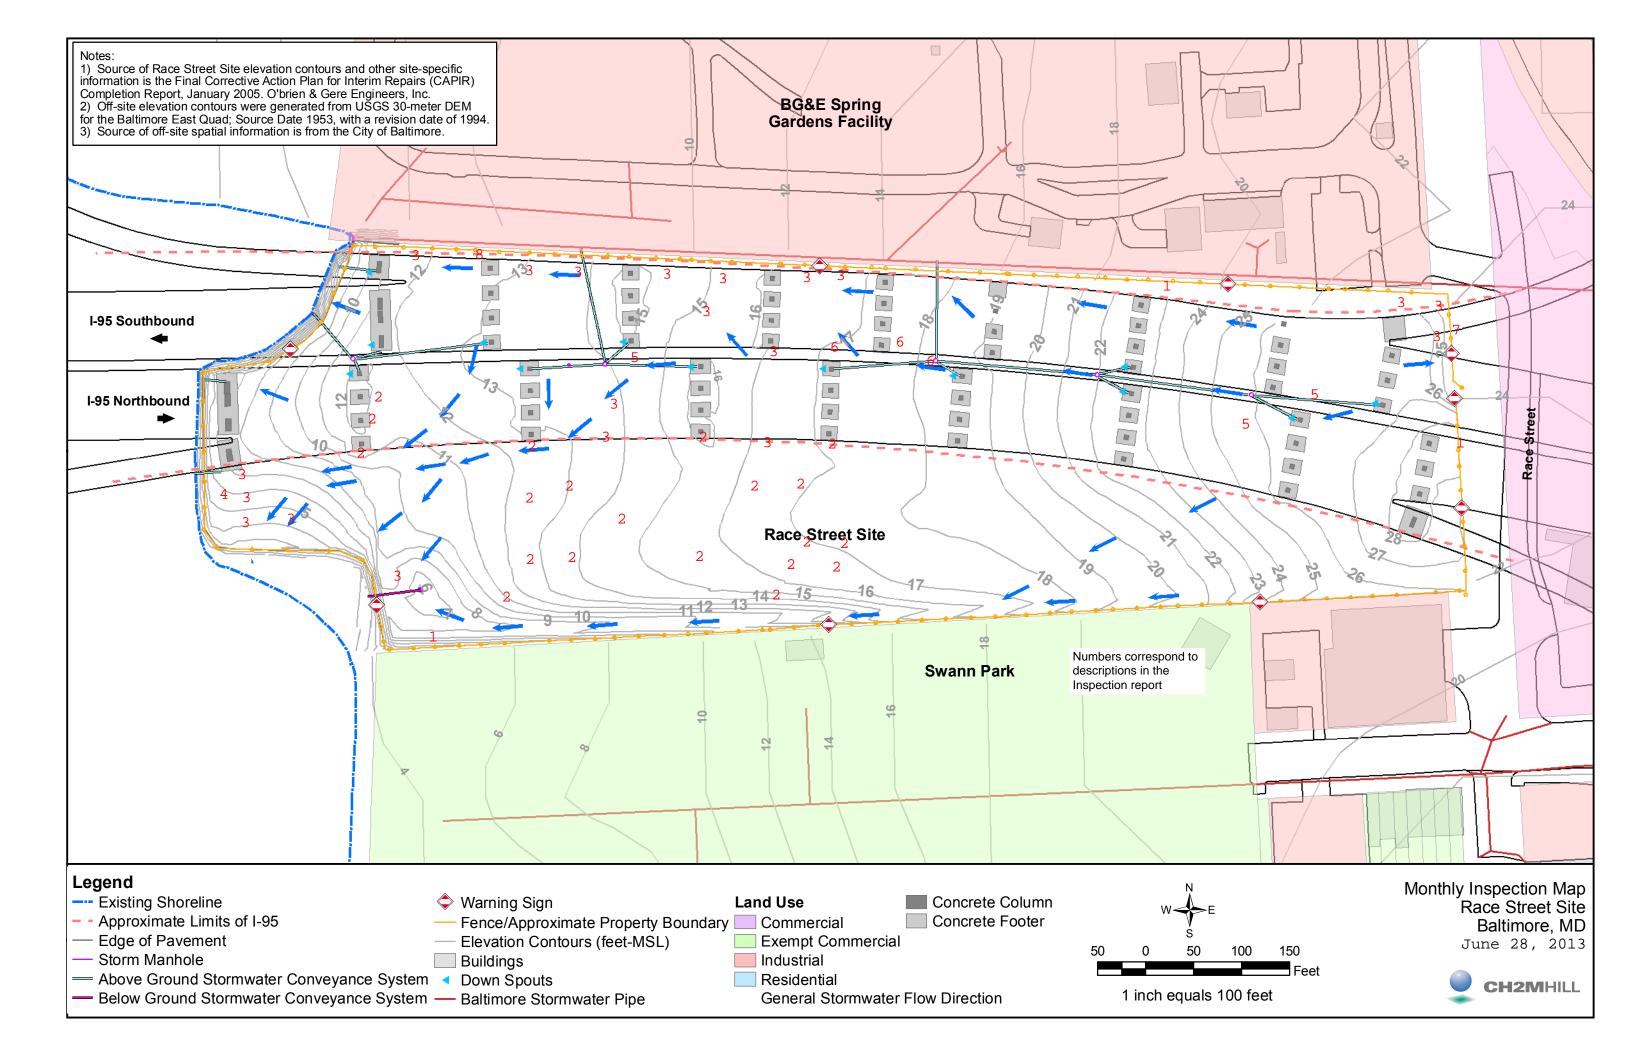
2. Interstate 95 Footings and Joints				
	None	None	NA	NA
	None	None	NA	NA
3. Engineered Cap				
	6) localized area with asphalt cracking	None	NA	Cap repairs periodically performed including crack sealing and asphalt patching.
Inspect cap for holes. Identify number of holes, width and depth, and location via description of on Site Plan (attach to Monthly Site Inspection Checklist)	 localized subsidence of asphalt surface. 	None	NA	Cap repairs periodically performed including crack sealing and asphalt patching.
Inspect cap for cracks less than 0.5 inches wide. Note number of cracks. Identify location of cracks via description or on Site Plan (attach to Monthly Site Inspection Checklist).	 localized cracks with vegetation. 			Herbicide application to be made by City during scheduled maintenance activities (see note below).
,	None	None	NA	NA
Inspect cap for any signs of ponding of water	5) localized pooled water	None	NA	Cap repairs periodically performed including crack sealing and asphalt patching.

7) damaged barbed wire top guard			City to perform fence repairs as part of scheduled maintenance activities.
Inspect gates, chains, and locks for damage	None	None		
Inspect fence to determine if any vegetation is damaging or otherwise compromising fence	1) vegetation along fence	None	NA	Herbicide application to be made by City during scheduled O&M activities (see note below).
Inspect fence to determine if there is any burrowing beneath fence	None	None	NA	NA
Identify any other observations related to the condition of the fence and potential for fence damage (e.g., points of weakness, corrosion)	None	None	NA	NA
