**Re: Transmittal of Quarterly Site Progress Report, Second Quarter 2023, 2000 Race Street Site, Baltimore, Maryland**

# Second Quarter 2023 Site Progress Report

2000 Race Street  
Baltimore, Maryland

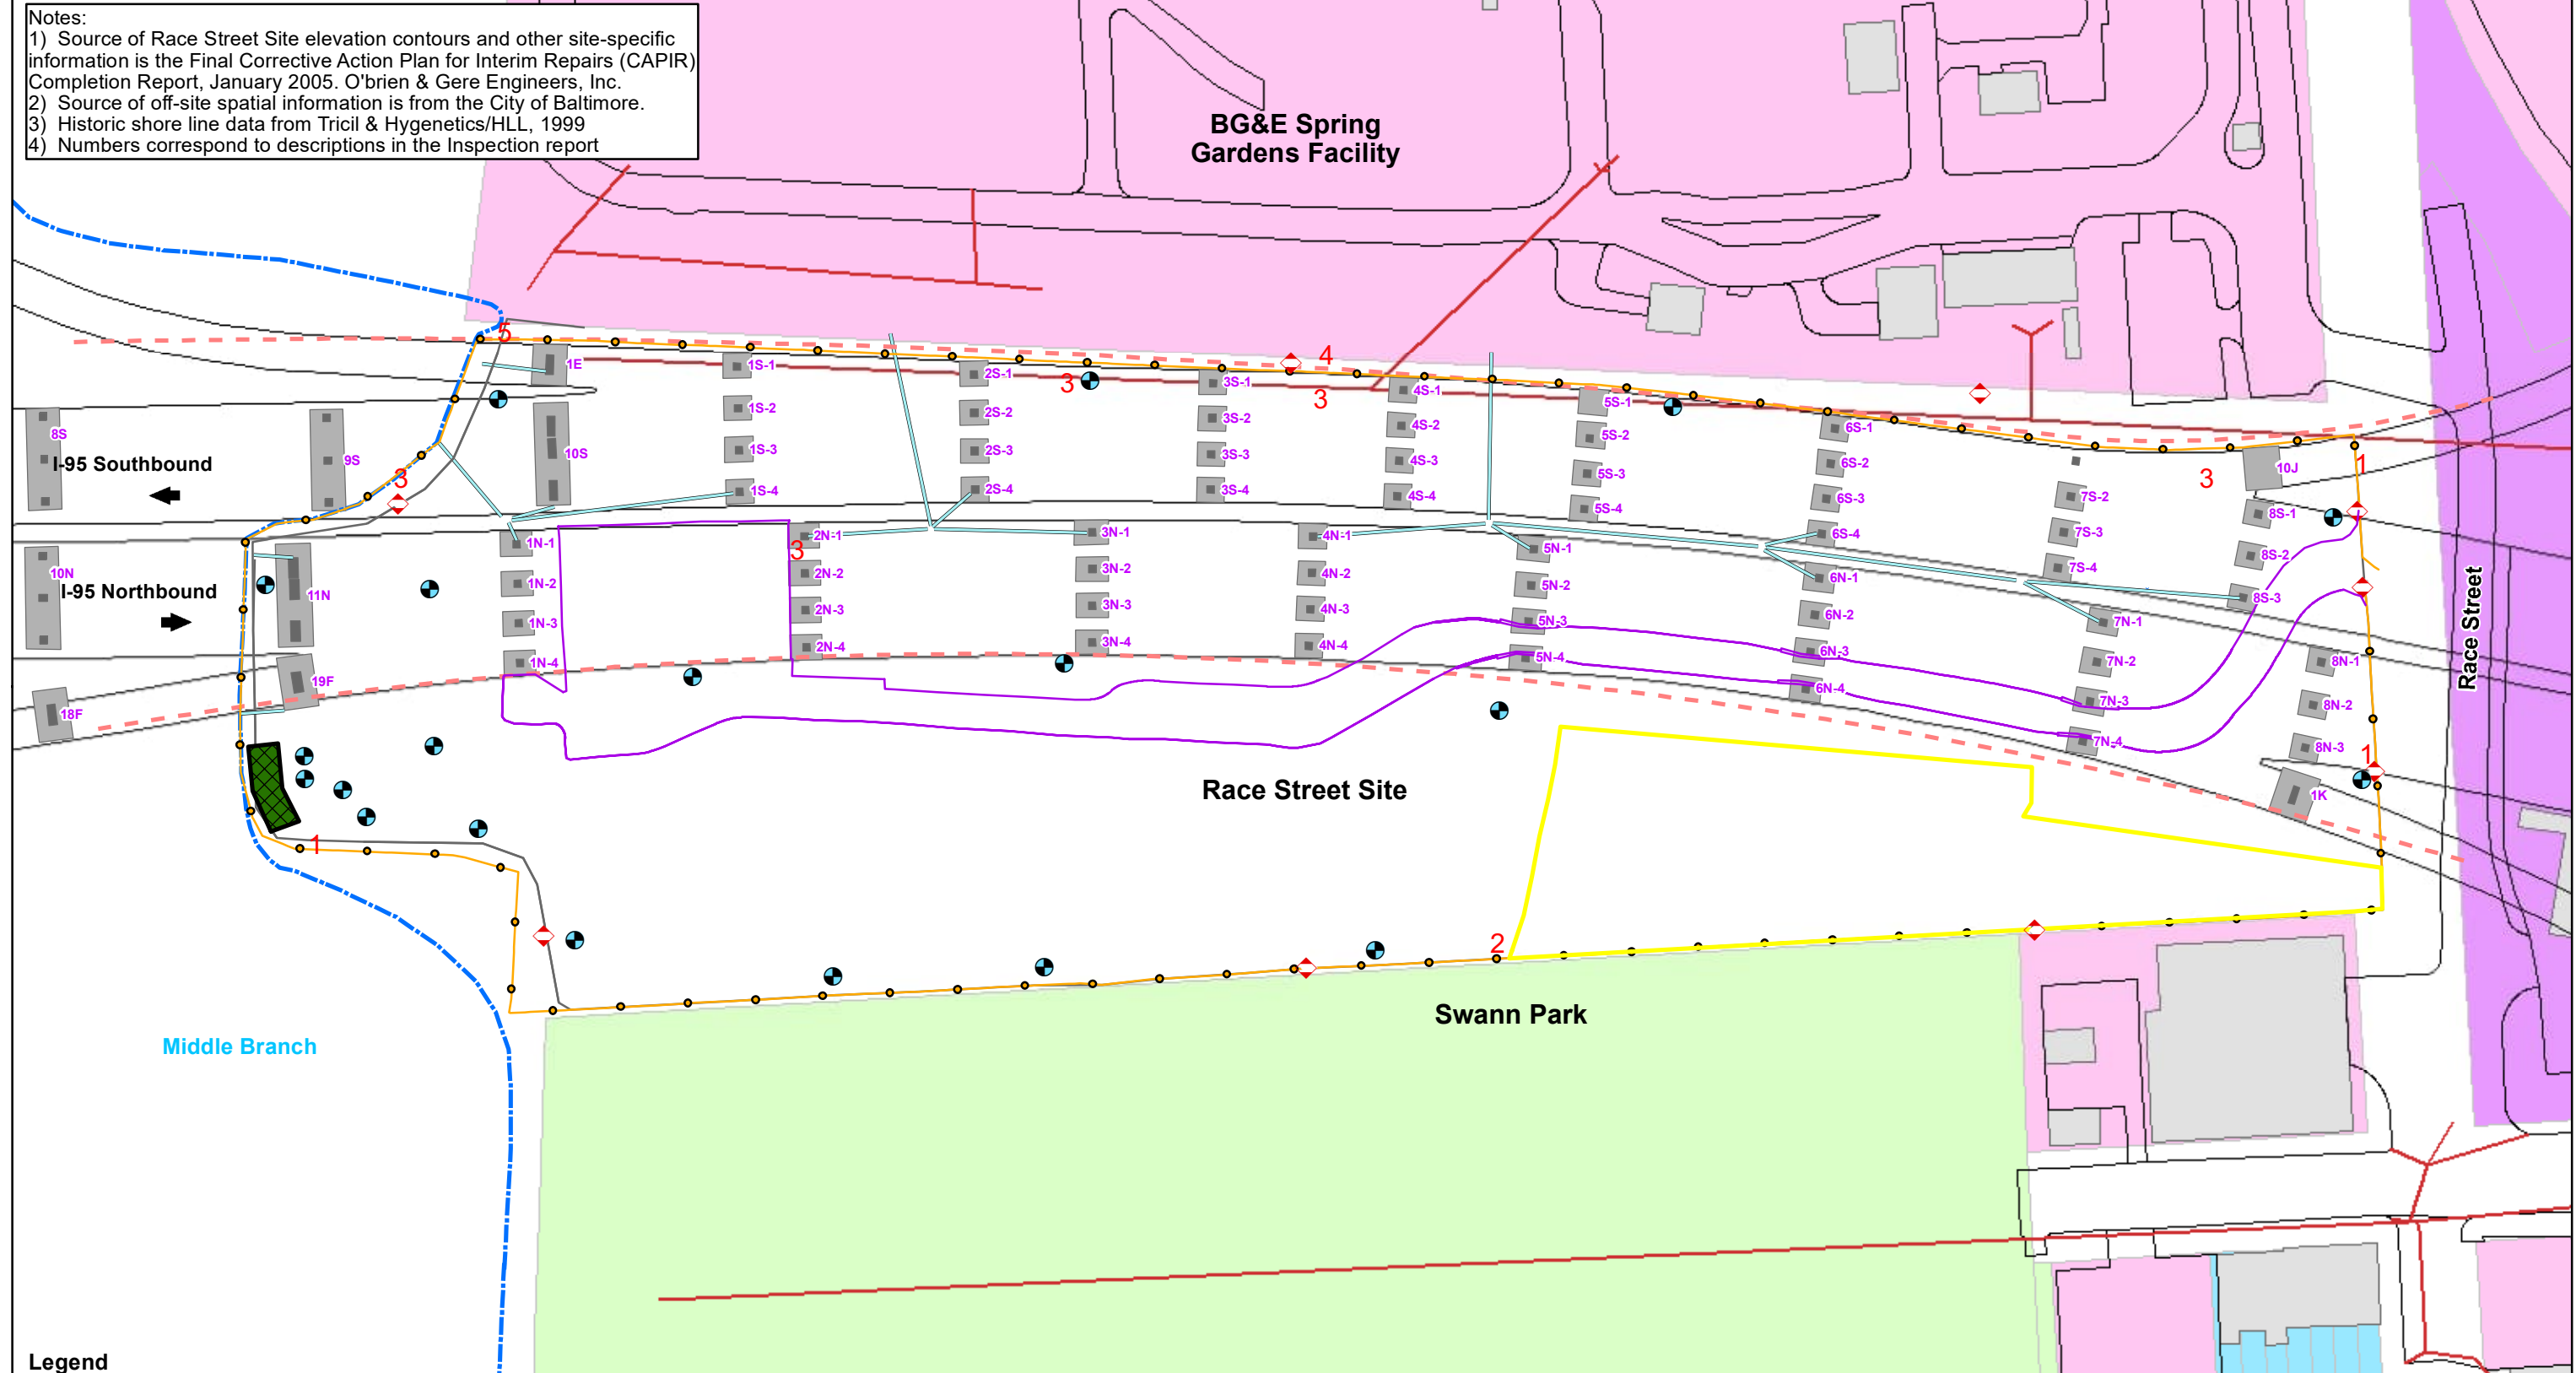
Monthly Inspection Map  
 Race Street Site  
 Baltimore, MD  
 April 20, 2023

Inspect cap for any signs of ponding of water	None	None	NA	NA
Inspect shorefront embankment for evidence of erosion or releases	None	None	NA	NA
Identify any other observations related to the condition of the cap and potential for cap damage	2: Sediment with vegetation growth 3: Sediment accumulation 4: Settlement along slope adjacent to asphalt	City notified of need to implement vegetation control, sediment cleanup and settlement issue	5/10/2023	City of Baltimore to address vegetation control, sediment cleanup and settlement repair as part of site maintenance.

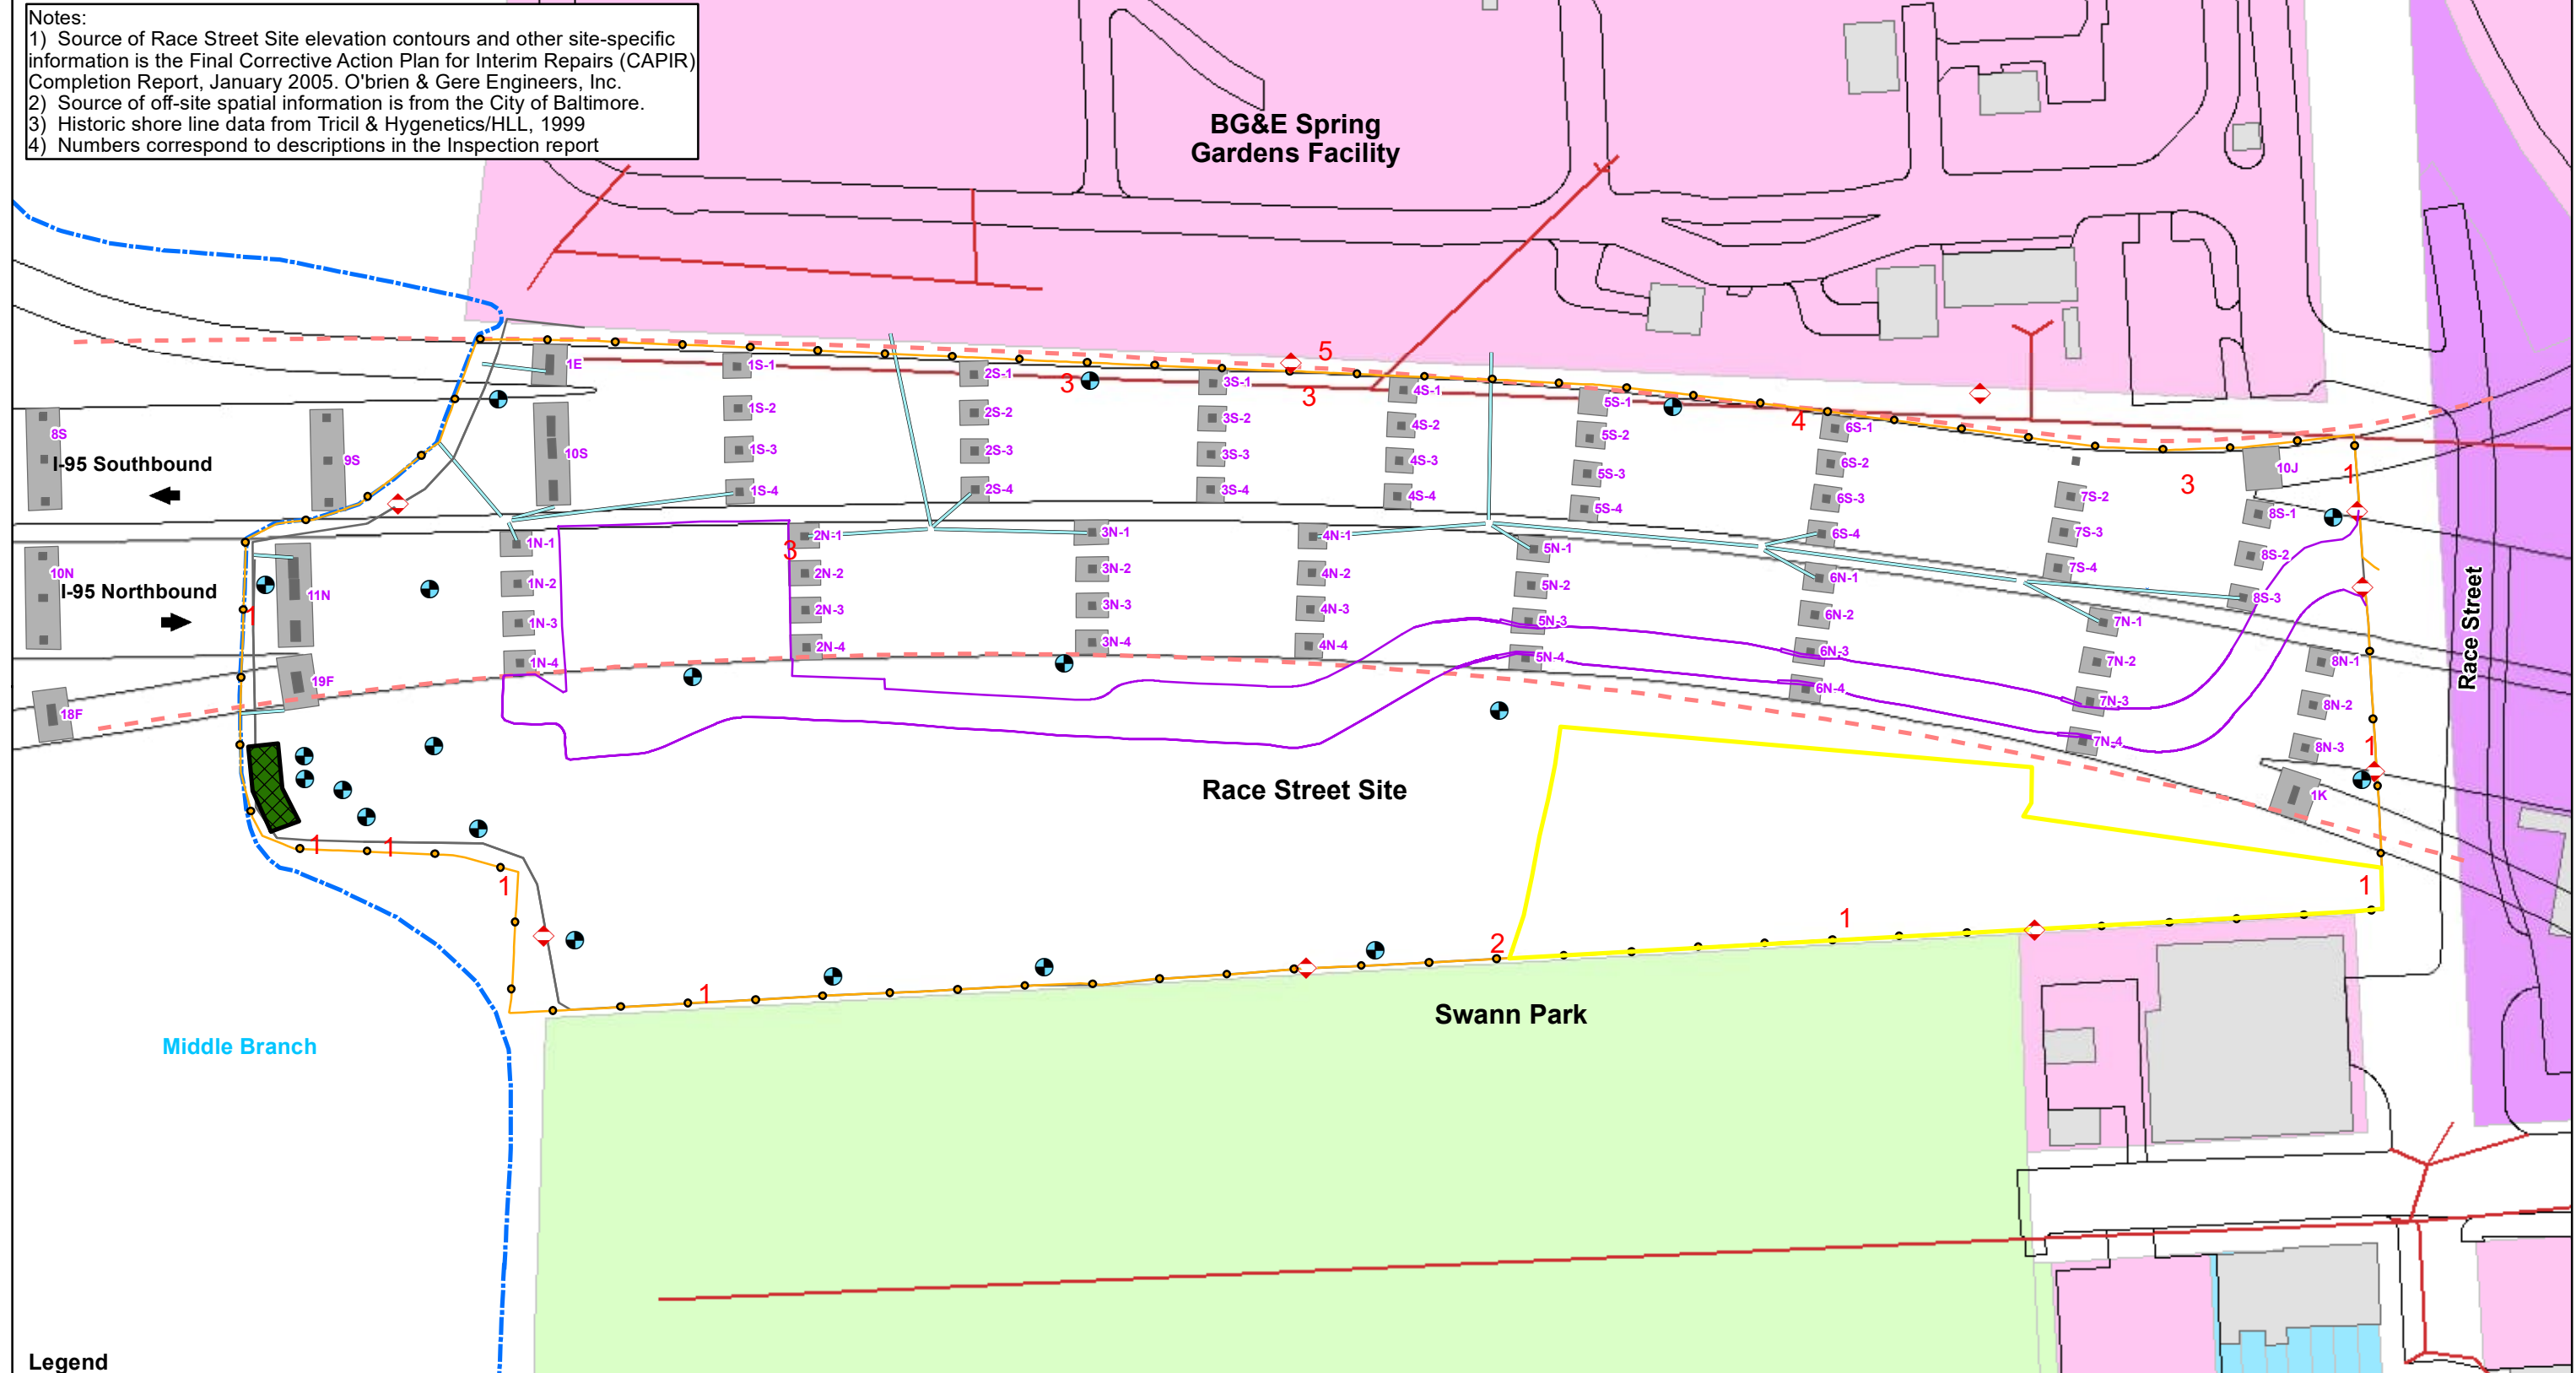
Monthly Inspection Map  
 Race Street Site  
 Baltimore, MD  
 May 18, 2023

Site Inspection Results				
Task	Observations	Actions Taken	Date Completed	Comments/Additional Observations
<b>1. General</b>				
Inspect site for presence of surface debris. Identify type, approximate volume of debris, and location via description or on Site Plan (attach to Monthly Site Inspection Checklist).	4: Trash accumulation along curb	City notified of need to implement debris cleanup	6/5/2023	City of Baltimore to address debris cleanup as part of site maintenance.
Inspect site for presence of vegetation. Identify estimated amount and location of vegetation via description or on Site Plan (attach to Monthly Site Inspection Checklist)	1: Vegetation growth along fence line.	City notified of need to implement vegetation control	6/5/2023	City of Baltimore to address vegetation control as part of site maintenance.
<b>2. Interstate 95 Footings and Joints</b>				
Inspect around pier footings for settlement. Identify settlement off-set from grade and location via description or on Site Plan (attach to Monthly Site Inspection Checklist)	None	None	NA	NA

Identify any other observations related to the condition of the cap and potential for cap damage	2: Sediment with vegetation growth 3: Sediment accumulation 5: Settlement along slope adjacent to asphalt	City notified of need to implement vegetation control, sediment cleanup and settlement issue	6/5/2023	City of Baltimore to address vegetation control, sediment cleanup and settlement repair as part of site maintenance.

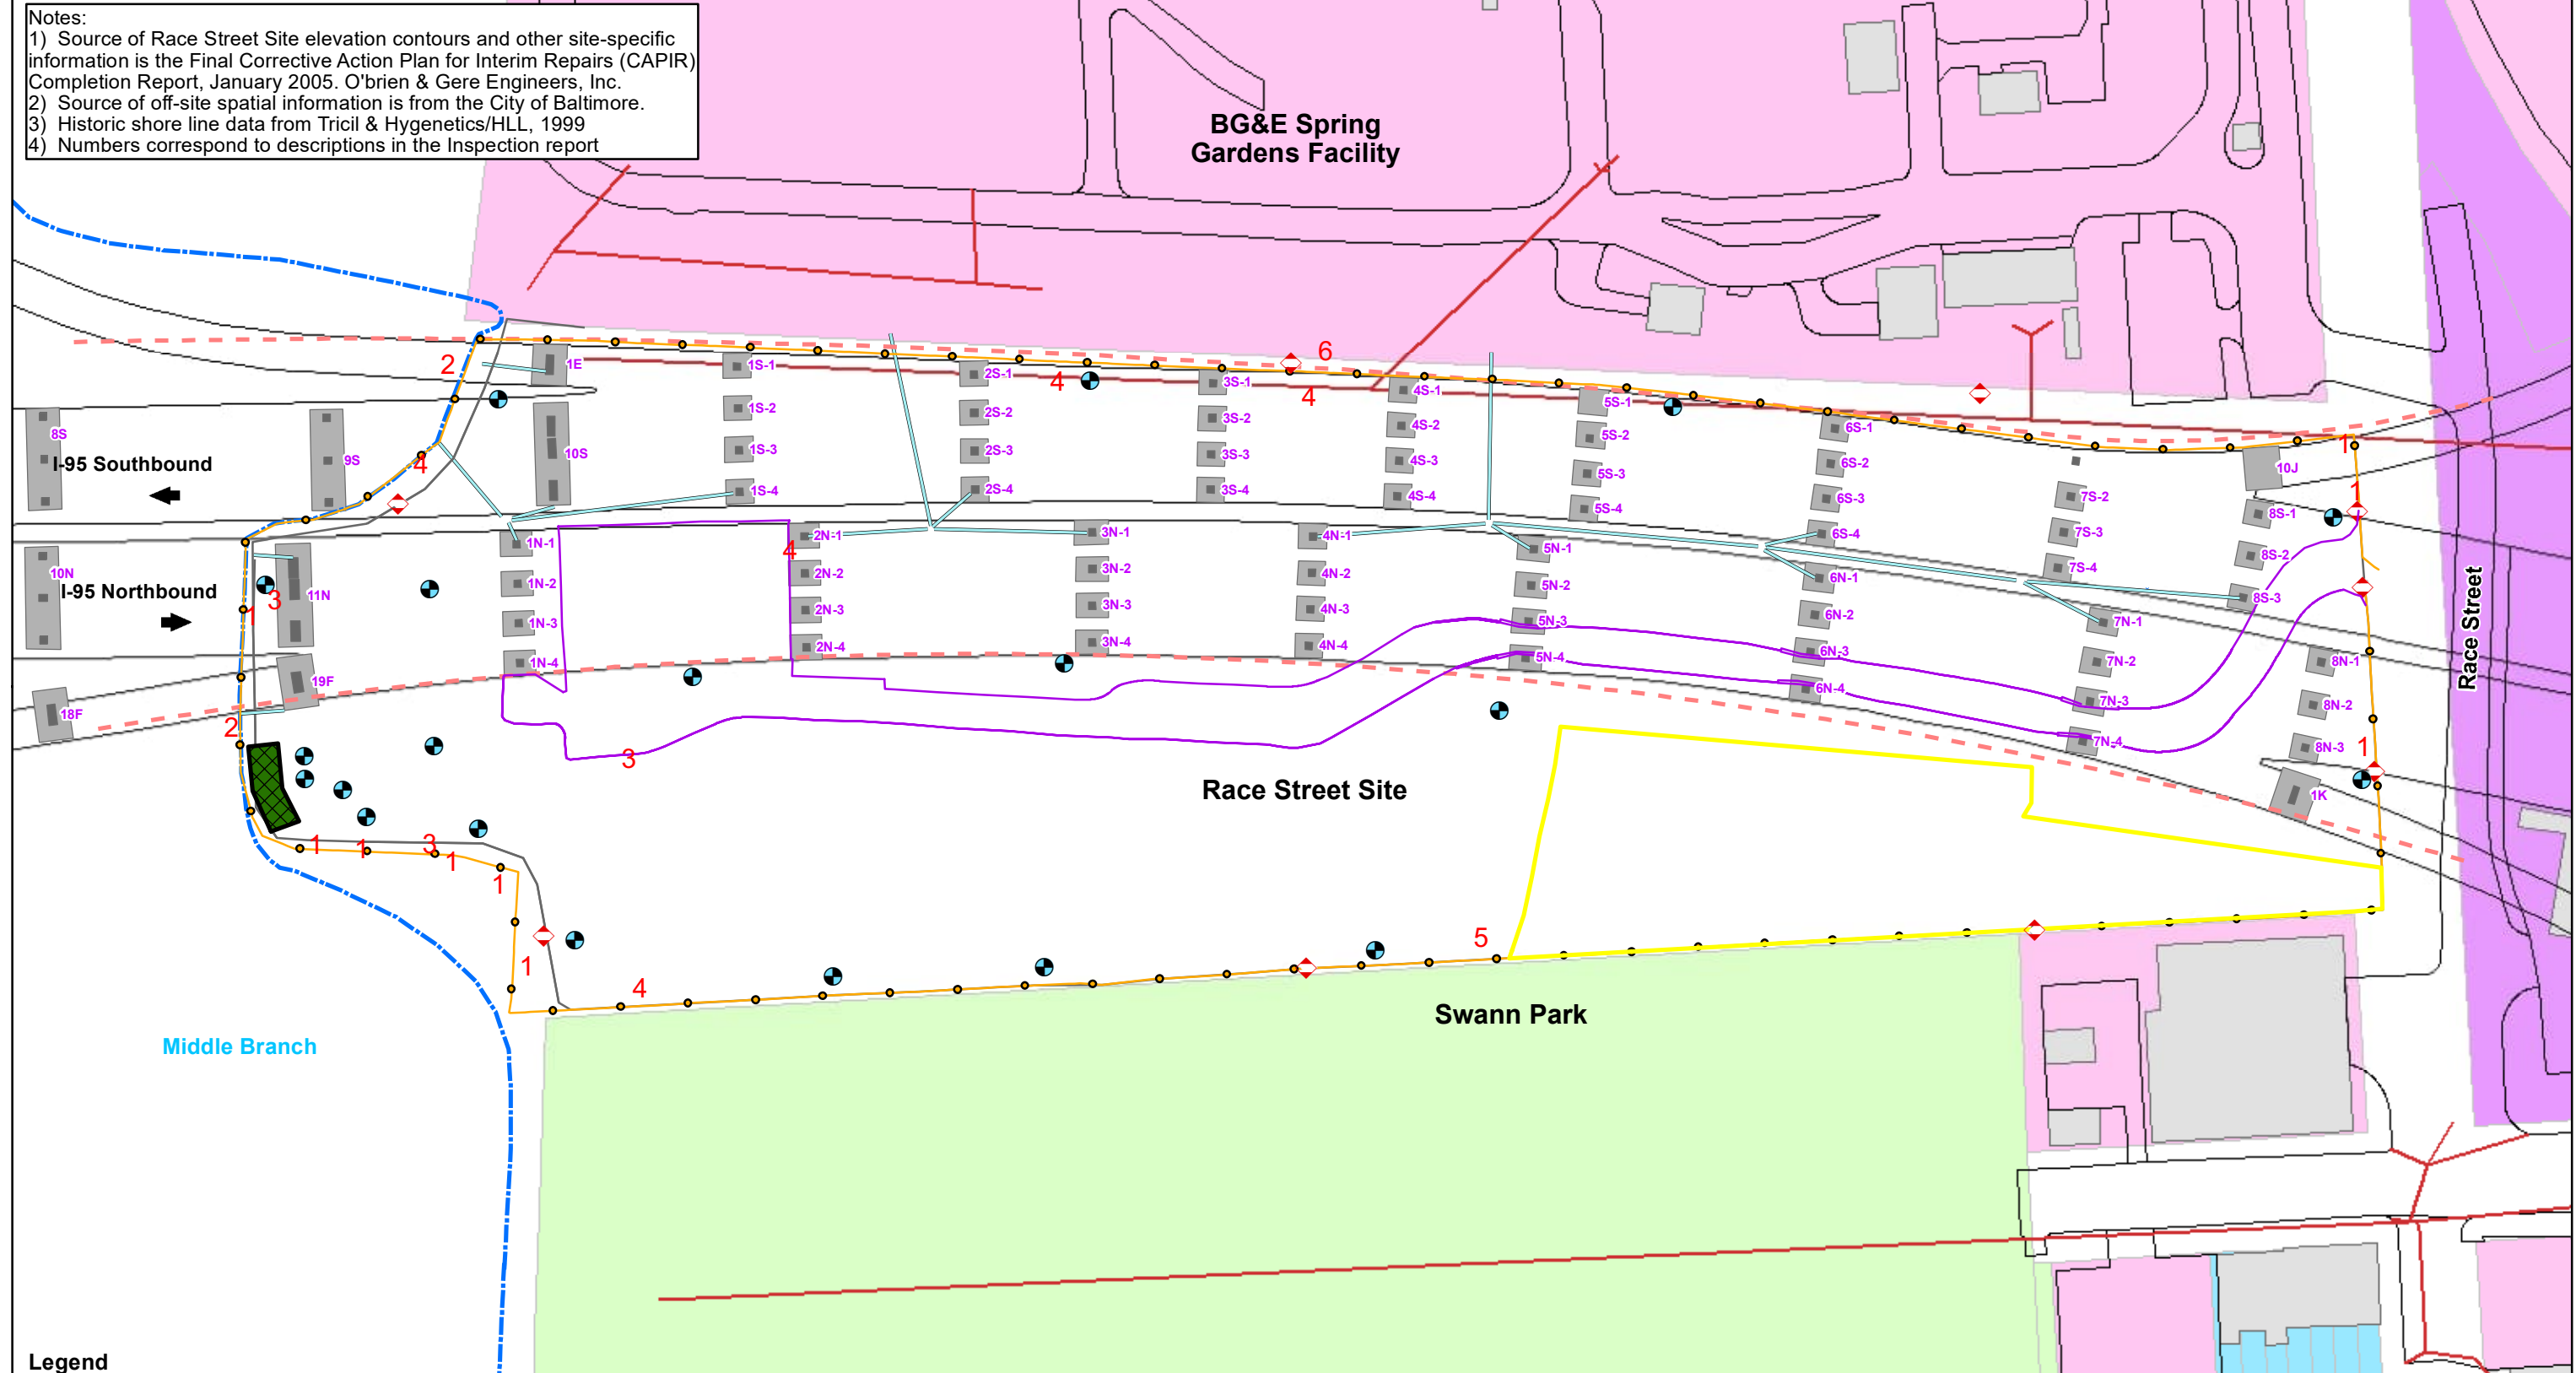
Monthly Inspection Map  
 Race Street Site  
 Baltimore, MD  
 June 15, 2023

Inspect cap for any signs of ponding of water	None	None	NA	NA
Inspect shorefront embankment for evidence of erosion or releases	None	None	NA	NA
Identify any other observations related to the condition of the cap and potential for cap damage	5: Sediment with vegetation growth 4: Sediment accumulation 6: Settlement along slope adjacent to asphalt	City notified of need to implement vegetation control, sediment cleanup and settlement issue	6/15/2023	City of Baltimore to address vegetation control, sediment cleanup and settlement repair as part of site maintenance.
